Profile/Photo Observation Report

Date:	03/26/2018	Weather:		Coding:	PACP 6.0
Pipe Length (ft):	332.7	Owner:	NA	Pre Clean:	No Pre-Cleaning
P.O.#:		Surveyor:	Justin Gonzales	PSR:	P-507-061-062
Customer:		Clean Date:	01/01/1900	Shape:	C

Street:	W 13TH PL	Flow Control:	Not Controlled
City:	Hobart, IN	Year Renewed:	
Location:	Light Highway	Tape/Media #:	
Purpose:	Routine Assessment	Dia/Height:	8"
Use:	Sanitary	Material:	PVC
Drain Area:	NA	Lining:	
Category:	NA		
Comment:	P_C at 326 ft debris . Flow direction wrong		
Location Details:		Direction of Survey:	Downstream
US MH:	M-507-062	DS MH:	M-507-061
		Total Length Surveyed (ft):	327.7

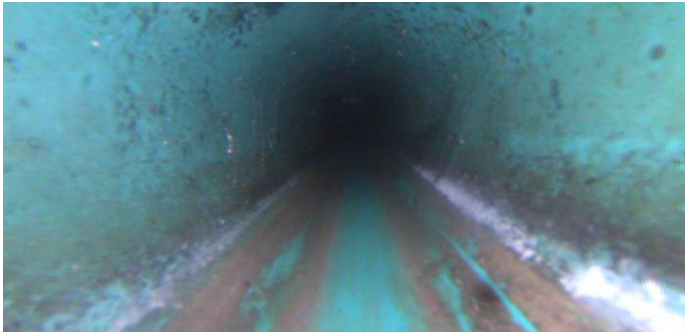
Code:	MWL
Description:	Water Level

Distance (ft):	.0
Structural Grade:	0
O&M Grade:	0
Clock Start/From:	
Clock To:	
1st Value:	
2nd Value:	
Value Percent:	5.000
Continuous Index:	
Within 8" of Joint:	NO
Remarks:

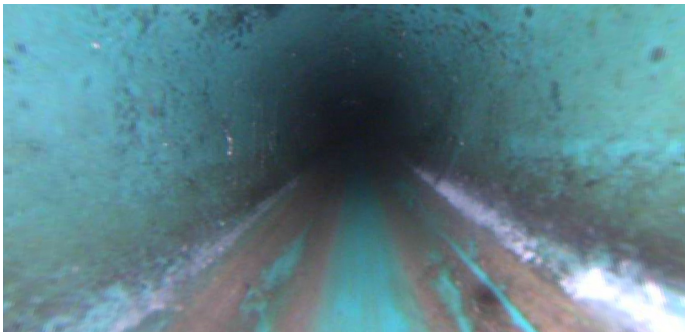
Code:	DAGS
Description:	Deposits Attached Grease

Distance (ft):	.0
Structural Grade:	0
O&M Grade:	2
Clock Start/From:	7
Clock To:	5
1st Value:	
2nd Value:	
Value Percent:	5.000
Continuous Index:	S01
Within 8" of Joint:	YES
Remarks:	WANDER

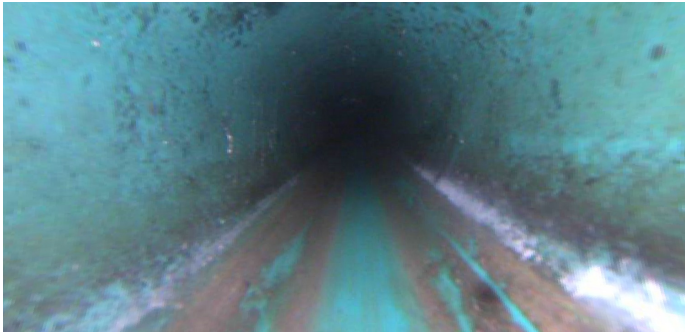
Code: **DAZ**
Description: **Deposits Attached Other**

Distance (ft): **.0**
Structural Grade: **0**
O&M Grade: **2**
Clock Start/From: **7**
Clock To: **5**
1st Value:
2nd Value:
Value Percent: **5.000**
Continuous Index: **S02**
Within 8" of Joint: **YES**
Remarks: **WANDER**

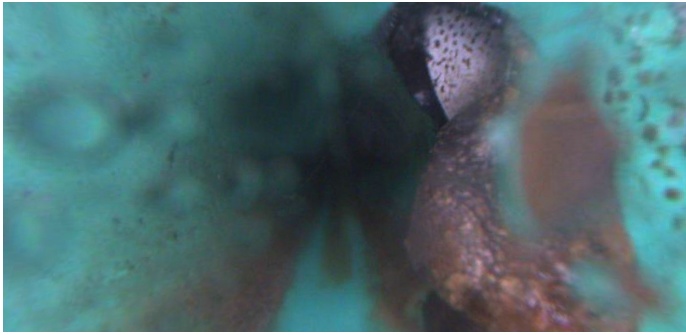
Code: **DAE**
Description: **Deposits Attached Encrustation**

Distance (ft): **167.4**
Structural Grade: **0**
O&M Grade: **2**
Clock Start/From: **2**
Clock To: **4**
1st Value:
2nd Value:
Value Percent: **10.000**
Continuous Index:
Within 8" of Joint: **NO**
Remarks:

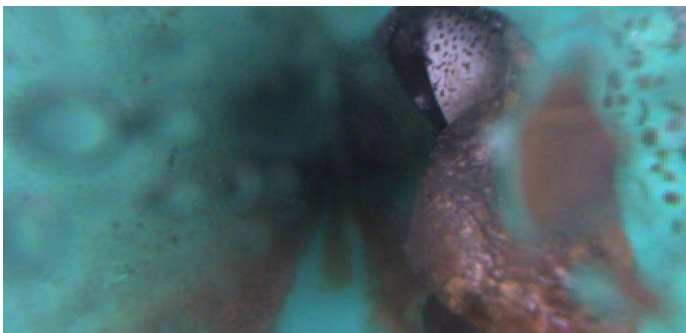
Code: **TFD**
Description: **Tap Factory Defective**

Distance (ft): **167.4**
Structural Grade: **0**
O&M Grade: **2**
Clock Start/From: **2**
Clock To:
1st Value: **4.000**
2nd Value:
Value Percent:
Continuous Index:
Within 8" of Joint:
Remarks: **DEPOSITS BLOCKING MOUTH OF TAP**

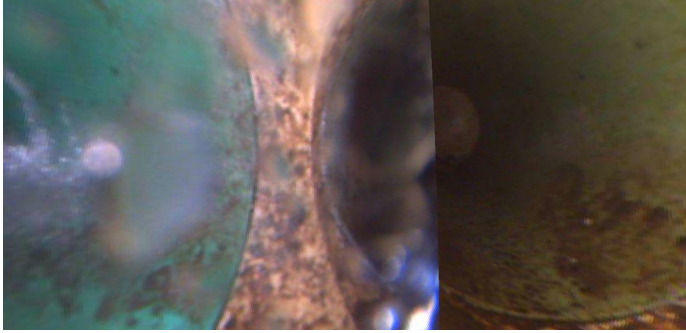
Code: **TFC**
Description: **Tap Factory Capped**

Distance (ft): **174.6**
Structural Grade: **0**
O&M Grade: **0**
Clock Start/From: **2**
Clock To:
1st Value: **4.000**
2nd Value:
Value Percent:
Continuous Index:
Within 8" of Joint:
Remarks:

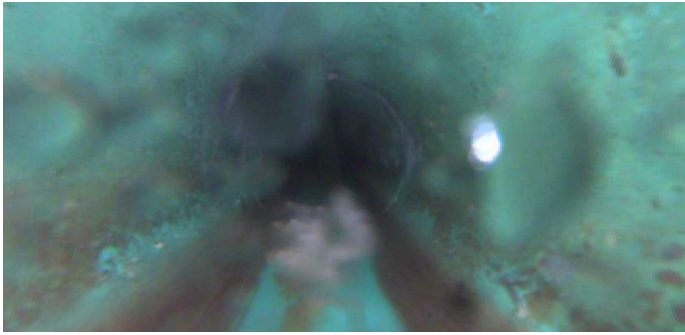
Code: **MGO**
Description: **General Observation**

Distance (ft): **251.3**
Structural Grade: **0**
O&M Grade: **0**
Clock Start/From:
Clock To:
1st Value:
2nd Value:
Value Percent:
Continuous Index:
Within 8" of Joint: **NO**
Remarks: **TOILET TISSUE**

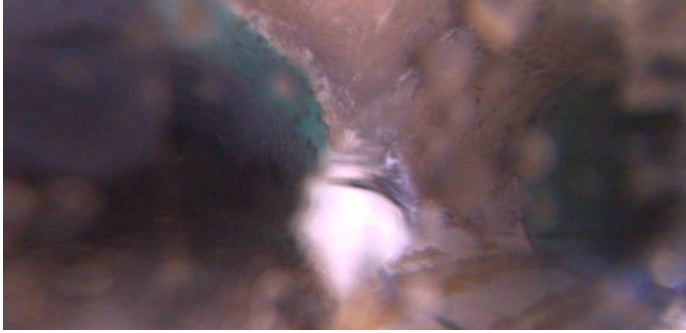
Code: **TFA**
Description: **Tap Factory Active**

Distance (ft): **323.0**
Structural Grade: **0**
O&M Grade: **0**
Clock Start/From: **3**
Clock To:
1st Value: **4.000**
2nd Value:
Value Percent:
Continuous Index:
Within 8" of Joint:
Remarks:

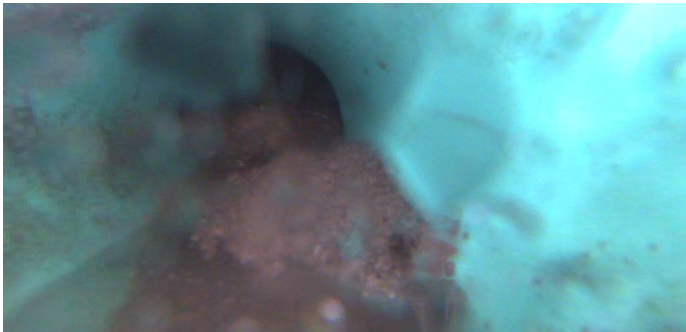
Code: **DSC**
Description: **Deposits Settled Compacted**

Distance (ft): **325.6**
Structural Grade: **0**
O&M Grade: **3**
Clock Start/From: **4**
Clock To: **7**
1st Value:
2nd Value:
Value Percent: **15.000**
Continuous Index:
Within 8" of Joint: **NO**
Remarks:

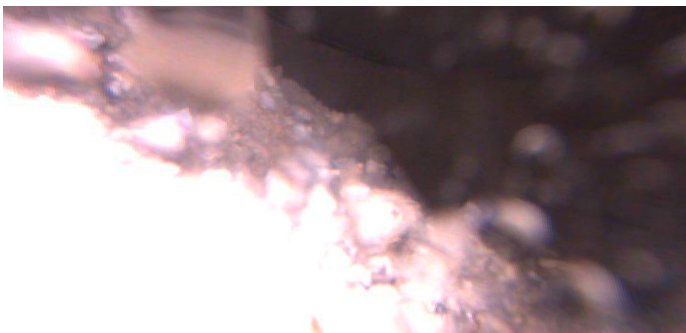
Code: **DAZ**
Description: **Deposits Attached Other**

Distance (ft): **327.7**
Structural Grade: **0**
O&M Grade: **2**
Clock Start/From: **7**
Clock To: **5**
1st Value:
2nd Value:
Value Percent: **5.000**
Continuous Index: **F02**
Within 8" of Joint: **YES**
Remarks: **WANDER**

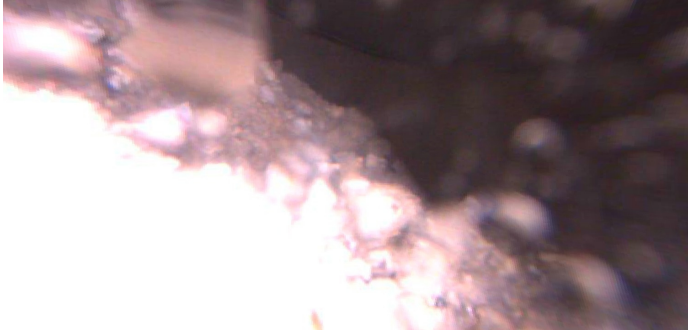
Code:	DAGS
Description:	Deposits Attached Grease
Distance (ft):	327.7
Structural Grade:	0
O&M Grade:	2
Clock Start/From:	7
Clock To:	5
1st Value:	
2nd Value:	
Value Percent:	5.000
Continuous Index:	F01
Within 8" of Joint:	YES
Remarks:	WANDER
