Profile/Photo Observation Report

Date:	03/26/2018	Weather:		Coding:	PACP 6.0
Pipe Length (ft):	332.7	Owner:	NA	Pre Clean:	No Pre-Cleaning
P.O.#:		Surveyor:	Justin Gonzales	PSR:	P-507-061-062
Customer:		Clean Date:	01/01/1900	Shape:	C

Street:	FOXCROFT STREET	Flow Control:	Not Controlled
City:	Hobart, IN	Year Renewed:	
Location:	Light Highway	Tape/Media #:	
Purpose:	Routine Assessment	Dia/Height:	8"
Use:	Sanitary	Material:	PVC
Drain Area:	NA	Lining:	
Category:	NA		
Comment:	P_C at 326 ft debris . Flow direction wrong		
Location Details:		Direction of Survey:	Downstream
US MH:	M-507-062	DS MH:	M-507-061
		Total Length Surveyed (ft):	327.7

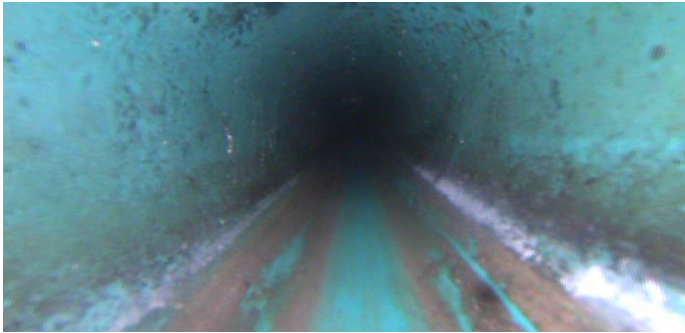
Code:	MWL
Description:	Water Level

Distance (ft):	.0
Structural Grade:	0
O&M Grade:	0
Clock Start/From:	
Clock To:	
1st Value:	
2nd Value:	
Value Percent:	5.000
Continuous Index:	
Within 8" of Joint:	NO
Remarks:

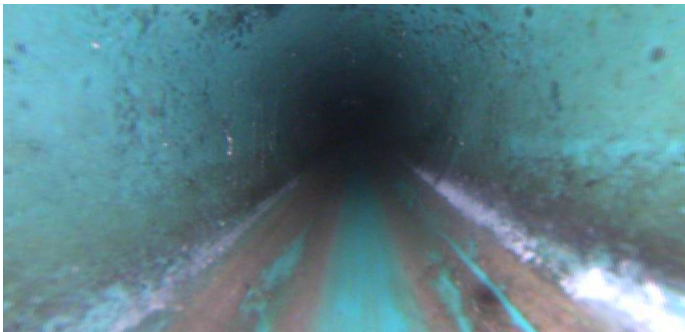
Code:	DAGS
Description:	Deposits Attached Grease

Distance (ft):	.0
Structural Grade:	0
O&M Grade:	2
Clock Start/From:	7
Clock To:	5
1st Value:	
2nd Value:	
Value Percent:	5.000
Continuous Index:	S01
Within 8" of Joint:	YES
Remarks:	WANDER

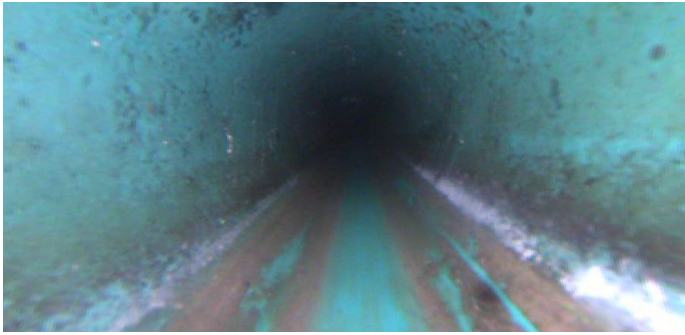
Code: **DAZ**
Description: **Deposits Attached Other**

Distance (ft): **.0**
Structural Grade: **0**
O&M Grade: **2**
Clock Start/From: **7**
Clock To: **5**
1st Value:
2nd Value:
Value Percent: **5.000**
Continuous Index: **S02**
Within 8" of Joint: **YES**
Remarks: **WANDER**

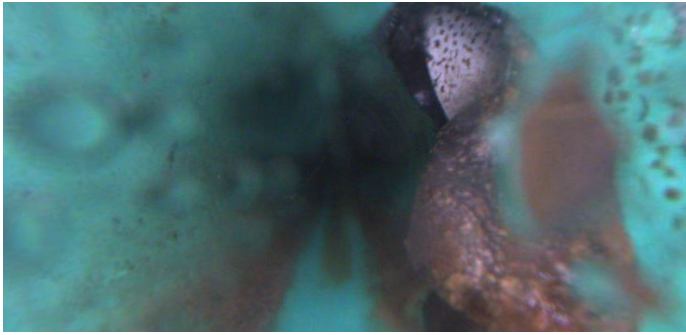
Code: **DAE**
Description: **Deposits Attached Encrustation**

Distance (ft): **167.4**
Structural Grade: **0**
O&M Grade: **2**
Clock Start/From: **2**
Clock To: **4**
1st Value:
2nd Value:
Value Percent: **10.000**
Continuous Index:
Within 8" of Joint: **NO**
Remarks:

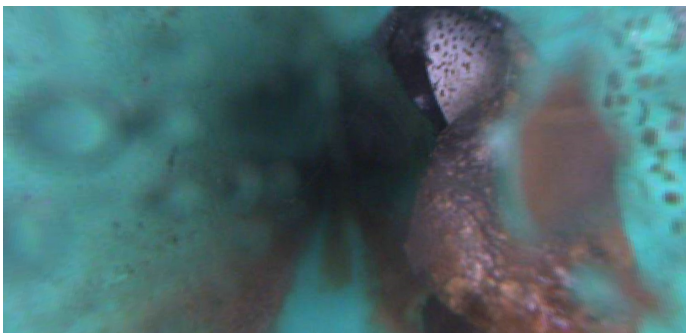
Code: **TFD**
Description: **Tap Factory Defective**

Distance (ft): **167.4**
Structural Grade: **0**
O&M Grade: **2**
Clock Start/From: **2**
Clock To:
1st Value: **4.000**
2nd Value:
Value Percent:
Continuous Index:
Within 8" of Joint:
Remarks: **DEPOSITS BLOCKING MOUTH OF TAP**

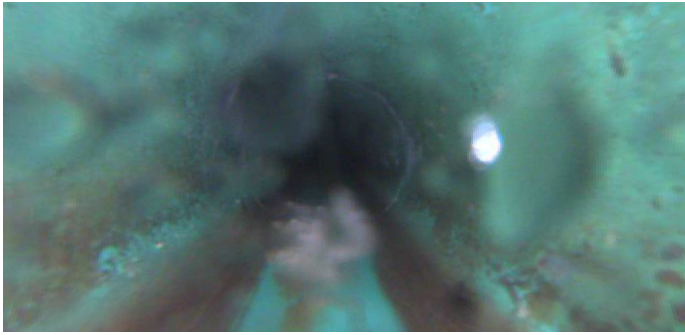
Code: **MGO**
Description: **General Observation**

Distance (ft): **251.3**
Structural Grade: **0**
O&M Grade: **0**
Clock Start/From:
Clock To:
1st Value:
2nd Value:
Value Percent:
Continuous Index:
Within 8" of Joint: **NO**
Remarks: **TOILET TISSUE**

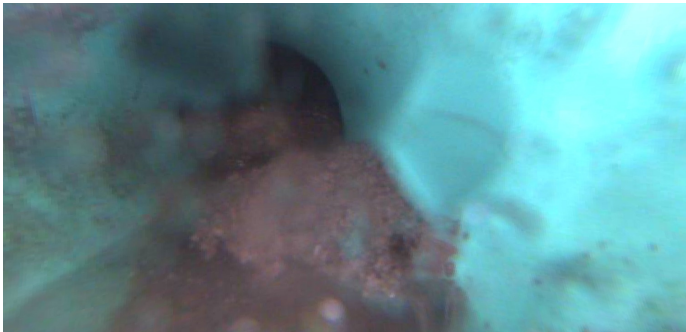
Code: **DSC**
Description: **Deposits Settled Compacted**

Distance (ft): **325.6**
Structural Grade: **0**
O&M Grade: **3**
Clock Start/From: **4**
Clock To: **7**
1st Value:
2nd Value:
Value Percent: **15.000**
Continuous Index:
Within 8" of Joint: **NO**
Remarks:

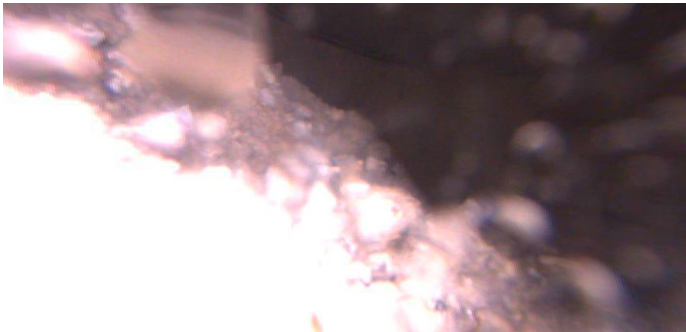
Code: **DAZ**
Description: **Deposits Attached Other**

Distance (ft): **327.7**
Structural Grade: **0**
O&M Grade: **2**
Clock Start/From: **7**
Clock To: **5**
1st Value:
2nd Value:
Value Percent: **5.000**
Continuous Index: **F02**
Within 8" of Joint: **YES**
Remarks: **WANDER**

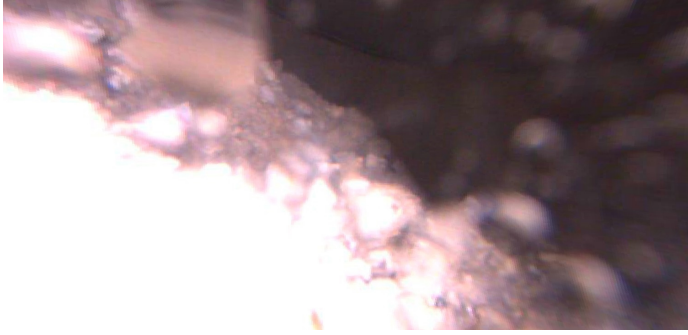
Code:	DAGS
Description:	Deposits Attached Grease
Distance (ft):	327.7
Structural Grade:	0
O&M Grade:	2
Clock Start/From:	7
Clock To:	5
1st Value:	
2nd Value:	
Value Percent:	5.000
Continuous Index:	F01
Within 8" of Joint:	YES
Remarks:	WANDER
