Profile/Photo Observation Report

Street:	W 13TH PL	Flow Control:	Not Controlled
City:	Hobart, IN	Year Renewed:	
Location:	Light Highway	Tape/Media #:	
Purpose:	Routine Assessment	Dia/Height:	8"
Use:	Sanitary	Material:	PVC
Drain Area:	NA	Lining:	
Category:	NA		
Comment:	Flow direction wrong

Location Details:		Direction of Survey:	Upstream
US MH:	M-507-062	DS MH:	M-507-061
		Total Length Surveyed (ft):	329.9

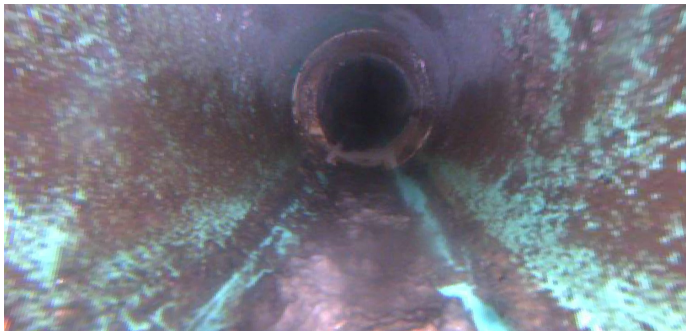
Code: **AMH**
Description: **Manhole**

Distance (ft): **.0**
Structural Grade: **0**
O&M Grade: **0**
Clock Start/From:
Clock To:
1st Value:
2nd Value:
Value Percent:
Continuous Index:
Within 8" of Joint: **NO**
Remarks: **M-507-061**

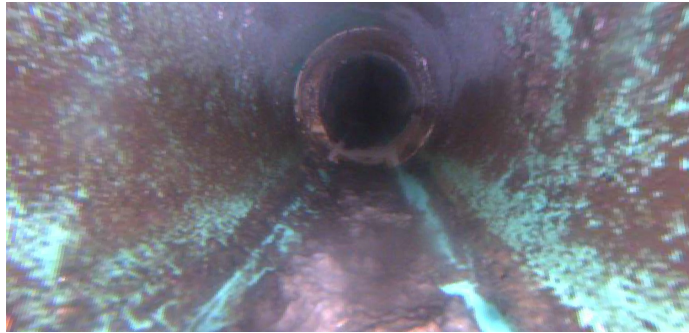
Code: **MWL**
Description: **Water Level**

Distance (ft): **.0**
Structural Grade: **0**
O&M Grade: **0**
Clock Start/From:
Clock To:
1st Value:
2nd Value:
Value Percent: **5.000**
Continuous Index:
Within 8" of Joint: **NO**
Remarks:

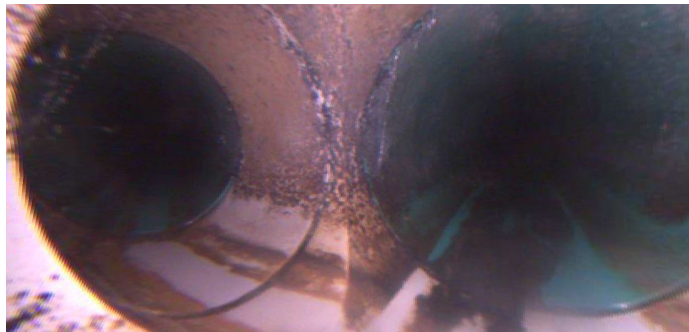
Code: **TF**
Description: **Tap Factory**

Distance (ft): **2.8**
Structural Grade: **0**
O&M Grade: **0**
Clock Start/From: **9**
Clock To:
1st Value: **4.000**
2nd Value:
Value Percent:
Continuous Index:
Within 8" of Joint:
Remarks:

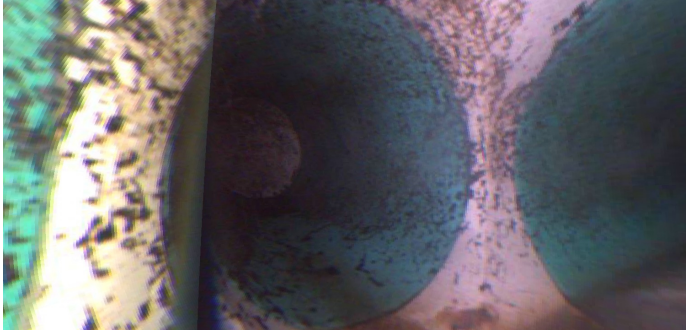
Code: **TFC**
Description: **Tap Factory Capped**

Distance (ft): **40.4**
Structural Grade: **0**
O&M Grade: **0**
Clock Start/From: **9**
Clock To:
1st Value: **4.000**
2nd Value:
Value Percent:
Continuous Index:
Within 8" of Joint:
Remarks:

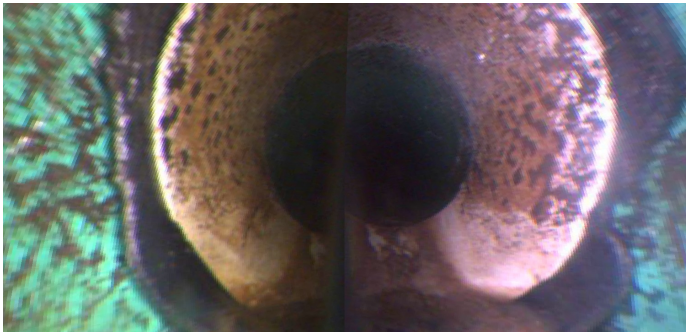
Code: **TF**
Description: **Tap Factory**

Distance (ft): **44.0**
Structural Grade: **0**
O&M Grade: **0**
Clock Start/From: **9**
Clock To:
1st Value: **4.000**
2nd Value:
Value Percent:
Continuous Index:
Within 8" of Joint:
Remarks:

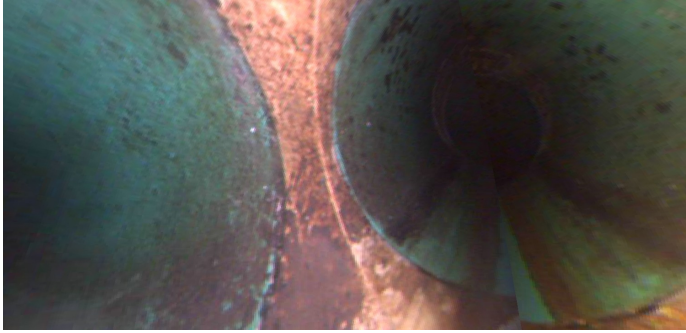
Code: **TF**
Description: **Tap Factory**

Distance (ft): **62.3**
Structural Grade: **0**
O&M Grade: **0**
Clock Start/From: **2**
Clock To:
1st Value: **4.000**
2nd Value:
Value Percent:
Continuous Index:
Within 8" of Joint:
Remarks:

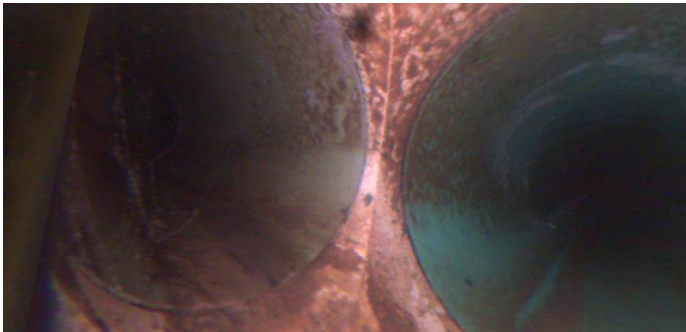
Code: **TF**
Description: **Tap Factory**

Distance (ft): **99.8**
Structural Grade: **0**
O&M Grade: **0**
Clock Start/From: **9**
Clock To:
1st Value: **4.000**
2nd Value:
Value Percent:
Continuous Index:
Within 8" of Joint:
Remarks:

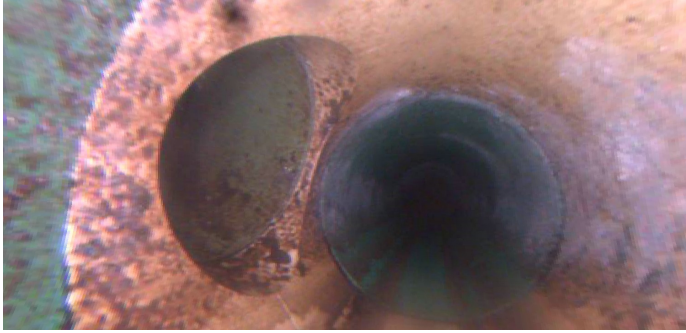
Code: **TF**
Description: **Tap Factory**

Distance (ft): **151.8**
Structural Grade: **0**
O&M Grade: **0**
Clock Start/From: **9**
Clock To:
1st Value: **4.000**
2nd Value:
Value Percent:
Continuous Index:
Within 8" of Joint:
Remarks:

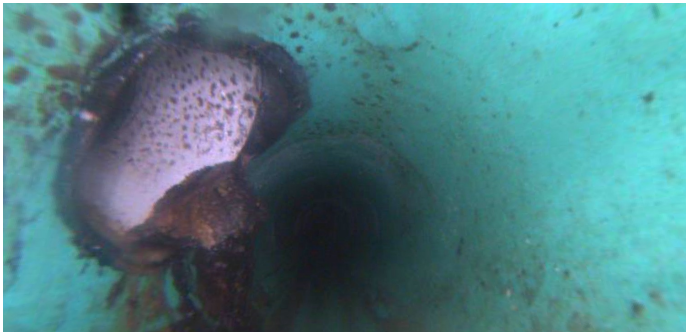
Code: **DAZ**
Description: **Deposits Attached Other**

Distance (ft): **158.2**
Structural Grade: **0**
O&M Grade: **2**
Clock Start/From: **7**
Clock To: **9**
1st Value:
2nd Value:
Value Percent: **10.000**
Continuous Index:
Within 8" of Joint: **NO**
Remarks:

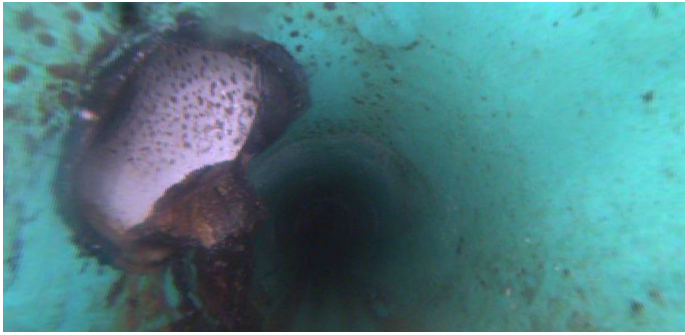
Code: **TFD**
Description: **Tap Factory Defective**

Distance (ft): **158.2**
Structural Grade: **0**
O&M Grade: **2**
Clock Start/From: **10**
Clock To:
1st Value: **4.000**
2nd Value:
Value Percent:
Continuous Index:
Within 8" of Joint: **NO**
Remarks: **DAZ**

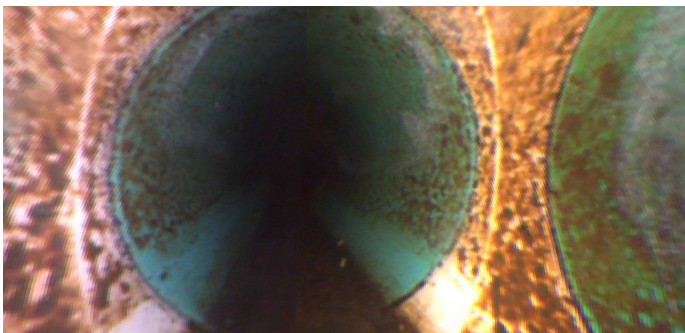
Code: **TF**
Description: **Tap Factory**

Distance (ft): **168.2**
Structural Grade: **0**
O&M Grade: **0**
Clock Start/From: **3**
Clock To:
1st Value: **4.000**
2nd Value:
Value Percent:
Continuous Index:
Within 8" of Joint:
Remarks:

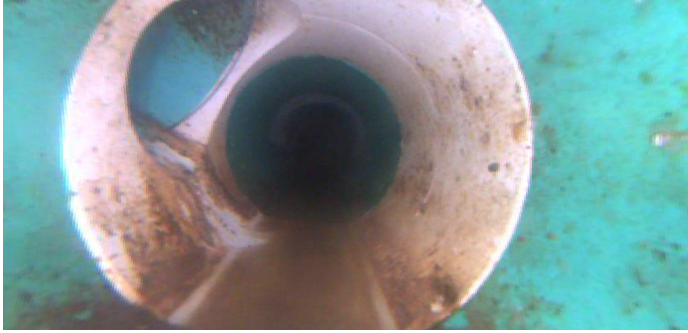
Code: **TF**
Description: **Tap Factory**

Distance (ft): **204.5**
Structural Grade: **0**
O&M Grade: **0**
Clock Start/From: **10**
Clock To:
1st Value: **4.000**
2nd Value:
Value Percent:
Continuous Index:
Within 8" of Joint:
Remarks:

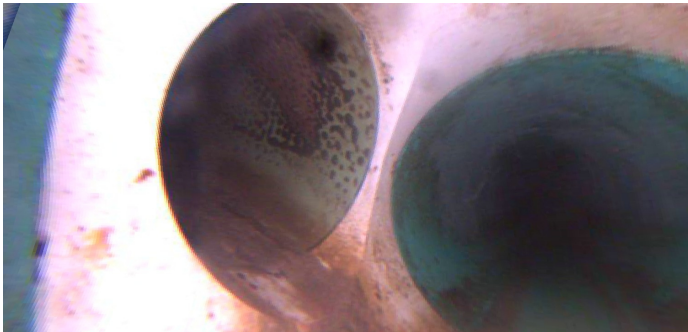
Code: **TF**
Description: **Tap Factory**

Distance (ft): **263.3**
Structural Grade: **0**
O&M Grade: **0**
Clock Start/From: **10**
Clock To:
1st Value: **4.000**
2nd Value:
Value Percent:
Continuous Index:
Within 8" of Joint:
Remarks:

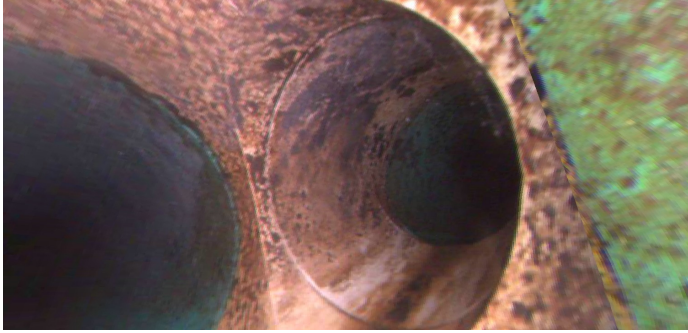
Code: **TF**
Description: **Tap Factory**

Distance (ft): **269.0**
Structural Grade: **0**
O&M Grade: **0**
Clock Start/From: **2**
Clock To:
1st Value: **4.000**
2nd Value:
Value Percent:
Continuous Index:
Within 8" of Joint:
Remarks:

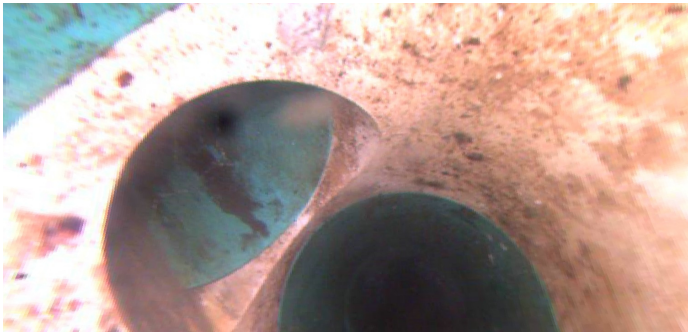
Code: **TF**
Description: **Tap Factory**

Distance (ft): **313.3**
Structural Grade: **0**
O&M Grade: **0**
Clock Start/From: **10**
Clock To:
1st Value: **4.000**
2nd Value:
Value Percent:
Continuous Index:
Within 8" of Joint:
Remarks:

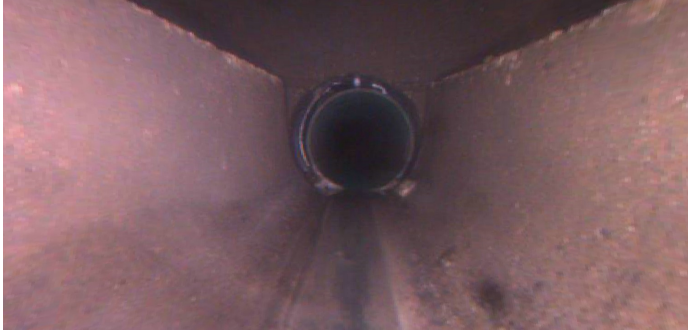
Code:	AMH
Description:	Manhole
Distance (ft):	329.9
Structural Grade:	0
O&M Grade:	0
Clock Start/From:	
Clock To:	
1st Value:	
2nd Value:	
Value Percent:	
Continuous Index:	
Within 8" of Joint:	NO
Remarks:	M-507-062
