Profile/Photo Observation Report

Date:	03/26/2018	Weather:		Coding:	PACP 6.0
Pipe Length (ft):	332.7	Owner:	NA	Pre Clean:	No Pre-Cleaning
P.O.#:		Surveyor:	Justin Gonzales	PSR:	P-507-061-062
Customer:		Clean Date:	01/01/1900	Shape:	C

Street:	FOXCROFT STREET	Flow Control:	Not Controlled
City:	Hobart, IN	Year Renewed:	
Location:	Light Highway	Tape/Media #:	
Purpose:	Routine Assessment	Dia/Height:	8"
Use:	Sanitary	Material:	PVC
Drain Area:	NA	Lining:	
Category:	NA		
Comment:	Flow direction wrong

Location Details:		Direction of Survey:	Upstream
US MH:	M-507-062	DS MH:	M-507-061
		Total Length Surveyed (ft):	329.9

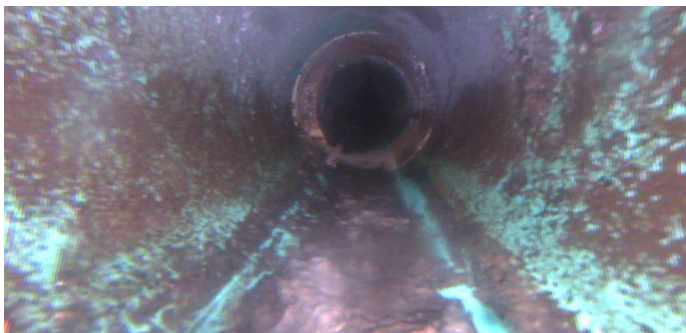
Code: **AMH**
Description: **Manhole**

Distance (ft): **.0**
Structural Grade: **0**
O&M Grade: **0**
Clock Start/From:
Clock To:
1st Value:
2nd Value:
Value Percent:
Continuous Index:
Within 8" of Joint: **NO**
Remarks: **M-507-061**

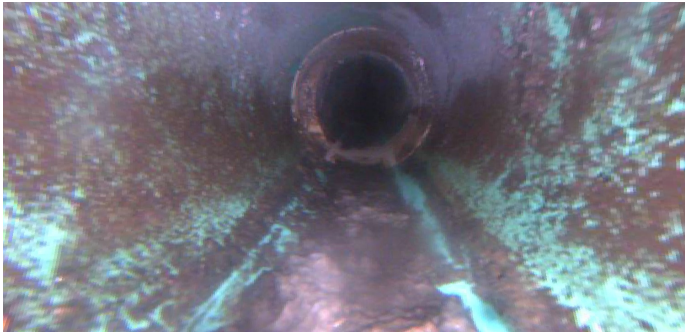
Code:	MWL
Description:	Water Level

Distance (ft):	.0
Structural Grade:	0
O&M Grade:	0
Clock Start/From:	
Clock To:	
1st Value:	
2nd Value:	
Value Percent:	5.000
Continuous Index:	
Within 8" of Joint:	NO
Remarks:

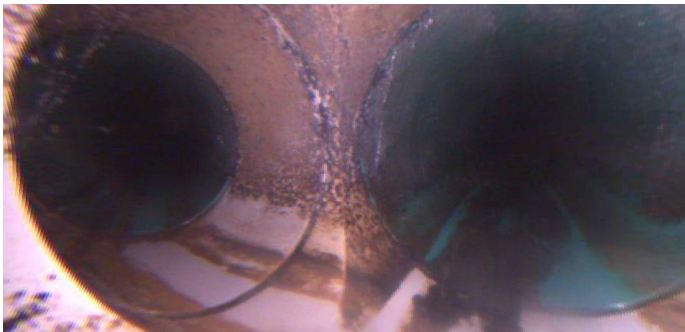
Code:	TF
Description:	Tap Factory

Distance (ft):	2.8
Structural Grade:	0
O&M Grade:	0
Clock Start/From:	9
Clock To:	
1st Value:	4.000
2nd Value:	
Value Percent:	
Continuous Index:	
Within 8" of Joint:	
Remarks:

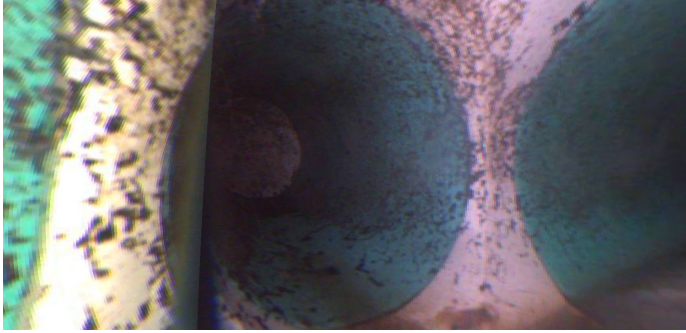
Code: **TFC**
Description: **Tap Factory Capped**

Distance (ft): **40.4**
Structural Grade: **0**
O&M Grade: **0**
Clock Start/From: **9**
Clock To:
1st Value: **4.000**
2nd Value:
Value Percent:
Continuous Index:
Within 8" of Joint:
Remarks:

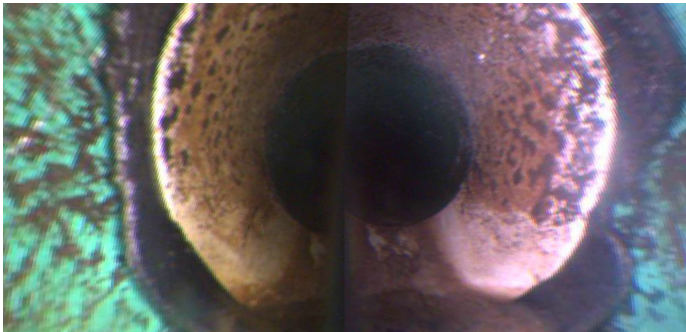
Code: **TF**
Description: **Tap Factory**

Distance (ft): **44.0**
Structural Grade: **0**
O&M Grade: **0**
Clock Start/From: **9**
Clock To:
1st Value: **4.000**
2nd Value:
Value Percent:
Continuous Index:
Within 8" of Joint:
Remarks:

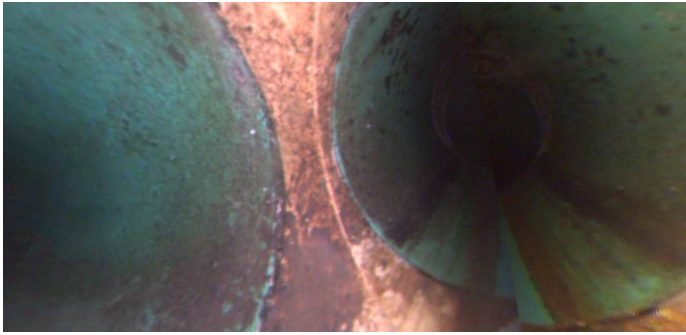
Code: **TF**
Description: **Tap Factory**

Distance (ft): **62.3**
Structural Grade: **0**
O&M Grade: **0**
Clock Start/From: **2**
Clock To:
1st Value: **4.000**
2nd Value:
Value Percent:
Continuous Index:
Within 8" of Joint:
Remarks:

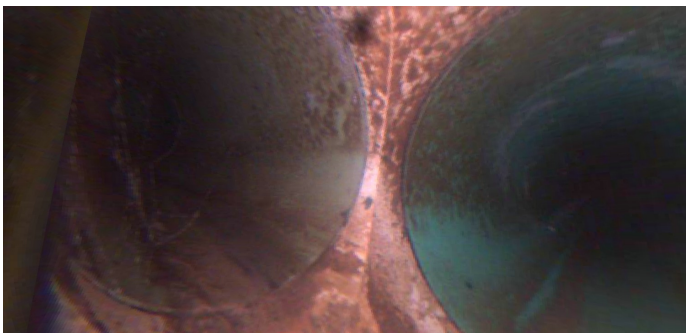
Code: **TF**
Description: **Tap Factory**

Distance (ft): **99.8**
Structural Grade: **0**
O&M Grade: **0**
Clock Start/From: **9**
Clock To:
1st Value: **4.000**
2nd Value:
Value Percent:
Continuous Index:
Within 8" of Joint:
Remarks:

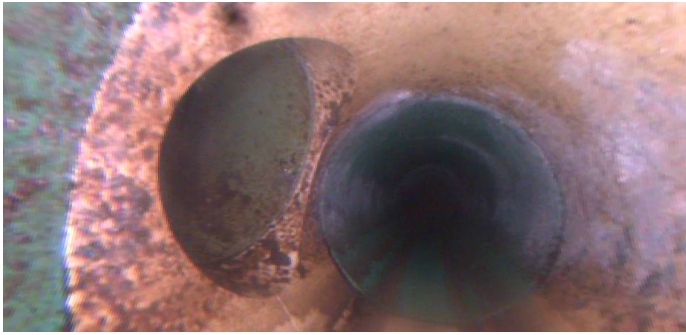
Code: **TF**
Description: **Tap Factory**

Distance (ft): **151.8**
Structural Grade: **0**
O&M Grade: **0**
Clock Start/From: **9**
Clock To:
1st Value: **4.000**
2nd Value:
Value Percent:
Continuous Index:
Within 8" of Joint:
Remarks:

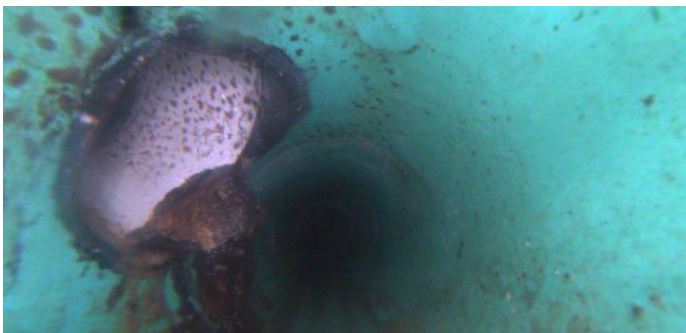
Code: **DAZ**
Description: **Deposits Attached Other**

Distance (ft): **158.2**
Structural Grade: **0**
O&M Grade: **2**
Clock Start/From: **7**
Clock To: **9**
1st Value:
2nd Value:
Value Percent: **10.000**
Continuous Index:
Within 8" of Joint: **NO**
Remarks:

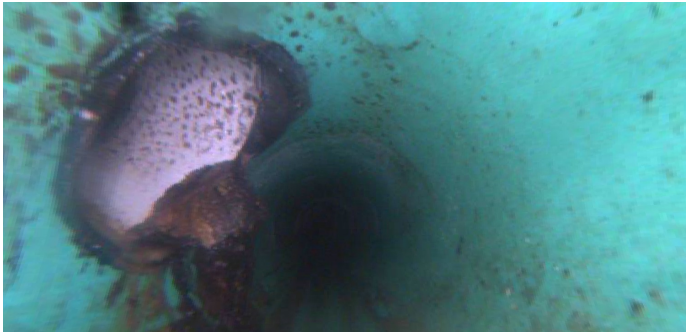
Code: **TFD**
Description: **Tap Factory Defective**

Distance (ft): **158.2**
Structural Grade: **0**
O&M Grade: **2**
Clock Start/From: **10**
Clock To:
1st Value: **4.000**
2nd Value:
Value Percent:
Continuous Index:
Within 8" of Joint: **NO**
Remarks: **DAZ**

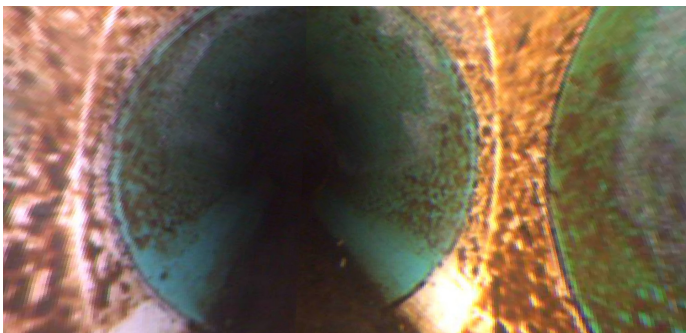
Code: **TF**
Description: **Tap Factory**

Distance (ft): **168.2**
Structural Grade: **0**
O&M Grade: **0**
Clock Start/From: **3**
Clock To:
1st Value: **4.000**
2nd Value:
Value Percent:
Continuous Index:
Within 8" of Joint:
Remarks:

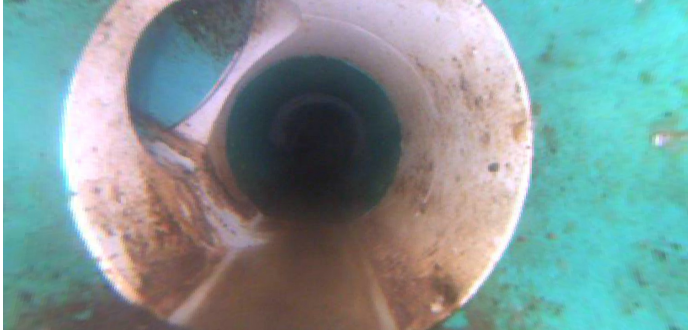
Code: **TF**
Description: **Tap Factory**

Distance (ft): **204.5**
Structural Grade: **0**
O&M Grade: **0**
Clock Start/From: **10**
Clock To:
1st Value: **4.000**
2nd Value:
Value Percent:
Continuous Index:
Within 8" of Joint:
Remarks:

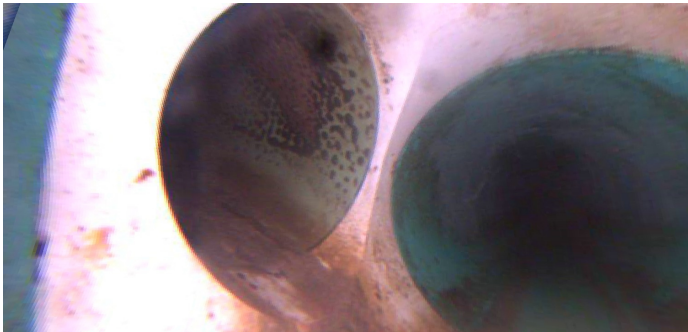
Code: **TF**
Description: **Tap Factory**

Distance (ft): **263.3**
Structural Grade: **0**
O&M Grade: **0**
Clock Start/From: **10**
Clock To:
1st Value: **4.000**
2nd Value:
Value Percent:
Continuous Index:
Within 8" of Joint:
Remarks:

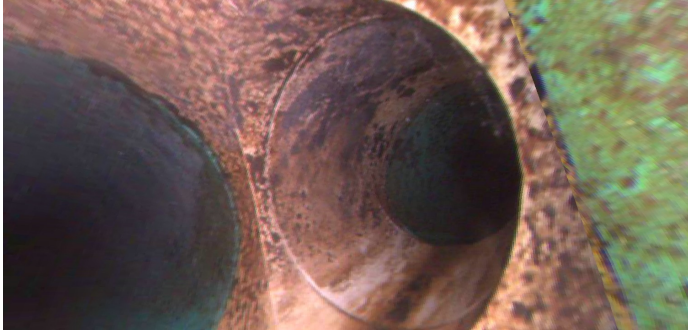
Code: **TF**
Description: **Tap Factory**

Distance (ft): **269.0**
Structural Grade: **0**
O&M Grade: **0**
Clock Start/From: **2**
Clock To:
1st Value: **4.000**
2nd Value:
Value Percent:
Continuous Index:
Within 8" of Joint:
Remarks:

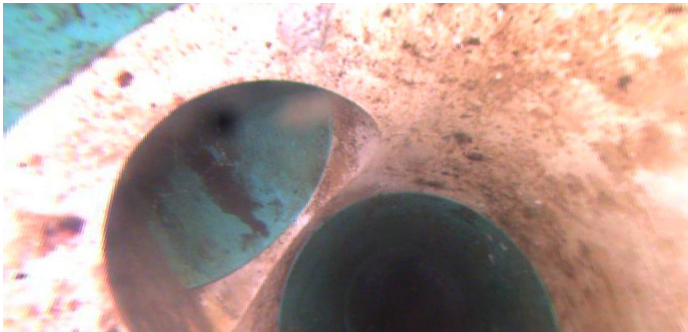
Code: **TF**
Description: **Tap Factory**

Distance (ft): **313.3**
Structural Grade: **0**
O&M Grade: **0**
Clock Start/From: **10**
Clock To:
1st Value: **4.000**
2nd Value:
Value Percent:
Continuous Index:
Within 8" of Joint:
Remarks:

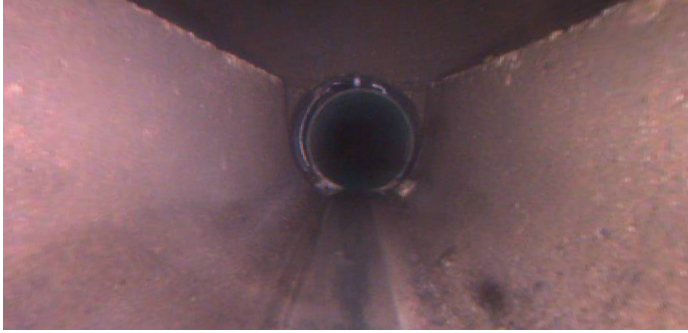
Code:	AMH
Description:	Manhole
Distance (ft):	329.9
Structural Grade:	0
O&M Grade:	0
Clock Start/From:	
Clock To:	
1st Value:	
2nd Value:	
Value Percent:	
Continuous Index:	
Within 8" of Joint:	NO
Remarks:	M-507-062
