Profile/Photo Observation Report

Date:	03/26/2018	Weather:		Coding:	PACP 6.0
Pipe Length (ft):	274.5	Owner:	NA	Pre Clean:	No Pre-Cleaning
P.O.#:		Surveyor:	Justin Gonzales	PSR:	P-507-062-063
Customer:		Clean Date:	01/01/1900	Shape:	C

Street:	W 13TH PL	Flow Control:	Not Controlled
City:	Hobart, IN	Year Renewed:	
Location:	Light Highway	Tape/Media #:	
Purpose:	Routine Assessment	Dia/Height:	8"
Use:	Sanitary	Material:	PVC
Drain Area:	NA	Lining:	
Category:	NA		
Comment:	Flow direction wrong

Location Details:		Direction of Survey:	Upstream
US MH:	M-507-063	DS MH:	M-507-062
		Total Length Surveyed (ft):	287.6

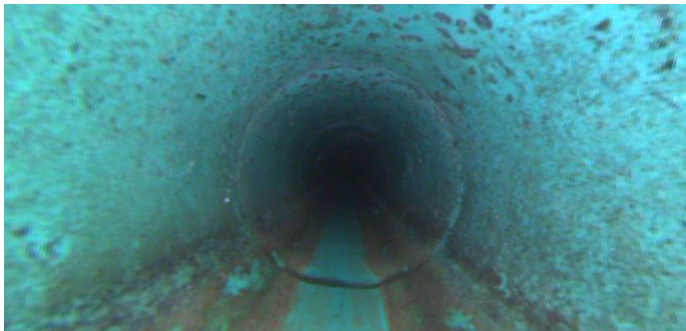
Code: **AMH**
Description: **Manhole**

Distance (ft): **.0**
Structural Grade: **0**
O&M Grade: **0**
Clock Start/From:
Clock To:
1st Value:
2nd Value:
Value Percent:
Continuous Index:
Within 8" of Joint: **NO**
Remarks: **M-507-062**

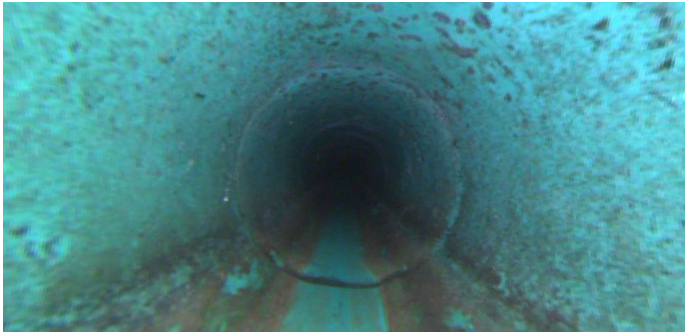
Code:	MWL
Description:	Water Level

Distance (ft):	.0
Structural Grade:	0
O&M Grade:	0
Clock Start/From:	
Clock To:	
1st Value:	
2nd Value:	
Value Percent:	5.000
Continuous Index:	
Within 8" of Joint:	NO
Remarks:

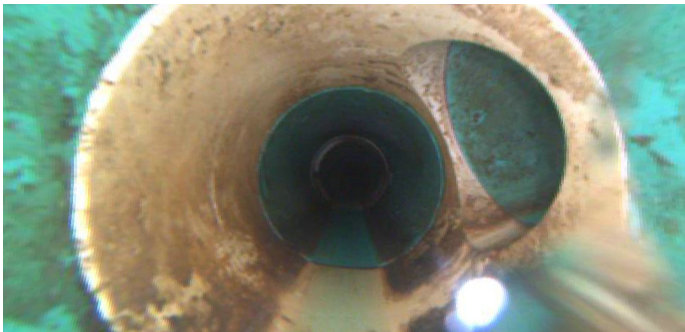
Code:	TF
Description:	Tap Factory

Distance (ft):	41.8
Structural Grade:	0
O&M Grade:	0
Clock Start/From:	3
Clock To:	
1st Value:	4.000
2nd Value:	
Value Percent:	
Continuous Index:	
Within 8" of Joint:	
Remarks:

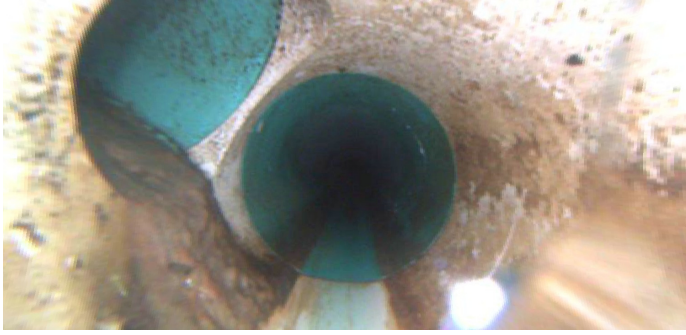
Code: **TF**
Description: **Tap Factory**

Distance (ft): **44.3**
Structural Grade: **0**
O&M Grade: **0**
Clock Start/From: **10**
Clock To:
1st Value: **4.000**
2nd Value:
Value Percent:
Continuous Index:
Within 8" of Joint:
Remarks:

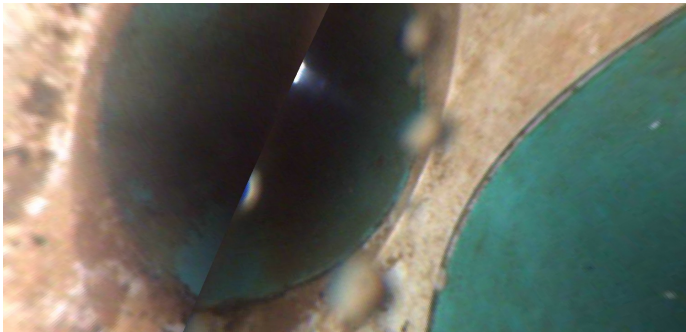
Code: **TF**
Description: **Tap Factory**

Distance (ft): **100.0**
Structural Grade: **0**
O&M Grade: **0**
Clock Start/From: **10**
Clock To:
1st Value: **4.000**
2nd Value:
Value Percent:
Continuous Index:
Within 8" of Joint:
Remarks:

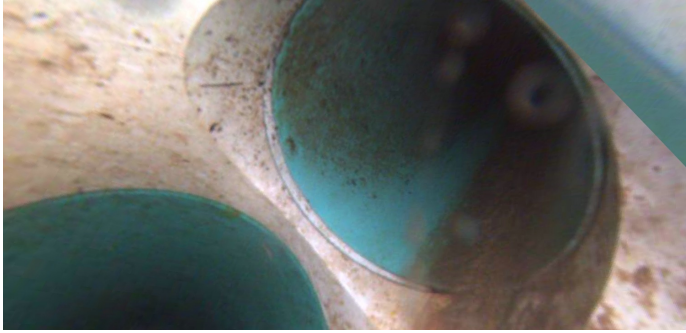
Code: **TF**
Description: **Tap Factory**

Distance (ft): **162.3**
Structural Grade: **0**
O&M Grade: **0**
Clock Start/From: **2**
Clock To:
1st Value: **4.000**
2nd Value:
Value Percent:
Continuous Index:
Within 8" of Joint:
Remarks:

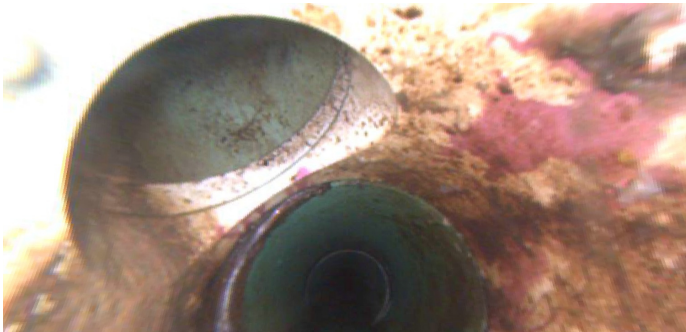
Code: **TF**
Description: **Tap Factory**

Distance (ft): **172.4**
Structural Grade: **0**
O&M Grade: **0**
Clock Start/From: **10**
Clock To:
1st Value: **4.000**
2nd Value:
Value Percent:
Continuous Index:
Within 8" of Joint:
Remarks:

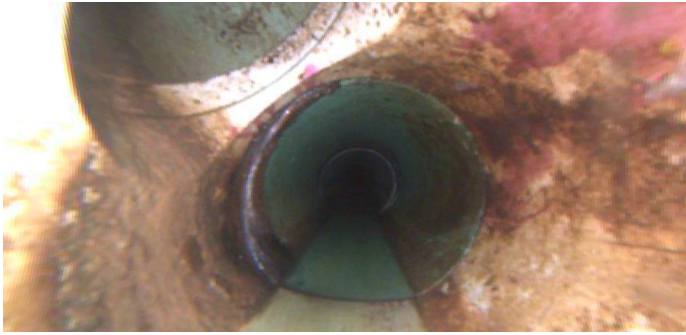
Code: **IS**
Description: **Infil Stain**

Distance (ft): **172.4**
Structural Grade: **0**
O&M Grade: **0**
Clock Start/From: **7**
Clock To: **11**
1st Value:
2nd Value:
Value Percent:
Continuous Index:
Within 8" of Joint: **YES**
Remarks:

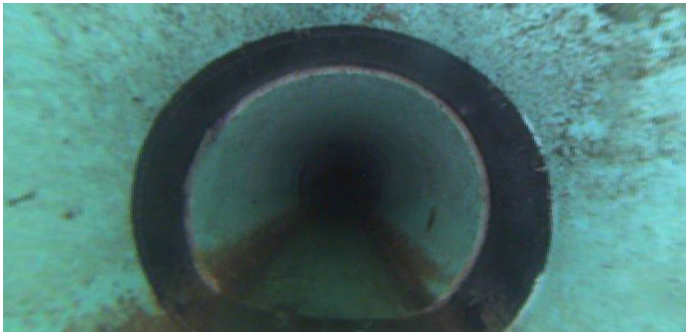
Code: **JSL**
Description: **Joint Separated Large**

Distance (ft): **174.6**
Structural Grade: **2**
O&M Grade: **0**
Clock Start/From:
Clock To:
1st Value:
2nd Value:
Value Percent:
Continuous Index:
Within 8" of Joint: **NO**
Remarks:

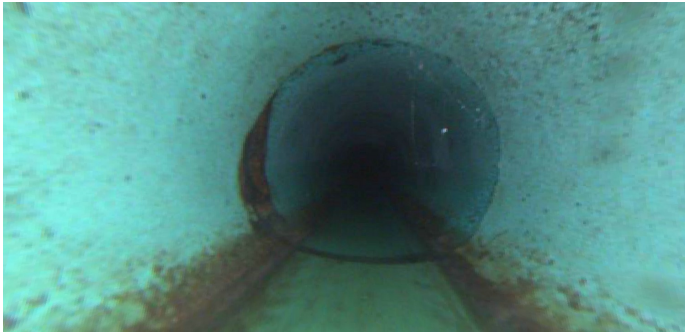
Code: **IS**
Description: **Infil Stain**

Distance (ft): **176.1**
Structural Grade: **0**
O&M Grade: **0**
Clock Start/From: **7**
Clock To: **9**
1st Value:
2nd Value:
Value Percent:
Continuous Index:
Within 8" of Joint: **YES**
Remarks:

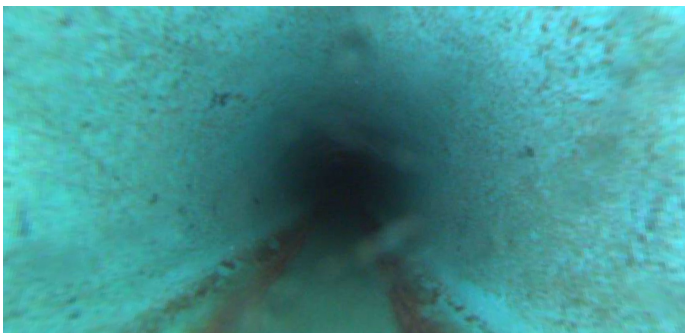
Code: **MGO**
Description: **General Observation**

Distance (ft): **191.3**
Structural Grade: **0**
O&M Grade: **0**
Clock Start/From:
Clock To:
1st Value:
2nd Value:
Value Percent:
Continuous Index:
Within 8" of Joint: **NO**
Remarks: **LARVAE ON LENS**

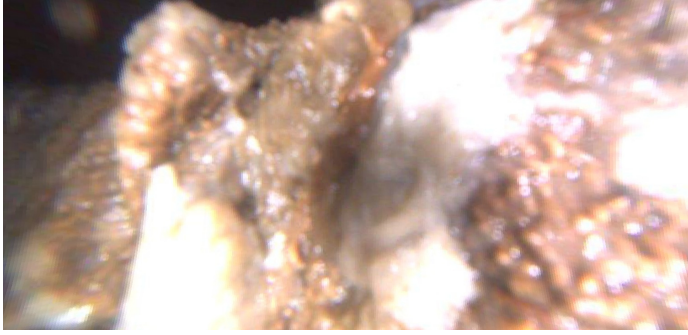
Code:	AMH
Description:	Manhole
Distance (ft):	287.6
Structural Grade:	0
O&M Grade:	0
Clock Start/From:	
Clock To:	
1st Value:	
2nd Value:	
Value Percent:	
Continuous Index:	
Within 8" of Joint:	NO
Remarks:	M-507-063
