Profile/Photo Observation Report

Date:	10/24/2021	Weather:		Coding:	PACP 6.0
Pipe Length (ft):		Owner:	Hobart, IN	Pre Clean:	Not Known
P.O.#:	999_1	Surveyor:	M. Pielacha	PSR:	P-507-063-064
Customer:	Hobart, IN	Clean Date:		Shape:	C

Street:	California Street	Flow Control:	Not Controlled
City:	Hobart, IN	Year Renewed:	
Location:	Light Highway	Tape/Media #:	999
Purpose:	Routine Assessment	Dia/Height:	8"
Use:	Sanitary	Material:	PVC
Drain Area:		Lining:	
Category:	NA		
Comment:			
Location Details:		Direction of Survey:	Upstream
US MH:	M-507-63	DS MH:	M-507-64
		Total Length Surveyed (ft):	.1

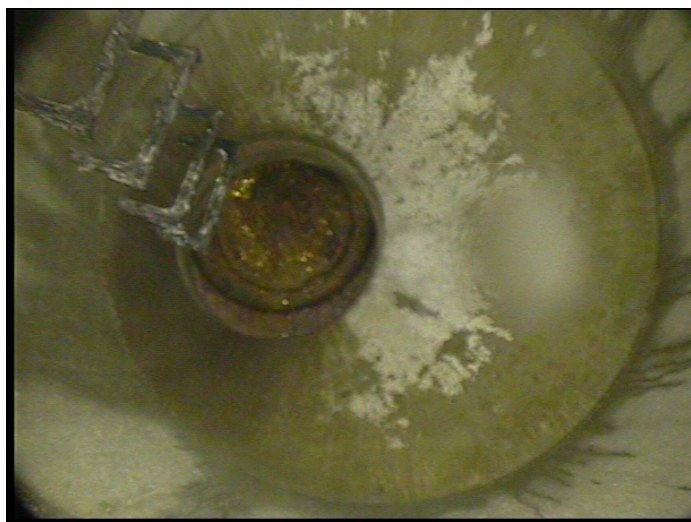
Code: **AMH**
Description: **Manhole**

Distance (ft): **.0**
Structural Grade: **0**
O&M Grade: **0**
Clock Start/From:
Clock To:
1st Value:
2nd Value:
Value Percent:
Continuous Index:
Within 8" of Joint: **NO**
Remarks: **M-507-64**

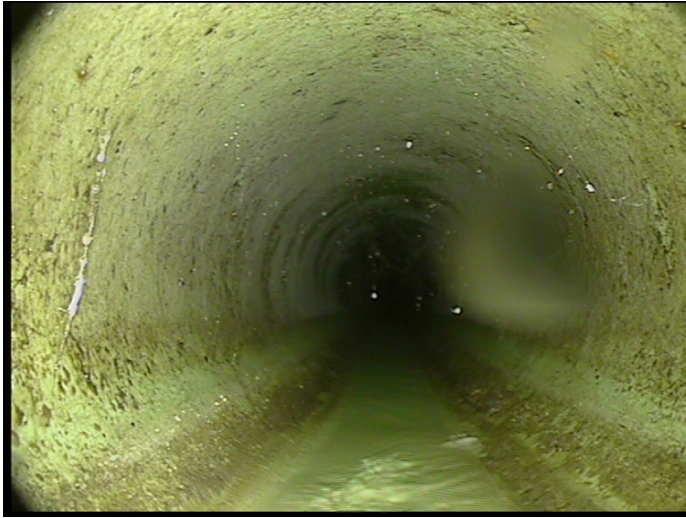
Code: **MWL**
Description: **Water Level**

Distance (ft): **.0**
Structural Grade: **0**
O&M Grade: **0**
Clock Start/From:
Clock To:
1st Value:
2nd Value:
Value Percent: **5.000**
Continuous Index:
Within 8" of Joint: **NO**
Remarks:

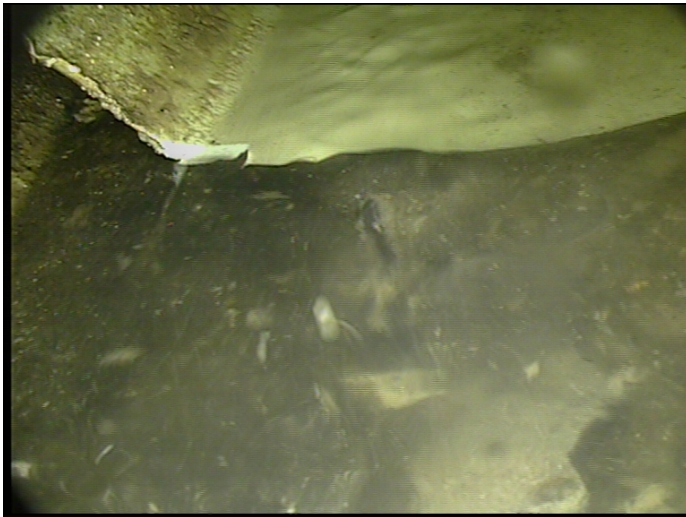
Code: **MSA**
Description: **Abandoned Survey**

Distance (ft): **.0**
Structural Grade: **0**
O&M Grade: **0**
Clock Start/From:
Clock To:
1st Value:
2nd Value:
Value Percent:
Continuous Index:
Within 8" of Joint: **NO**
Remarks: **Can not get over gap between pipe and invert.**
