Profile/Photo Observation Report

Date:	03/26/2018	Weather:		Coding:	PACP 6.0
Pipe Length (ft):	211.8	Owner:	NA	Pre Clean:	No Pre-Cleaning
P.O.#:		Surveyor:	Jen Costello	PSR:	P-507-064-067
Customer:		Clean Date:	01/01/1900	Shape:	C

Street:	S CALIFORNIA ST & CSOKASY LN	Flow Control:	Not Controlled
City:	Hobart, IN	Year Renewed:	
Location:	Light Highway	Tape/Media #:	
Purpose:	Routine Assessment	Dia/Height:	8"
Use:	Sanitary	Material:	PVC
Drain Area:	NA	Lining:	
Category:	NA		
Comment:	Flow direction wrong

Location Details:		Direction of Survey:	Upstream
US MH:	M-507-064	DS MH:	M-507-067
		Total Length Surveyed (ft):	198.8

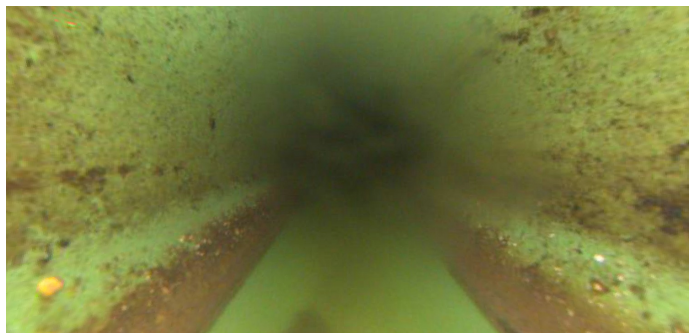
Code: AMH

Description: Manhole

Distance (ft): .0

Remarks: M-507-067

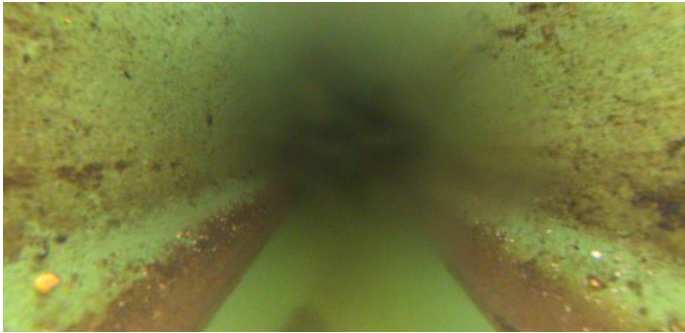
Code:	MWL
Description:	Water Level

Distance (ft):	.0
Structural Grade:	0
O&M Grade:	0
Clock Start/From:	
Clock To:	
1st Value:	
2nd Value:	
Value Percent:	10.000
Continuous Index:	
Within 8" of Joint:	NO
Remarks:

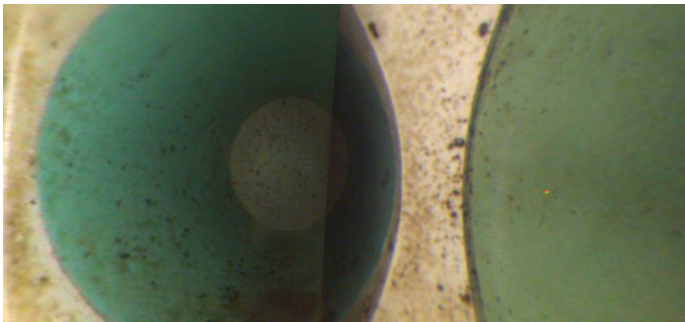
Code:	TFC
Description:	Tap Factory Capped

Distance (ft):	63.2
Structural Grade:	0
O&M Grade:	0
Clock Start/From:	9
Clock To:	
1st Value:	4.000
2nd Value:	
Value Percent:	
Continuous Index:	
Within 8" of Joint:	
Remarks:

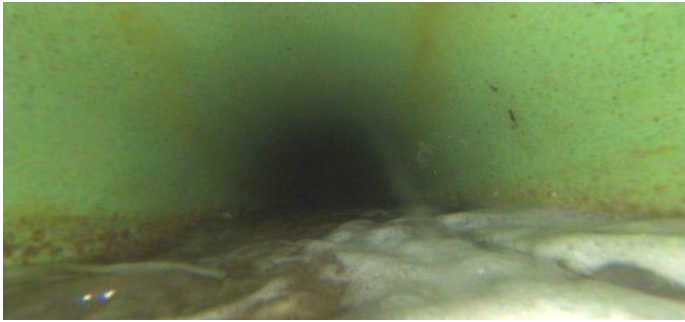
Code: **MGO**
Description: **General Observation**

Distance (ft): **86.4**
Structural Grade: **0**
O&M Grade: **0**
Clock Start/From:
Clock To:
1st Value:
2nd Value:
Value Percent:
Continuous Index:
Within 8" of Joint: **NO**
Remarks: **rear camera**

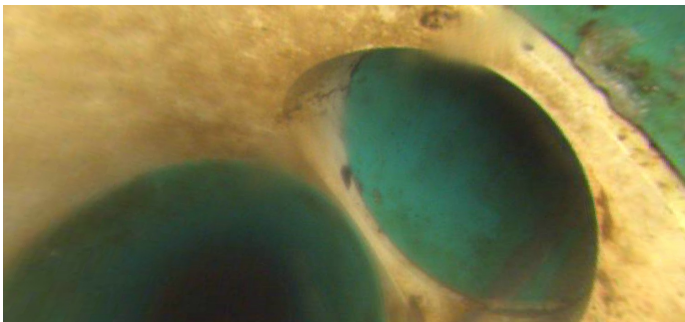
Code: **TF**
Description: **Tap Factory**

Distance (ft): **93.9**
Structural Grade: **0**
O&M Grade: **0**
Clock Start/From: **10**
Clock To:
1st Value: **4.000**
2nd Value:
Value Percent:
Continuous Index:
Within 8" of Joint:
Remarks:

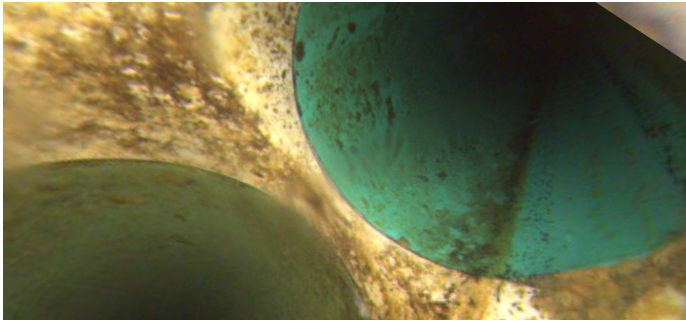
Code: **TF**
Description: **Tap Factory**

Distance (ft): **152.3**
Structural Grade: **0**
O&M Grade: **0**
Clock Start/From: **10**
Clock To:
1st Value: **4.000**
2nd Value:
Value Percent:
Continuous Index:
Within 8" of Joint:
Remarks:

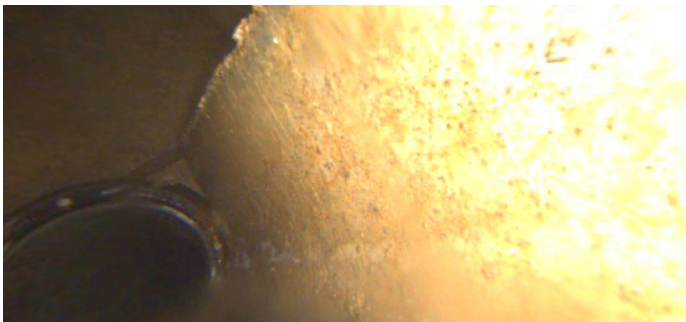
Code: **AMH**
Description: **Manhole**

Distance (ft): **198.8**
Structural Grade: **0**
O&M Grade: **0**
Clock Start/From:
Clock To:
1st Value:
2nd Value:
Value Percent:
Continuous Index:
Within 8" of Joint: **NO**
Remarks: **M-507-064**
