## Profile/Photo Observation Report

Date:	<b>04/02/2018</b>	Weather:		Coding:	<b>PACP 6.0</b>
Pipe Length (ft):	<b>172.3</b>	Owner:	<b>NA</b>	Pre Clean:	<b>No Pre-Cleaning</b>
P.O.#:		Surveyor:	<b>Jen Costello</b>	PSR:	<b>P-507-068-069</b>
Customer:		Clean Date:	<b>01/01/1900</b>	Shape:	<b>C</b>

Street:	<b>CSOKASY LN</b>	Flow Control:	<b>Not Controlled</b>
City:	<b>Hobart, IN</b>	Year Renewed:	
Location:	<b>Yard</b>	Tape/Media #:	
Purpose:	<b>Routine Assessment</b>	Dia/Height:	<b>8"</b>
Use:	<b>Sanitary</b>	Material:	<b>PVC</b>
Drain Area:	<b>NA</b>	Lining:	
Category:	<b>NA</b>		
Comment:			
Location Details:		Direction of Survey:	<b>Upstream</b>
US MH:	<b>M-507-068</b>	DS MH:	<b>M-507-069</b>
		Total Length Surveyed (ft):	<b>170.4</b>

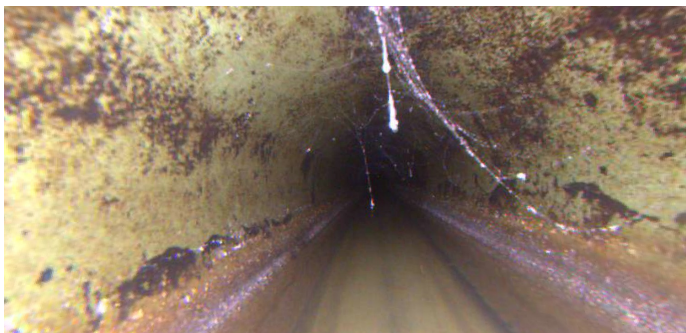
Code: **AMH**  
Description: **Manhole**

Distance (ft): **.0**  
Structural Grade: **0**  
O&M Grade: **0**  
Clock Start/From:  
Clock To:  
1st Value:  
2nd Value:  
Value Percent:  
Continuous Index:  
Within 8" of Joint: **NO**  
Remarks: **M-507-069**

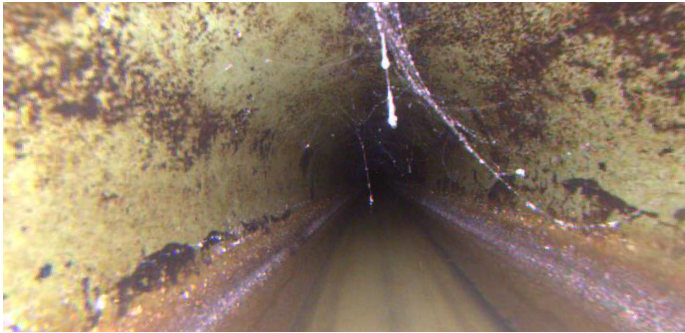
Code:	<b>MWL</b>
Description:	<b>Water Level</b>

Distance (ft):	<b>.0</b>
Structural Grade:	<b>0</b>
O&M Grade:	<b>0</b>
Clock Start/From:	
Clock To:	
1st Value:	
2nd Value:	
Value Percent:	<b>10.000</b>
Continuous Index:	
Within 8" of Joint:	<b>NO</b>
Remarks:

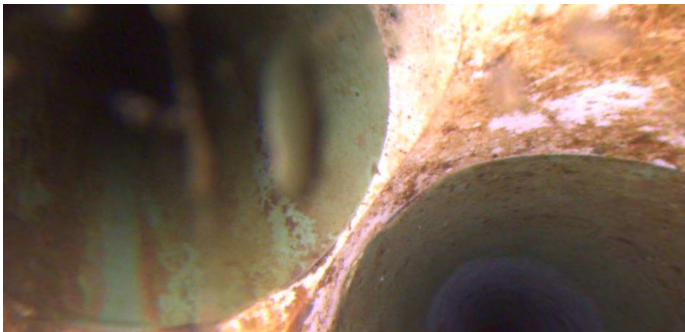
Code:	<b>TF</b>
Description:	<b>Tap Factory</b>

Distance (ft):	<b>23.5</b>
Structural Grade:	<b>0</b>
O&M Grade:	<b>0</b>
Clock Start/From:	<b>10</b>
Clock To:	
1st Value:	<b>4.000</b>
2nd Value:	
Value Percent:	
Continuous Index:	
Within 8" of Joint:	
Remarks:

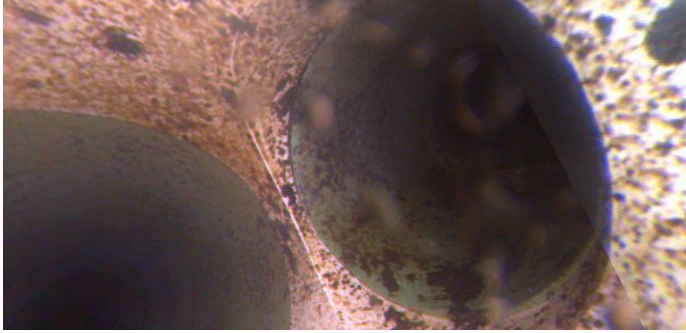
Code: **TF**  
Description: **Tap Factory**

Distance (ft): **35.8**  
Structural Grade: **0**  
O&M Grade: **0**  
Clock Start/From: **2**  
Clock To:  
1st Value: **4.000**  
2nd Value:  
Value Percent:  
Continuous Index:  
Within 8" of Joint:  
Remarks:

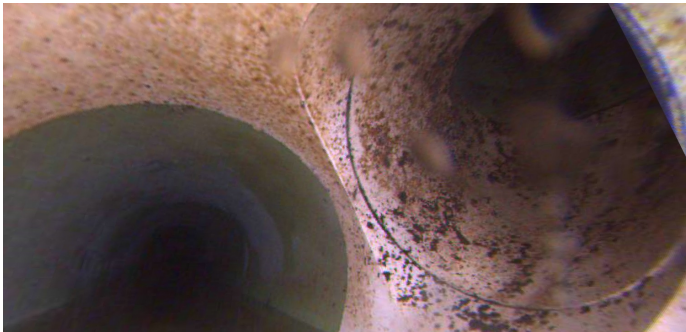
Code: **TF**  
Description: **Tap Factory**

Distance (ft): **85.7**  
Structural Grade: **0**  
O&M Grade: **0**  
Clock Start/From: **2**  
Clock To:  
1st Value: **4.000**  
2nd Value:  
Value Percent:  
Continuous Index:  
Within 8" of Joint:  
Remarks:

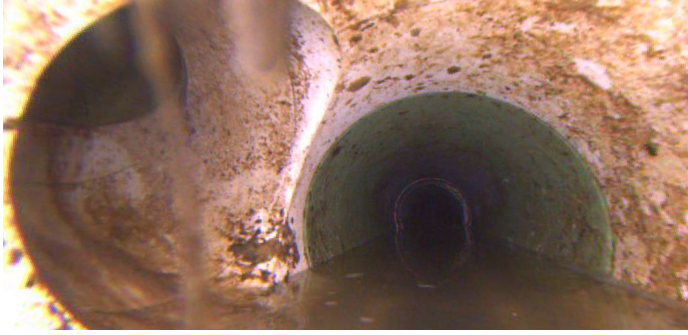
Code: **TF**  
Description: **Tap Factory**

Distance (ft): **143.6**  
Structural Grade: **0**  
O&M Grade: **0**  
Clock Start/From: **9**  
Clock To:  
1st Value: **4.000**  
2nd Value:  
Value Percent:  
Continuous Index:  
Within 8" of Joint:  
Remarks:

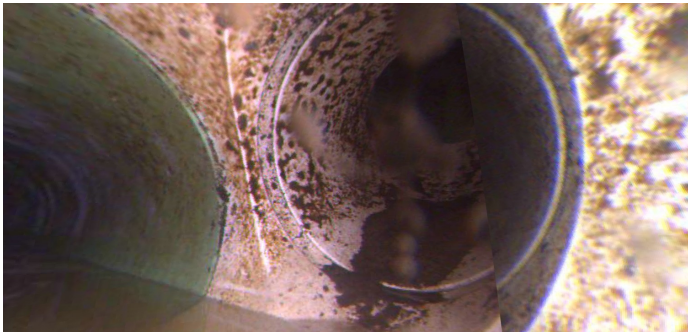
Code: **TF**  
Description: **Tap Factory**

Distance (ft): **146.6**  
Structural Grade: **0**  
O&M Grade: **0**  
Clock Start/From: **3**  
Clock To:  
1st Value: **4.000**  
2nd Value:  
Value Percent:  
Continuous Index:  
Within 8" of Joint:  
Remarks:

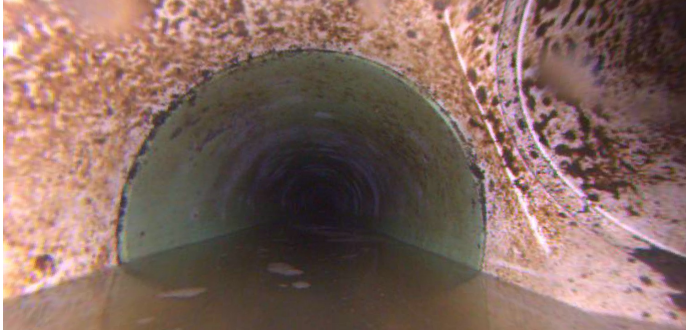
Code:	<b>MWL</b>
Description:	<b>Water Level</b>
Distance (ft):	<b>146.6</b>
Structural Grade:	<b>0</b>
O&M Grade:	<b>0</b>
Clock Start/From:	
Clock To:	
1st Value:	
2nd Value:	
Value Percent:	<b>30.000</b>
Continuous Index:	
Within 8" of Joint:	<b>NO</b>
Remarks:

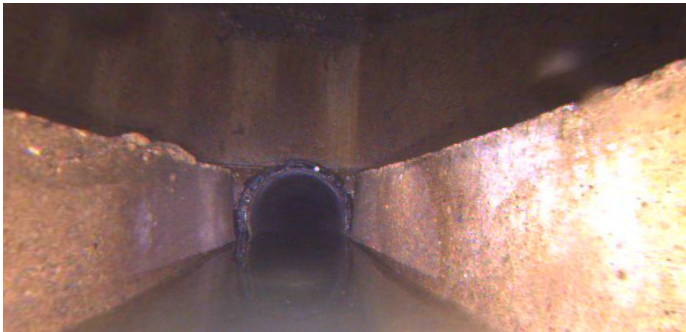
Code:	<b>AMH</b>
Description:	<b>Manhole</b>
Distance (ft):	<b>170.4</b>
Structural Grade:	<b>0</b>
O&M Grade:	<b>0</b>
Clock Start/From:	
Clock To:	
1st Value:	
2nd Value:	
Value Percent:	
Continuous Index:	
Within 8" of Joint:	<b>NO</b>
Remarks:	<b>M-507-068</b>
