## Profile/Photo Observation Report

Date:	<b>04/02/2018</b>	Weather:		Coding:	<b>PACP 6.0</b>
Pipe Length (ft):	<b>188.8</b>	Owner:	<b>NA</b>	Pre Clean:	<b>No Pre-Cleaning</b>
P.O.#:		Surveyor:	<b>Jen Costello</b>	PSR:	<b>P-507-072-071</b>
Customer:		Clean Date:	<b>01/01/1900</b>	Shape:	<b>C</b>

Street:	<b>CSOKASY CT</b>	Flow Control:	<b>Not Controlled</b>
City:	<b>Hobart, IN</b>	Year Renewed:	
Location:	<b>Yard</b>	Tape/Media #:	
Purpose:	<b>Routine Assessment</b>	Dia/Height:	<b>8"</b>
Use:	<b>Sanitary</b>	Material:	<b>PVC</b>
Drain Area:	<b>NA</b>	Lining:	
Category:	<b>NA</b>		
Comment:			
Location Details:		Direction of Survey:	<b>Upstream</b>
US MH:	<b>M-507-071</b>	DS MH:	<b>M-507-072</b>
		Total Length Surveyed (ft):	<b>157.5</b>

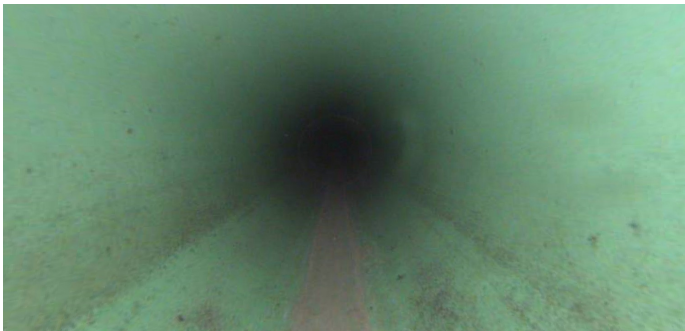
Code: **AMH**  
Description: **Manhole**

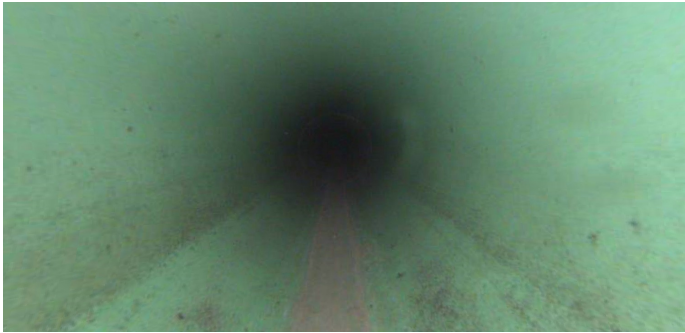
Code:	<b>MWL</b>
Description:	<b>Water Level</b>

Distance (ft):	<b>.0</b>
Structural Grade:	<b>0</b>
O&M Grade:	<b>0</b>
Clock Start/From:	
Clock To:	
1st Value:	
2nd Value:	
Value Percent:	<b>5.000</b>
Continuous Index:	
Within 8" of Joint:	<b>NO</b>
Remarks:

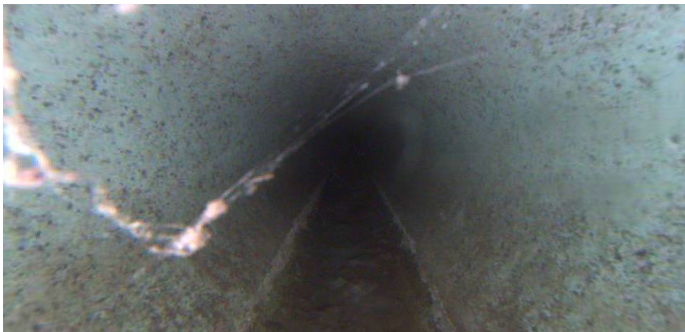
Code:	<b>DSF</b>
Description:	<b>Deposits Settled Fine</b>

Distance (ft):	<b>22.3</b>
Structural Grade:	<b>0</b>
O&M Grade:	<b>2</b>
Clock Start/From:	<b>6</b>
Clock To:	
1st Value:	
2nd Value:	
Value Percent:	<b>5.000</b>
Continuous Index:	<b>S01</b>
Within 8" of Joint:	<b>NO</b>
Remarks:

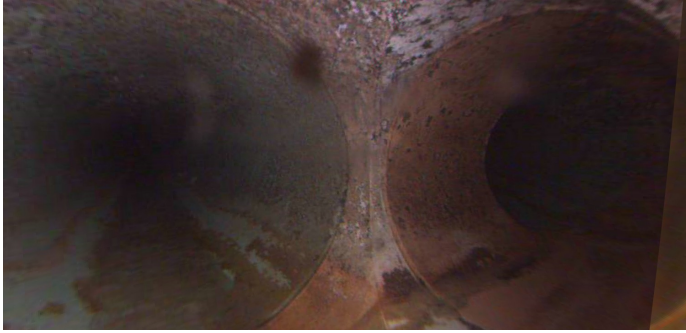
Code: **TFA**  
Description: **Tap Factory Active**

Distance (ft): **29.5**  
Structural Grade: **0**  
O&M Grade: **0**  
Clock Start/From: **3**  
Clock To:  
1st Value: **4.000**  
2nd Value:  
Value Percent:  
Continuous Index:  
Within 8" of Joint:  
Remarks:

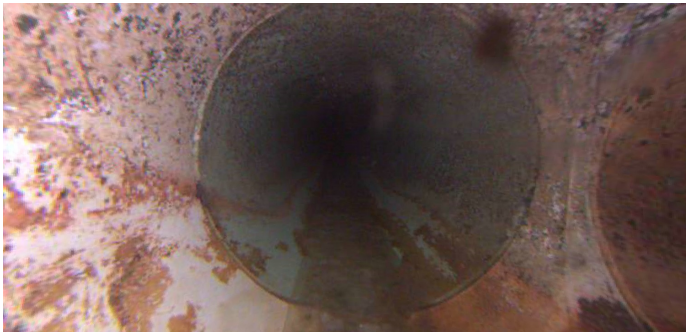
Code: **DSF**  
Description: **Deposits Settled Fine**

Distance (ft): **29.5**  
Structural Grade: **0**  
O&M Grade: **2**  
Clock Start/From: **6**  
Clock To:  
1st Value:  
2nd Value:  
Value Percent: **5.000**  
Continuous Index: **F01**  
Within 8" of Joint: **NO**  
Remarks:

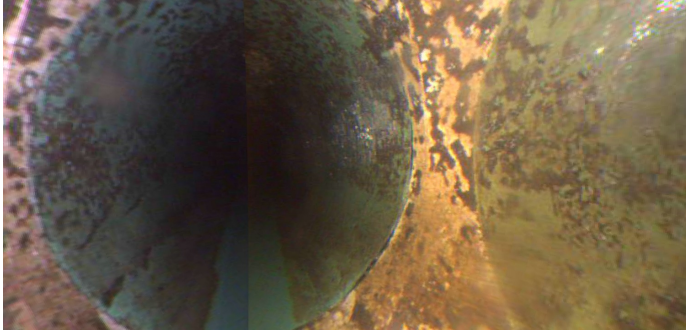
Code: **TF**  
Description: **Tap Factory**

Distance (ft): **65.9**  
Structural Grade: **0**  
O&M Grade: **0**  
Clock Start/From: **3**  
Clock To:  
1st Value: **4.000**  
2nd Value:  
Value Percent:  
Continuous Index:  
Within 8" of Joint:  
Remarks:

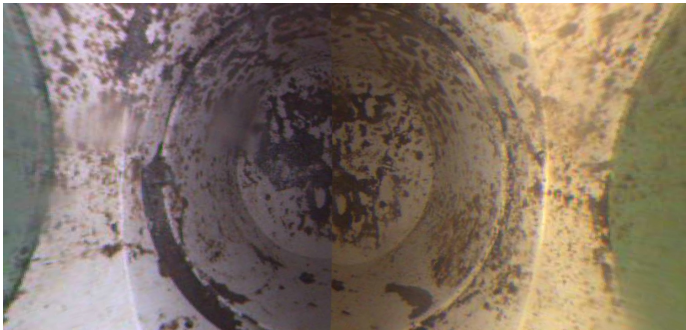
Code: **TFC**  
Description: **Tap Factory Capped**

Distance (ft): **94.5**  
Structural Grade: **0**  
O&M Grade: **0**  
Clock Start/From: **3**  
Clock To:  
1st Value: **4.000**  
2nd Value:  
Value Percent:  
Continuous Index:  
Within 8" of Joint:  
Remarks:

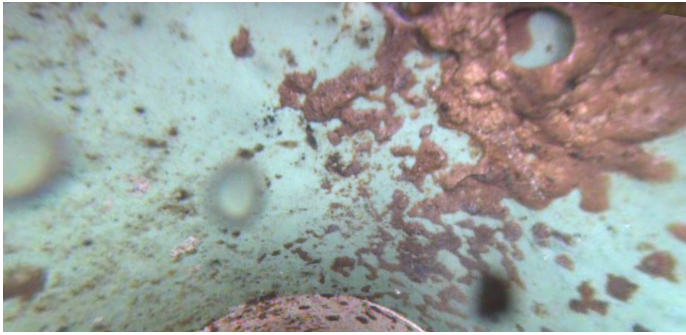
Code: **DAGS**  
Description: **Deposits Attached Grease**

Distance (ft): **128.7**  
Structural Grade: **0**  
O&M Grade: **2**  
Clock Start/From: **12**  
Clock To: **1**  
1st Value:  
2nd Value:  
Value Percent: **5.000**  
Continuous Index:  
Within 8" of Joint: **NO**  
Remarks:

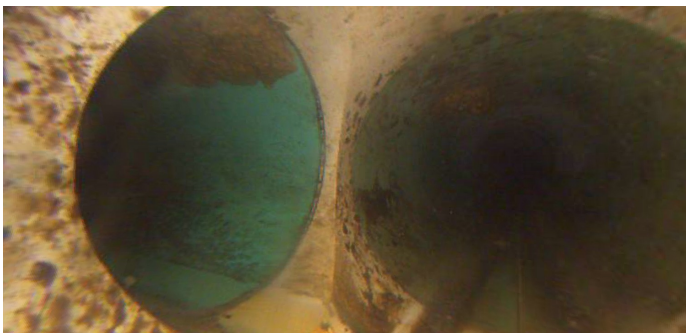
Code: **TF**  
Description: **Tap Factory**

Distance (ft): **130.0**  
Structural Grade: **0**  
O&M Grade: **0**  
Clock Start/From: **3**  
Clock To:  
1st Value: **4.000**  
2nd Value:  
Value Percent:  
Continuous Index:  
Within 8" of Joint:  
Remarks:

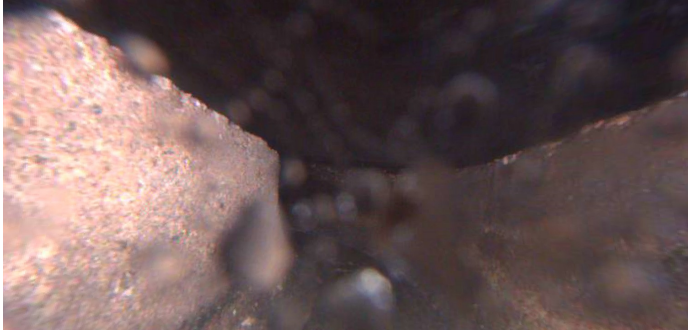
Code:	AMH
Description:	Manhole
Distance (ft):	157.5
Structural Grade:	0
O&M Grade:	0
Clock Start/From:	
Clock To:	
1st Value:	
2nd Value:	
Value Percent:	
Continuous Index:	
Within 8" of Joint:	NO
Remarks:	M-507-071
