Profile/Photo Observation Report

Street:	S VIRGINIA ST	Flow Control:	Not Controlled
City:	Hobart, IN	Year Renewed:	
Location:	Yard	Tape/Media #:	
Purpose:	Routine Assessment	Dia/Height:	8"
Use:	Sanitary	Material:	VCP
Drain Area:	NA	Lining:	
Category:	NA		
Comment:

Location Details:		Direction of Survey:	Downstream
US MH:	M-507-074	DS MH:	M-507-075
		Total Length Surveyed (ft):	15.4

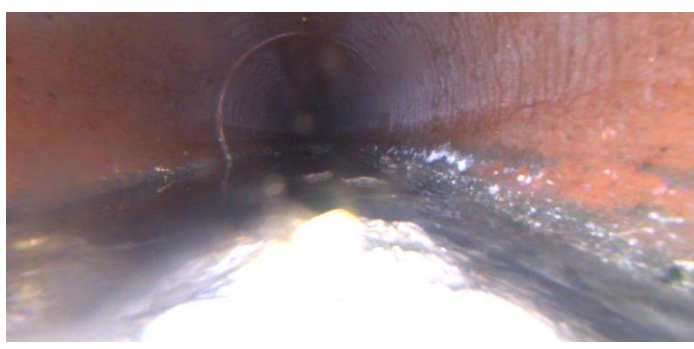
Code: **AMH**
Description: **Manhole**

Distance (ft): **.0**
Structural Grade: **0**
O&M Grade: **0**
Clock Start/From:
Clock To:
1st Value:
2nd Value:
Value Percent:
Continuous Index:
Within 8" of Joint: **NO**
Remarks: **M-507-074**

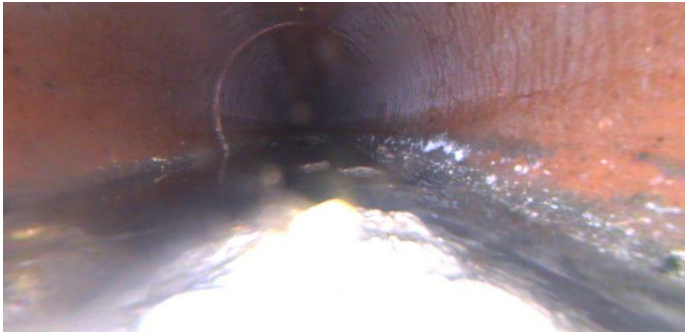
Code:	MWL
Description:	Water Level

Distance (ft):	.0
Structural Grade:	0
O&M Grade:	0
Clock Start/From:	
Clock To:	
1st Value:	
2nd Value:	
Value Percent:	20.000
Continuous Index:	
Within 8" of Joint:	NO
Remarks:

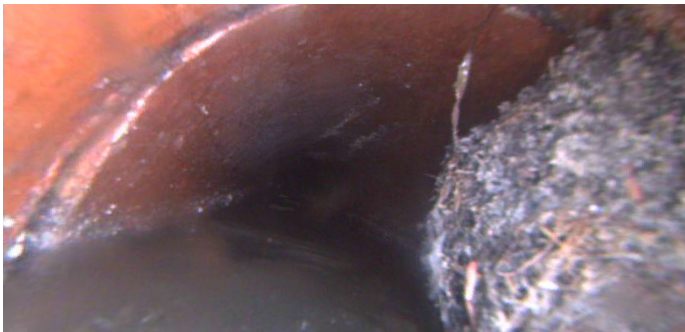
Code:	RMJ
Description:	Roots Medium Joint

Distance (ft):	14.2
Structural Grade:	0
O&M Grade:	3
Clock Start/From:	12
Clock To:	4
1st Value:	
2nd Value:	
Value Percent:	40.000
Continuous Index:	
Within 8" of Joint:	YES
Remarks:

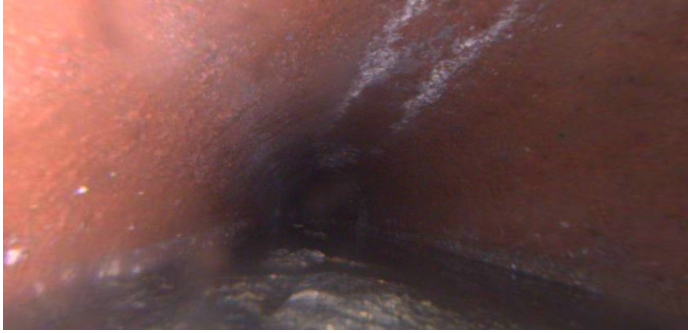
Code:	MSA
Description:	Abandoned Survey
Distance (ft):	15.4
Structural Grade:	0
O&M Grade:	0
Clock Start/From:	
Clock To:	
1st Value:	
2nd Value:	
Value Percent:	
Continuous Index:	
Within 8" of Joint:	NO
Remarks:	ROOTS
