Profile/Photo Observation Report

Date:	04/12/2018	Weather:		Coding:	PACP 6.0
Pipe Length (ft):	40.2	Owner:	NA	Pre Clean:	No Pre-Cleaning
P.O.#:		Surveyor:	Jen Costello	PSR:	P-507-074-085
Customer:		Clean Date:	01/01/1900	Shape:	C

Street:	S COLORADO ST	Flow Control:	Not Controlled
City:	Hobart, IN	Year Renewed:	
Location:	Yard	Tape/Media #:	
Purpose:	Routine Assessment	Dia/Height:	12"
Use:	Sanitary	Material:	VCP
Drain Area:	NA	Lining:	
Category:	NA		
Comment:	.

Location Details:		Direction of Survey:	Upstream
US MH:	M-507-074	DS MH:	M-507-085
		Total Length Surveyed (ft):	7.2

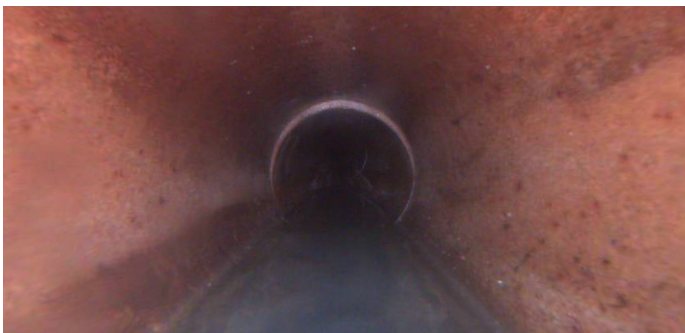
Code: **AMH**
Description: **Manhole**

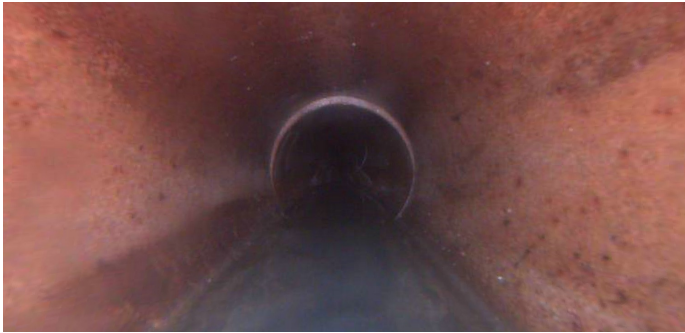
Code:	MWL
Description:	Water Level

Distance (ft):	.0
Structural Grade:	0
O&M Grade:	0
Clock Start/From:	
Clock To:	
1st Value:	
2nd Value:	
Value Percent:	20.000
Continuous Index:	
Within 8" of Joint:	NO
Remarks:

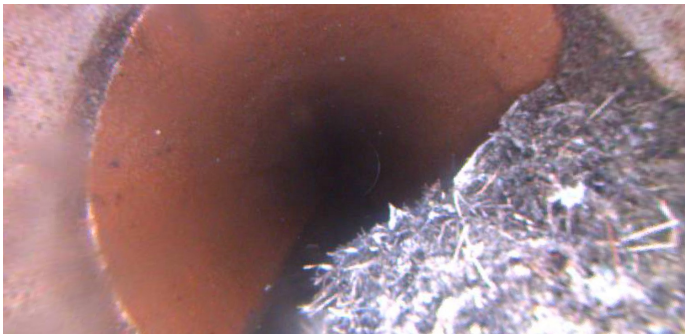
Code:	RMJ
Description:	Roots Medium Joint

Distance (ft):	7.2
Structural Grade:	0
O&M Grade:	3
Clock Start/From:	2
Clock To:	6
1st Value:	
2nd Value:	
Value Percent:	40.000
Continuous Index:	
Within 8" of Joint:	YES
Remarks:

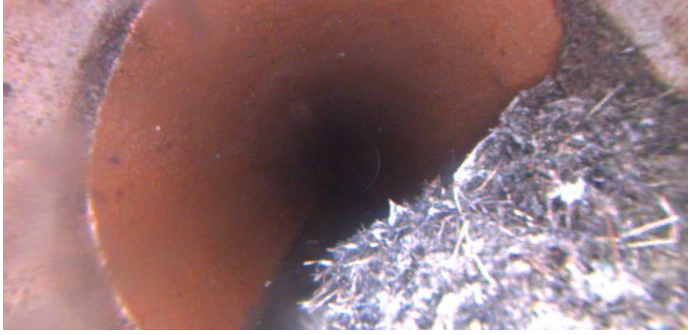
Code:	MSA
Description:	Abandoned Survey
Distance (ft):	7.2
Structural Grade:	0
O&M Grade:	0
Clock Start/From:	
Clock To:	
1st Value:	
2nd Value:	
Value Percent:	
Continuous Index:	
Within 8" of Joint:	NO
Remarks:	roots
