Profile/Photo Observation Report

Street:	FOXCROFT STREET	Flow Control:	Not Controlled
City:	Hobart, IN	Year Renewed:	
Location:	Yard	Tape/Media #:	
Purpose:	Routine Assessment	Dia/Height:	12"
Use:	Sanitary	Material:	VCP
Drain Area:	NA	Lining:	
Category:	NA		
Comment:	.

Location Details:		Direction of Survey:	Upstream
US MH:	M-507-074	DS MH:	M-507-085
		Total Length Surveyed (ft):	7.2

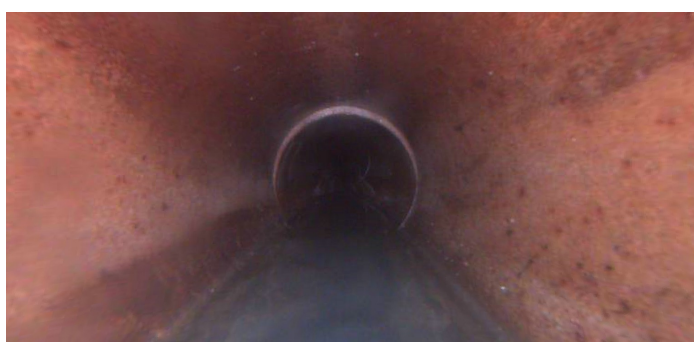
Code: **AMH**
Description: **Manhole**

Distance (ft): **.0**
Structural Grade: **0**
O&M Grade: **0**
Clock Start/From:
Clock To:
1st Value:
2nd Value:
Value Percent:
Continuous Index:
Within 8" of Joint: **NO**
Remarks: **M-507-085**

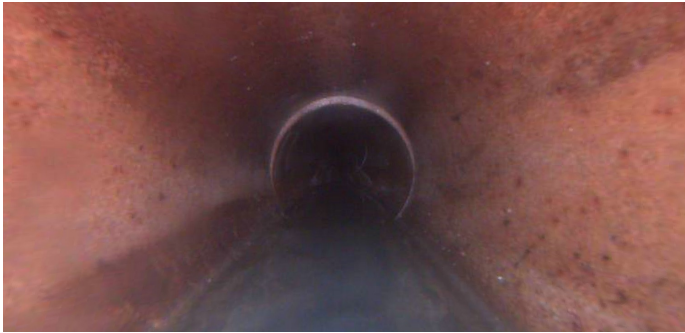
Code:	MWL
Description:	Water Level

Distance (ft):	.0
Structural Grade:	0
O&M Grade:	0
Clock Start/From:	
Clock To:	
1st Value:	
2nd Value:	
Value Percent:	20.000
Continuous Index:	
Within 8" of Joint:	NO
Remarks:

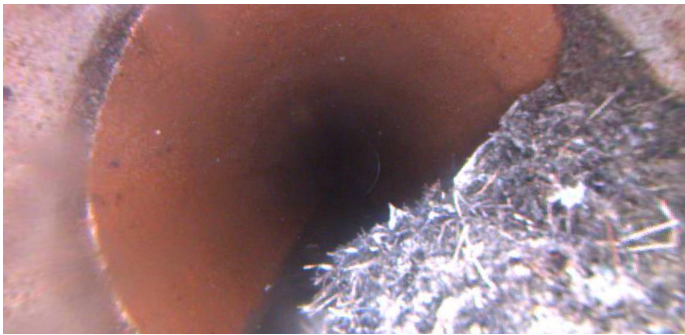
Code:	RMJ
Description:	Roots Medium Joint

Distance (ft):	7.2
Structural Grade:	0
O&M Grade:	3
Clock Start/From:	2
Clock To:	6
1st Value:	
2nd Value:	
Value Percent:	40.000
Continuous Index:	
Within 8" of Joint:	YES
Remarks:

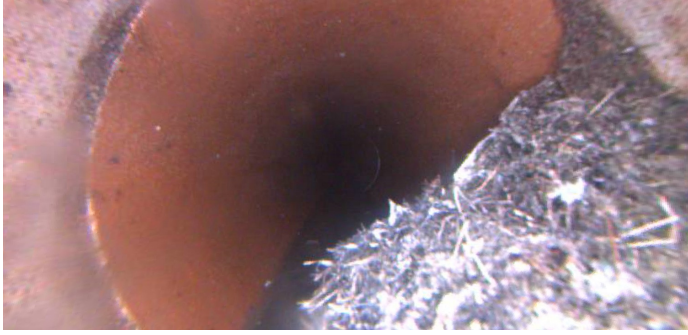
Code:	MSA
Description:	Abandoned Survey
Distance (ft):	7.2
Structural Grade:	0
O&M Grade:	0
Clock Start/From:	
Clock To:	
1st Value:	
2nd Value:	
Value Percent:	
Continuous Index:	
Within 8" of Joint:	NO
Remarks:	roots
