Profile/Photo Observation Report

Street:	S COLORADO ST	Flow Control:	Not Controlled
City:	Hobart, IN	Year Renewed:	
Location:	Yard	Tape/Media #:	
Purpose:	Routine Assessment	Dia/Height:	12"
Use:	Sanitary	Material:	VCP
Drain Area:	NA	Lining:	
Category:	NA		
Comment:	.		
Location Details:		Direction of Survey:	Downstream
US MH:	M-507-074	DS MH:	M-507-085
		Total Length Surveyed (ft):	12.0

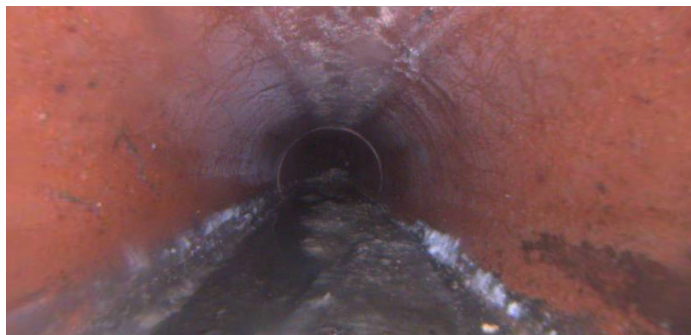
Code: **AMH**
Description: **Manhole**

Distance (ft): **.0**
Structural Grade: **0**
O&M Grade: **0**
Clock Start/From:
Clock To:
1st Value:
2nd Value:
Value Percent:
Continuous Index:
Within 8" of Joint: **NO**
Remarks: **M-507-074**

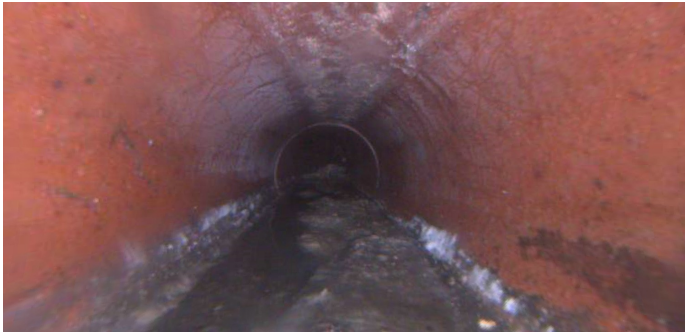
Code:	MWL
Description:	Water Level

Distance (ft):	.0
Structural Grade:	0
O&M Grade:	0
Clock Start/From:	
Clock To:	
1st Value:	
2nd Value:	
Value Percent:	10.000
Continuous Index:	
Within 8" of Joint:	NO
Remarks:

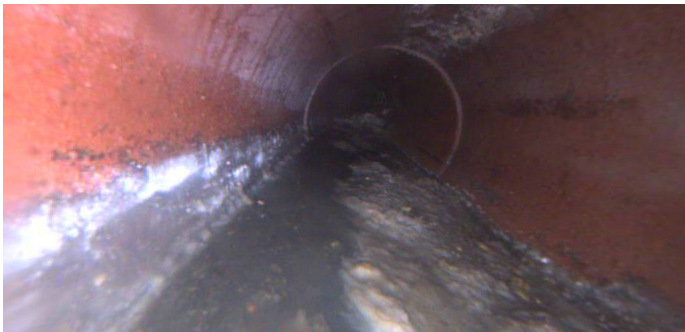
Code:	DSF
Description:	Deposits Settled Fine

Distance (ft):	2.3
Structural Grade:	0
O&M Grade:	2
Clock Start/From:	4
Clock To:	6
1st Value:	
2nd Value:	
Value Percent:	10.000
Continuous Index:	
Within 8" of Joint:	NO
Remarks:

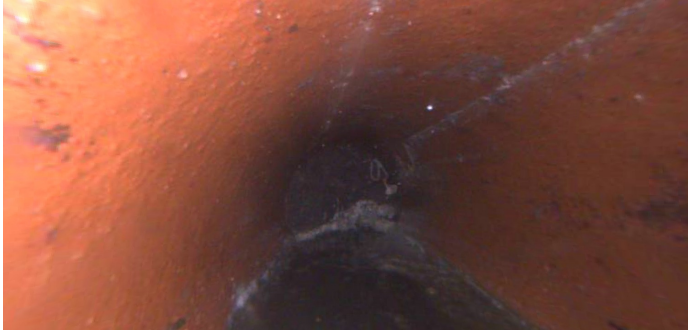
Code:	MSA
Description:	Abandoned Survey
Distance (ft):	12.0
Structural Grade:	0
O&M Grade:	0
Clock Start/From:	
Clock To:	
1st Value:	
2nd Value:	
Value Percent:	
Continuous Index:	
Within 8" of Joint:	NO
Remarks:	roots
