Profile/Photo Observation Report

Date:	12/05/2024	Weather:		Coding:	PACP 7.0
Pipe Length (ft):	251.0	Owner:	City of Hobart	Pre Clean:	Heavy Cleaning
P.O.#:	YES502259	Surveyor:	S. Bucklin	PSR:	P-507-075-076
Customer:	City of Hobart	Clean Date:	09/05/2024	Shape:	C

Street:	West 10th Street	Flow Control:	Not Controlled
City:	Hobart, IN	Year Renewed:	
Location:	Easement/Right of Way	Tape/Media #:	
Purpose:	Sewer System Evaluation Survey (SS)	Dia/Height:	10"
Use:	Sanitary Sewage Pipe	Material:	VCP
Drain Area:		Lining:	None
Category:	NA		
Comment:			
Location Details:		Direction of Survey:	Downstream
US MH:	M-507-078	DS MH:	M-507-075
		Total Length Surveyed (ft):	328.2

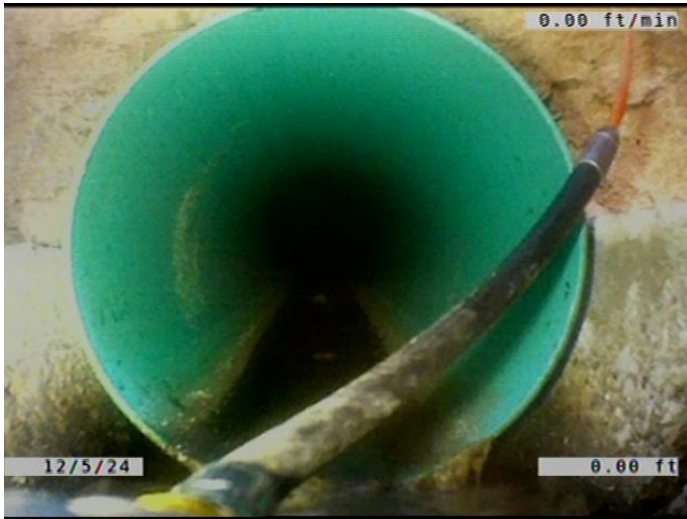
Code: **AMH**
Description: **Manhole**

Distance (ft): **.0**
Structural Grade: **0**
O&M Grade: **0**
Clock Start/From:
Clock To:
1st Value:
2nd Value:
Value Percent:
Continuous Index:
Within 8" of Joint: **NO**
Remarks: **M-507-078**

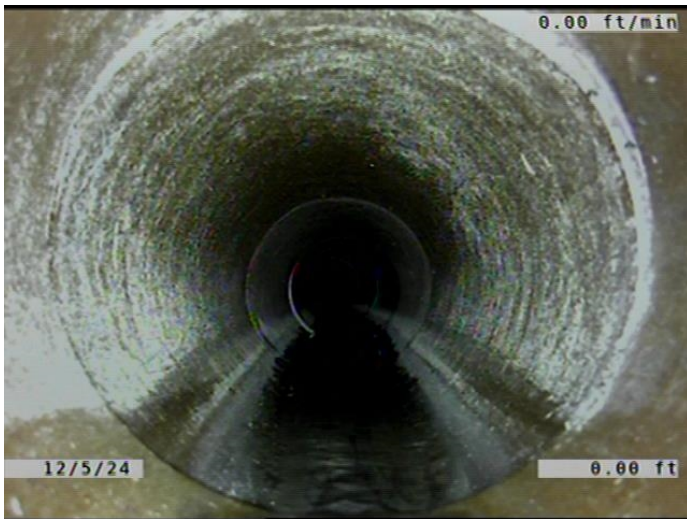
Code: **MWL**
Description: **Miscellaneous Water Level**

Distance (ft): **.0**
Structural Grade: **0**
O&M Grade: **0**
Clock Start/From:
Clock To:
1st Value:
2nd Value:
Value Percent: **5.000**
Continuous Index:
Within 8" of Joint: **NO**
Remarks:

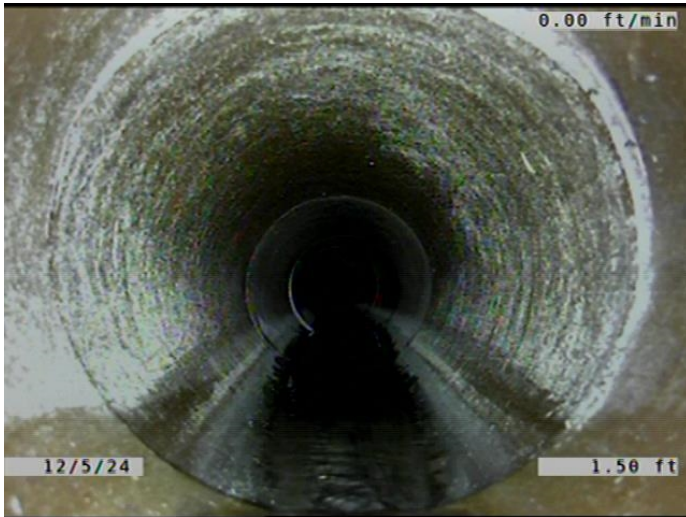
Code: **MGO**
Description: **Miscellaneous General Observation**

Distance (ft): **1.5**
Structural Grade: **0**
O&M Grade: **0**
Clock Start/From:
Clock To:
1st Value:
2nd Value:
Value Percent:
Continuous Index:
Within 8" of Joint: **NO**
Remarks: **MANHOLE CHANNEL IS MISSING.
HAD TO START IN THE PIPE.**

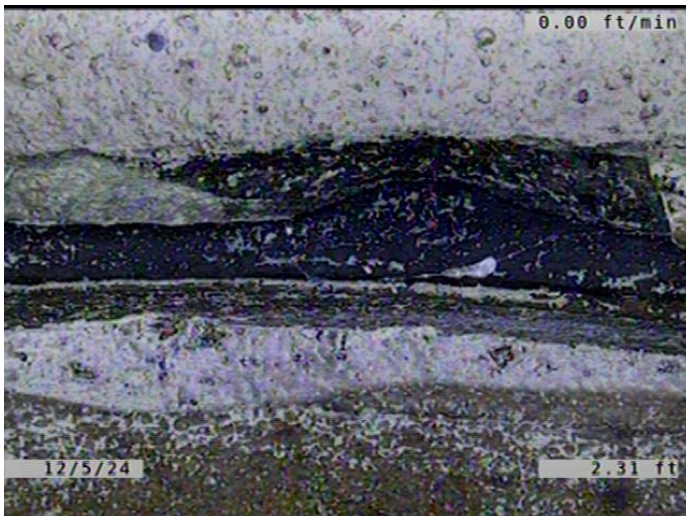
Code: **SZ**
Description: **Surface Damage Other**

Distance (ft): **2.3**
Structural Grade: **0**
O&M Grade: **0**
Clock Start/From: **11**
Clock To: **12**
1st Value:
2nd Value:
Value Percent:
Continuous Index:
Within 8" of Joint: **YES**
Remarks: **A PIECE CHIPPED AWAY FROM THE
JOINT.**

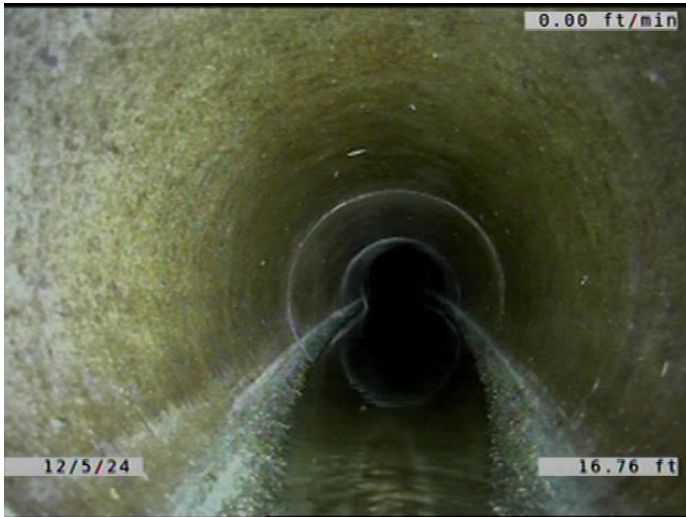
Code: **MWLS**
Description: **Miscellaneous Water Level Sag**

Distance (ft): **16.8**
Structural Grade: **2**
O&M Grade: **0**
Clock Start/From:
Clock To:
1st Value:
2nd Value:
Value Percent: **20.000**
Continuous Index: **S01**
Within 8" of Joint: **NO**
Remarks:

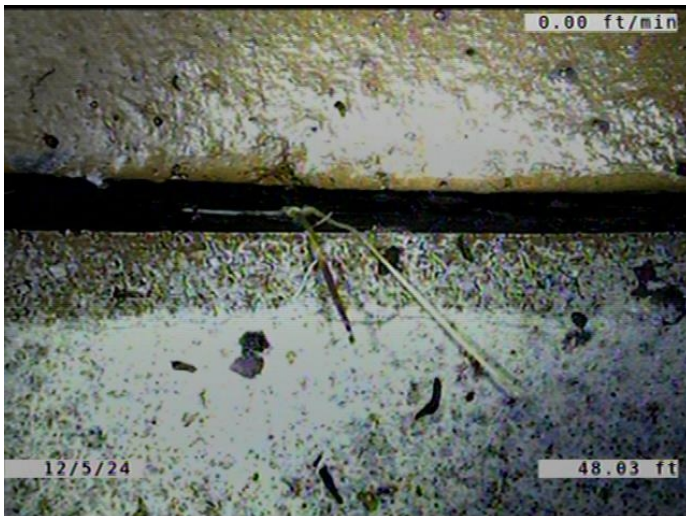
Code: **RFJ**
Description: **Roots Fine Joint**

Distance (ft): **48.0**
Structural Grade: **0**
O&M Grade: **1**
Clock Start/From: **9**
Clock To: **3**
1st Value:
2nd Value:
Value Percent:
Continuous Index: **S02**
Within 8" of Joint: **YES**
Remarks:

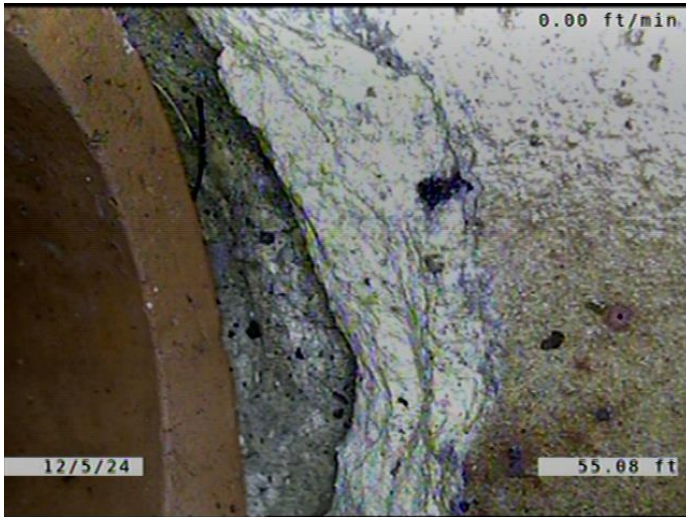
Code: **SSS**
Description: **Surface Damage Surface Spalling**

Distance (ft): **55.1**
Structural Grade: **2**
O&M Grade: **0**
Clock Start/From: **10**
Clock To: **12**
1st Value:
2nd Value:
Value Percent:
Continuous Index:
Within 8" of Joint: **YES**
Remarks:

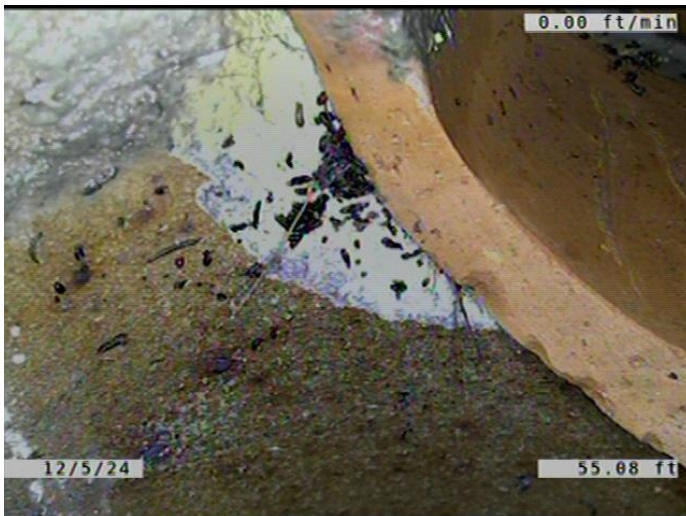
Code: **RFB**
Description: **Roots Fine Barrel**

Distance (ft): **55.2**
Structural Grade: **0**
O&M Grade: **2**
Clock Start/From: **10**
Clock To: **12**
1st Value:
2nd Value:
Value Percent:
Continuous Index:
Within 8" of Joint: **NO**
Remarks:

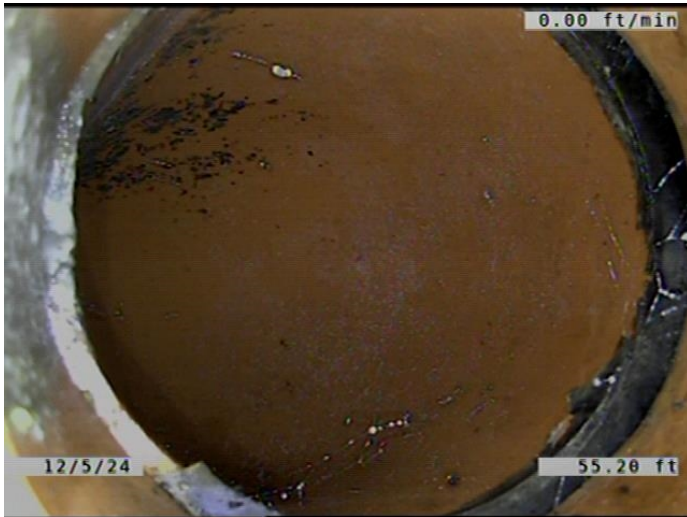
Code:	TBI
Description:	Tap Break-in Intruding
Distance (ft):	55.2
Structural Grade:	0
O&M Grade:	2
Clock Start/From:	11
Clock To:	
1st Value:	6.000
2nd Value:	1.000
Value Percent:	
Continuous Index:	
Within 8" of Joint:	YES
Remarks:	SERVICE CONNECTION TO MAIN DOESNT LOOK SEATED TO THE SERVI

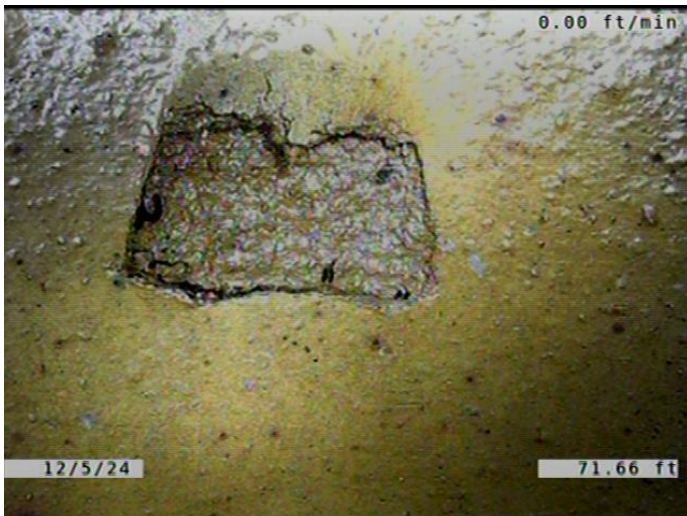
Code:	SSS
Description:	Surface Damage Surface Spalling
Distance (ft):	71.7
Structural Grade:	2
O&M Grade:	0
Clock Start/From:	11
Clock To:	
1st Value:	
2nd Value:	
Value Percent:	
Continuous Index:	
Within 8" of Joint:	YES
Remarks:

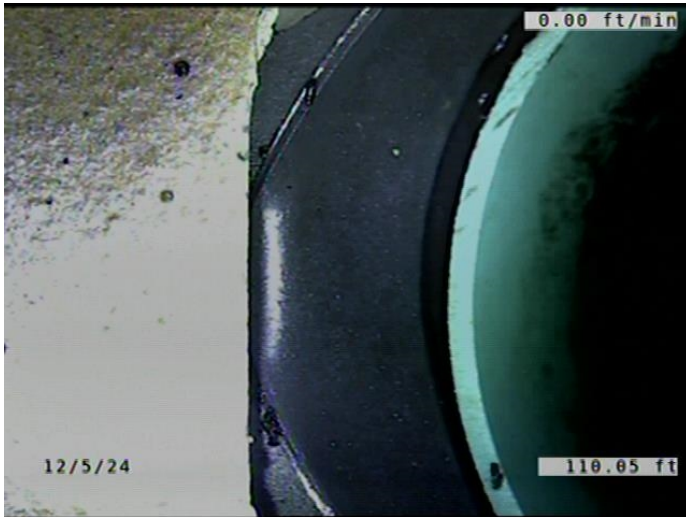
Code: **SSS**
Description: **Surface Damage Surface Spalling**

Distance (ft): **110.0**
Structural Grade: **2**
O&M Grade: **0**
Clock Start/From: **1**
Clock To: **3**
1st Value:
2nd Value:
Value Percent:
Continuous Index:
Within 8" of Joint: **YES**
Remarks:

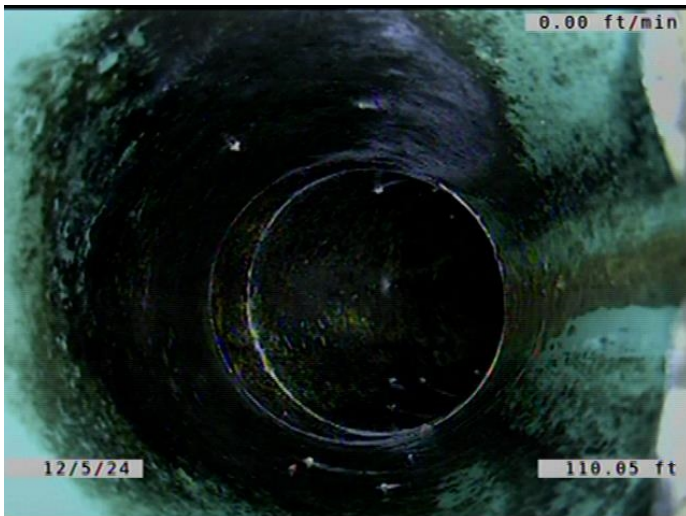
Code: **TS**
Description: **Tap Saddle**

Distance (ft): **110.0**
Structural Grade: **0**
O&M Grade: **0**
Clock Start/From: **2**
Clock To:
1st Value: **6.000**
2nd Value:
Value Percent:
Continuous Index:
Within 8" of Joint: **YES**
Remarks: **SERVICE IS PVC.**

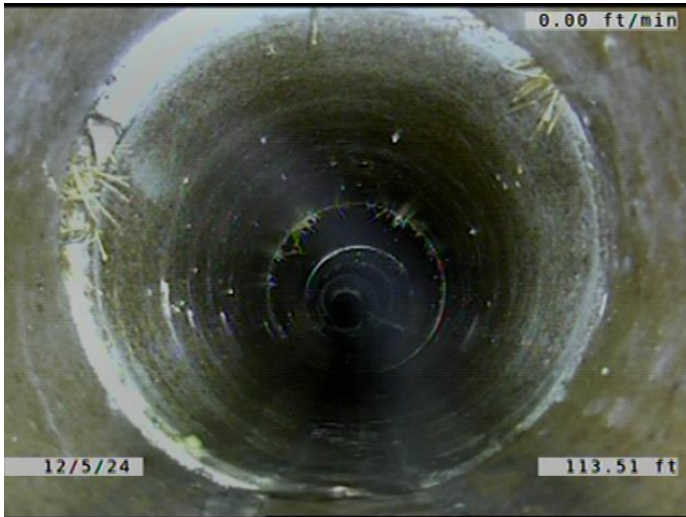
Code: **MWLS**
Description: **Miscellaneous Water Level Sag**

Distance (ft): **113.5**
Structural Grade: **2**
O&M Grade: **0**
Clock Start/From:
Clock To:
1st Value:
2nd Value:
Value Percent: **20.000**
Continuous Index: **F01**
Within 8" of Joint: **NO**
Remarks:

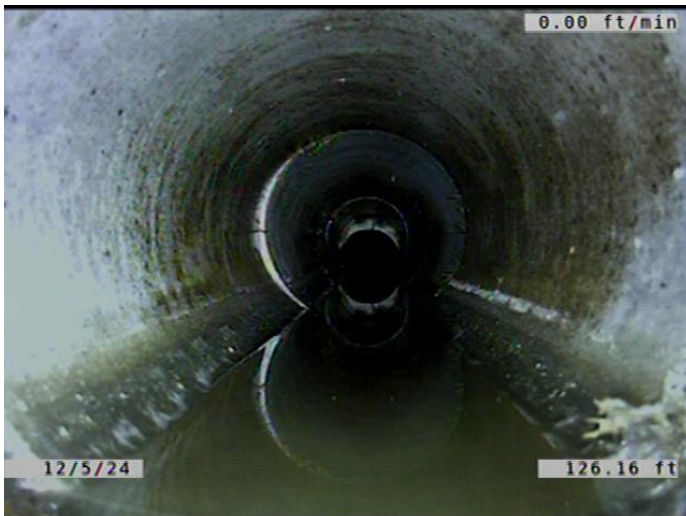
Code: **MWLS**
Description: **Miscellaneous Water Level Sag**

Distance (ft): **126.2**
Structural Grade: **2**
O&M Grade: **0**
Clock Start/From:
Clock To:
1st Value:
2nd Value:
Value Percent: **10.000**
Continuous Index: **S03**
Within 8" of Joint: **NO**
Remarks:

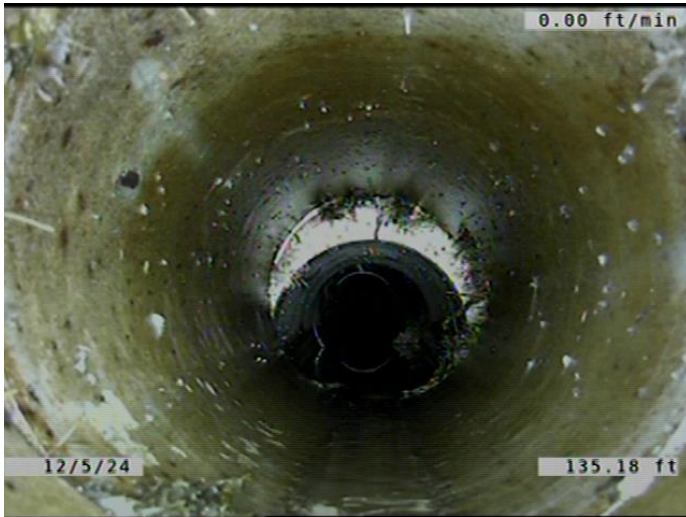
Code: **MWLS**
Description: **Miscellaneous Water Level Sag**

Distance (ft): **135.2**
Structural Grade: **2**
O&M Grade: **0**
Clock Start/From:
Clock To:
1st Value:
2nd Value:
Value Percent: **10.000**
Continuous Index: **F03**
Within 8" of Joint: **NO**
Remarks:

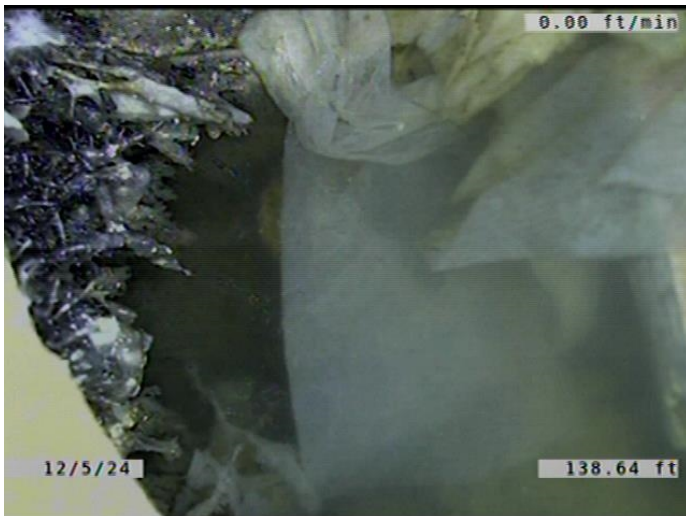
Code: **BVV**
Description: **Broken Void Visible**

Distance (ft): **138.6**
Structural Grade: **5**
O&M Grade: **0**
Clock Start/From: **2**
Clock To: **8**
1st Value:
2nd Value:
Value Percent:
Continuous Index:
Within 8" of Joint: **YES**
Remarks: **PIPE MISSING FROM 5-8 AND PIPE PUSHED BACK FROM 2-5.**

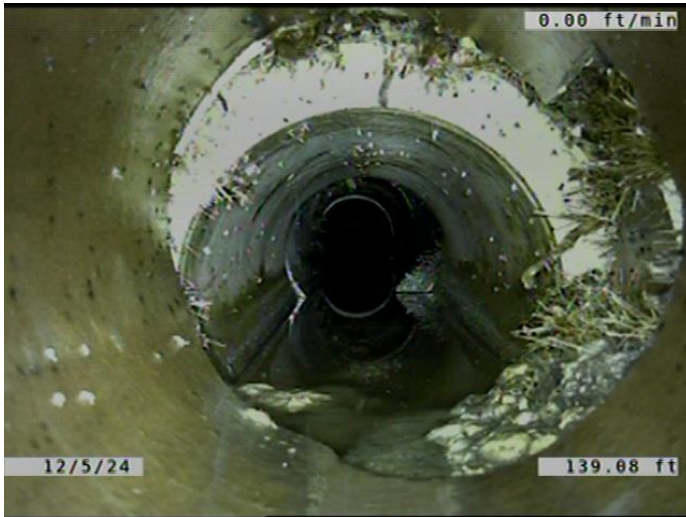
Code: **JOLD**
Description: **Joint Offset Large Defective**

Distance (ft): **139.1**
Structural Grade: **4**
O&M Grade: **0**
Clock Start/From:
Clock To:
1st Value:
2nd Value:
Value Percent:
Continuous Index:
Within 8" of Joint: **NO**
Remarks: **Soil visible**

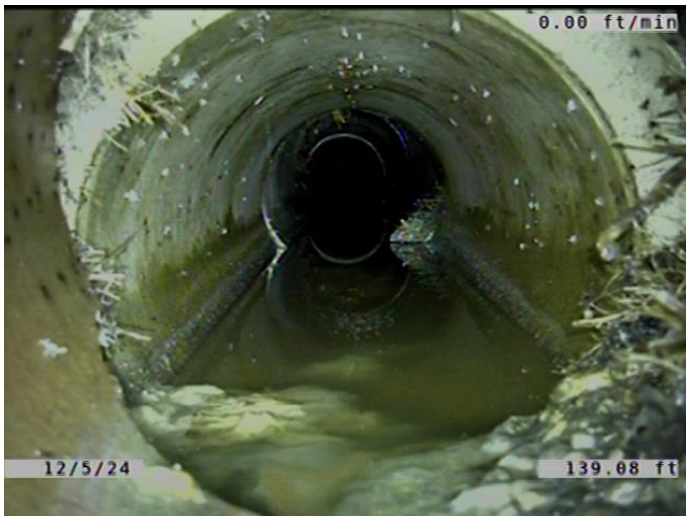
Code: **MWLS**
Description: **Miscellaneous Water Level Sag**

Distance (ft): **139.1**
Structural Grade: **2**
O&M Grade: **0**
Clock Start/From:
Clock To:
1st Value:
2nd Value:
Value Percent: **20.000**
Continuous Index: **S04**
Within 8" of Joint: **NO**
Remarks:

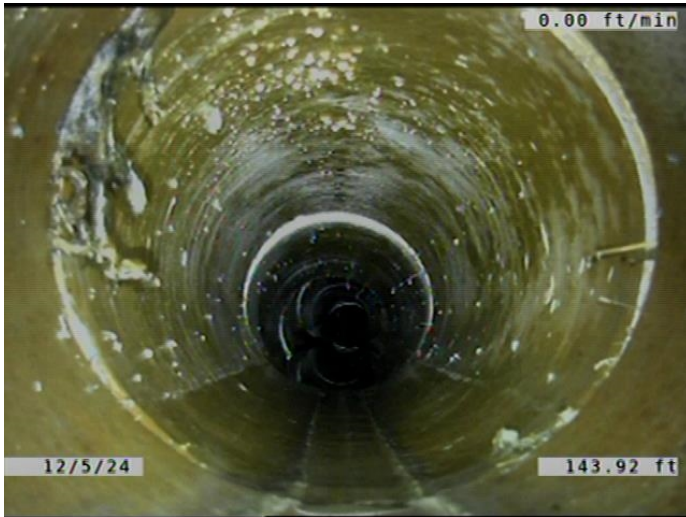
Code: **MWLS**
Description: **Miscellaneous Water Level Sag**

Distance (ft): **143.9**
Structural Grade: **2**
O&M Grade: **0**
Clock Start/From:
Clock To:
1st Value:
2nd Value:
Value Percent: **20.000**
Continuous Index: **F04**
Within 8" of Joint: **NO**
Remarks:

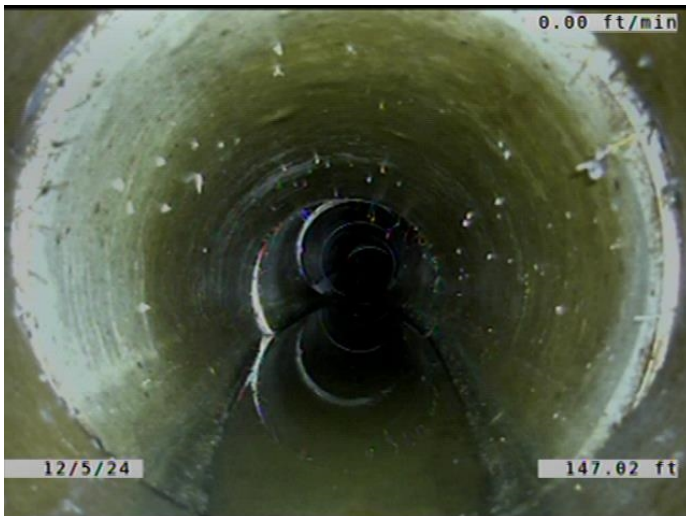
Code: **MWLS**
Description: **Miscellaneous Water Level Sag**

Distance (ft): **147.0**
Structural Grade: **2**
O&M Grade: **0**
Clock Start/From:
Clock To:
1st Value:
2nd Value:
Value Percent: **15.000**
Continuous Index: **S05**
Within 8" of Joint: **NO**
Remarks:

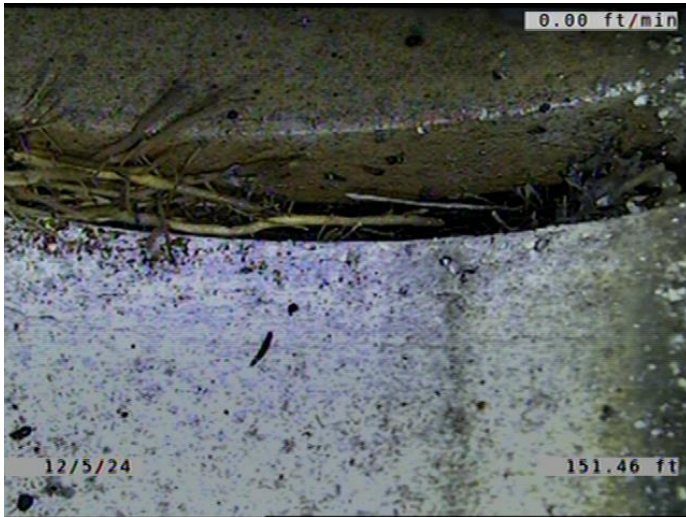
Code: **JOMD**
Description: **Joint Offset Medium Defective**

Distance (ft): **151.5**
Structural Grade: **3**
O&M Grade: **0**
Clock Start/From:
Clock To:
1st Value:
2nd Value:
Value Percent:
Continuous Index:
Within 8" of Joint: **NO**
Remarks:

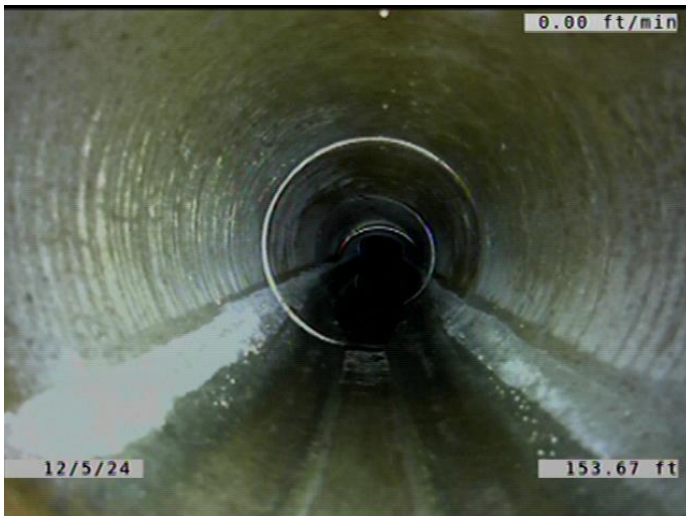
Code: **MWLS**
Description: **Miscellaneous Water Level Sag**

Distance (ft): **153.7**
Structural Grade: **2**
O&M Grade: **0**
Clock Start/From:
Clock To:
1st Value:
2nd Value:
Value Percent: **15.000**
Continuous Index: **F05**
Within 8" of Joint: **NO**
Remarks:

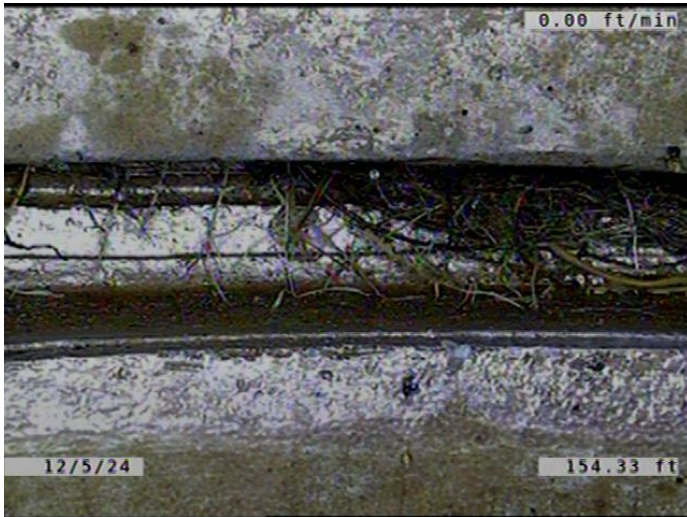
Code: **JAM**
Description: **Joint Angular Medium**

Distance (ft): **154.3**
Structural Grade: **3**
O&M Grade: **0**
Clock Start/From:
Clock To:
1st Value:
2nd Value:
Value Percent:
Continuous Index:
Within 8" of Joint: **NO**
Remarks:

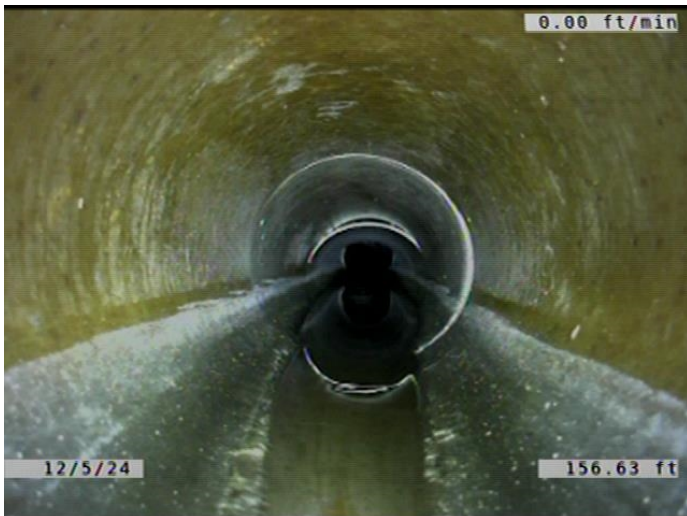
Code: **MWLS**
Description: **Miscellaneous Water Level Sag**

Distance (ft): **156.6**
Structural Grade: **2**
O&M Grade: **0**
Clock Start/From:
Clock To:
1st Value:
2nd Value:
Value Percent: **20.000**
Continuous Index: **S06**
Within 8" of Joint: **NO**
Remarks:

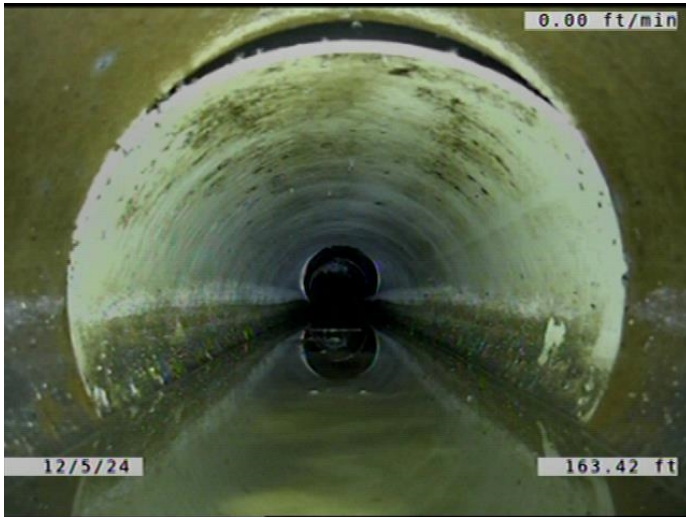
Code: **JOM**
Description: **Joint Offset Medium**

Distance (ft): **163.4**
Structural Grade: **3**
O&M Grade: **0**
Clock Start/From:
Clock To:
1st Value:
2nd Value:
Value Percent:
Continuous Index:
Within 8" of Joint: **NO**
Remarks:

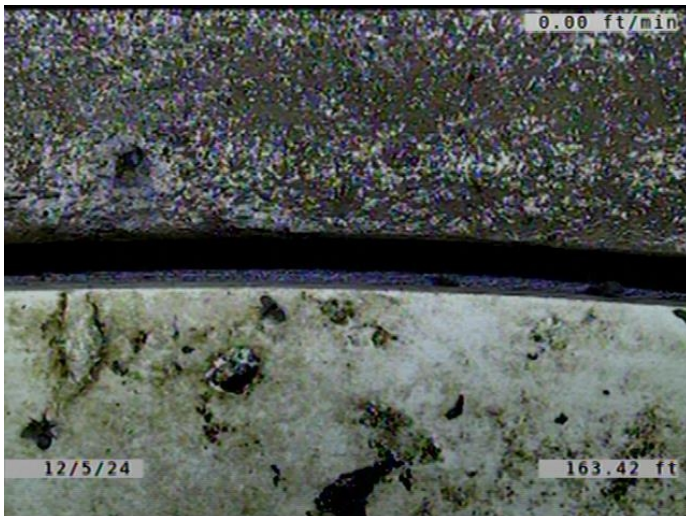
Code: **RPRD**
Description: **Point Repair Replacement Defective**

Distance (ft): **163.4**
Structural Grade: **4**
O&M Grade: **0**
Clock Start/From:
Clock To:
1st Value:
2nd Value:
Value Percent:
Continuous Index: **S07**
Within 8" of Joint: **YES**
Remarks: **REPLACED WITH PVC.**

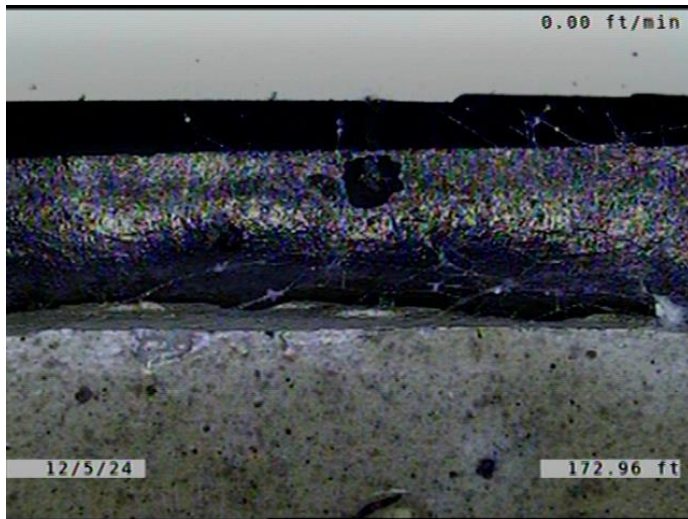
Code: **RPRD**
Description: **Point Repair Replacement Defective**

Distance (ft): **173.0**
Structural Grade: **4**
O&M Grade: **0**
Clock Start/From:
Clock To:
1st Value:
2nd Value:
Value Percent:
Continuous Index: **F07**
Within 8" of Joint: **YES**
Remarks: **REPLACED WITH PVC.**

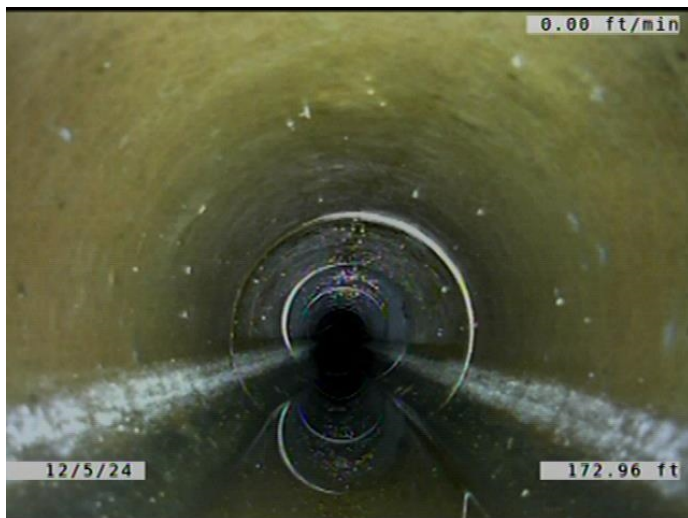
Code: **RFJ**
Description: **Roots Fine Joint**

Distance (ft): **173.0**
Structural Grade: **0**
O&M Grade: **1**
Clock Start/From: **9**
Clock To: **3**
1st Value:
2nd Value:
Value Percent:
Continuous Index: **F02**
Within 8" of Joint: **YES**
Remarks:

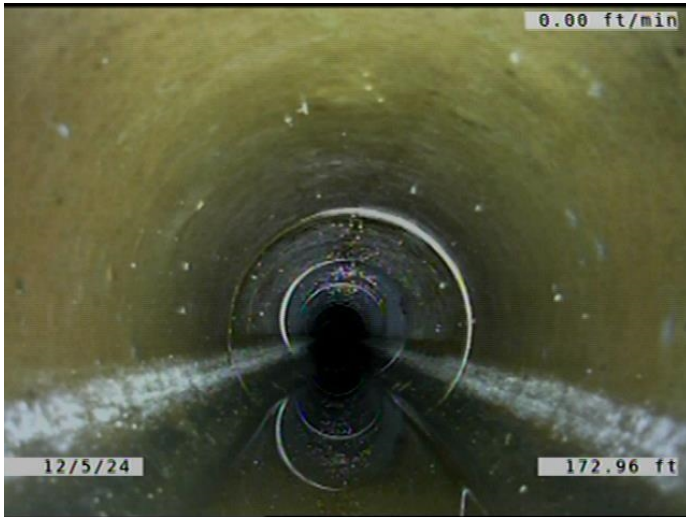
Code: **MWLS**
Description: **Miscellaneous Water Level Sag**

Distance (ft): **173.0**
Structural Grade: **2**
O&M Grade: **0**
Clock Start/From:
Clock To:
1st Value:
2nd Value:
Value Percent: **20.000**
Continuous Index: **F06**
Within 8" of Joint: **NO**
Remarks:

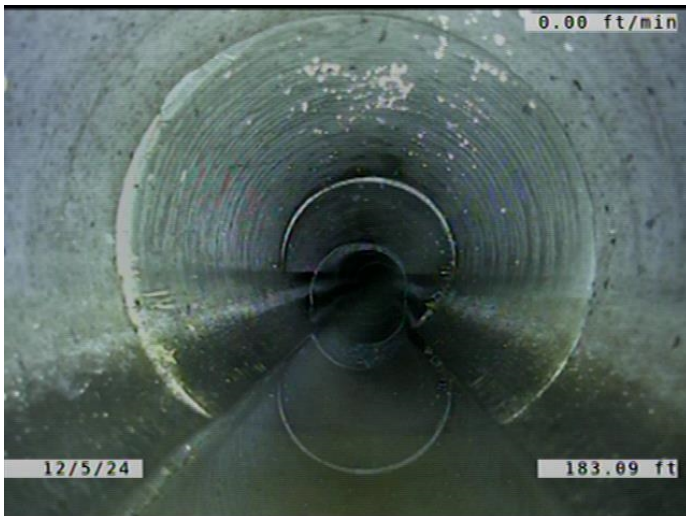
Code: **MWLS**
Description: **Miscellaneous Water Level Sag**

Distance (ft): **183.1**
Structural Grade: **2**
O&M Grade: **0**
Clock Start/From:
Clock To:
1st Value:
2nd Value:
Value Percent: **20.000**
Continuous Index: **S08**
Within 8" of Joint: **NO**
Remarks:

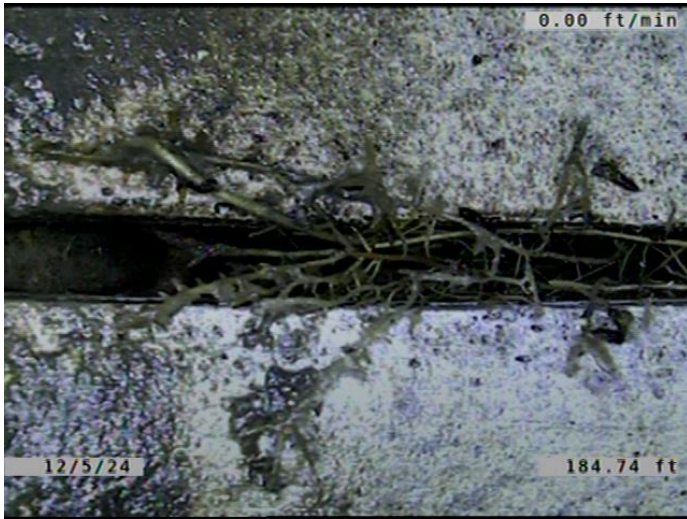
Code: **RFJ**
Description: **Roots Fine Joint**

Distance (ft): **184.7**
Structural Grade: **0**
O&M Grade: **1**
Clock Start/From: **8**
Clock To: **4**
1st Value:
2nd Value:
Value Percent:
Continuous Index: **S09**
Within 8" of Joint: **YES**
Remarks:

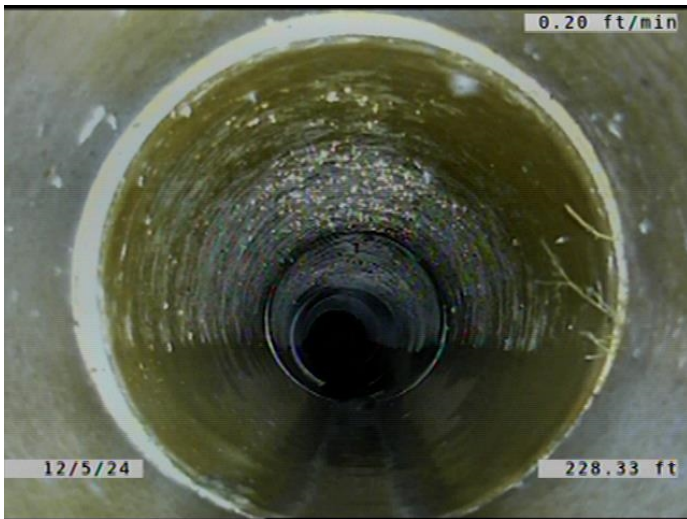
Code: **MWLS**
Description: **Miscellaneous Water Level Sag**

Distance (ft): **228.3**
Structural Grade: **2**
O&M Grade: **0**
Clock Start/From:
Clock To:
1st Value:
2nd Value:
Value Percent: **20.000**
Continuous Index: **F08**
Within 8" of Joint: **NO**
Remarks:

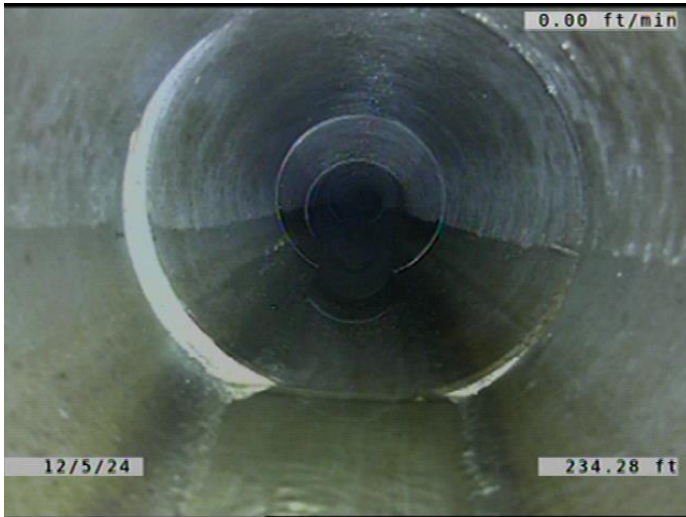
Code: **MWLS**
Description: **Miscellaneous Water Level Sag**

Distance (ft): **234.3**
Structural Grade: **2**
O&M Grade: **0**
Clock Start/From:
Clock To:
1st Value:
2nd Value:
Value Percent: **10.000**
Continuous Index: **S10**
Within 8" of Joint: **NO**
Remarks:

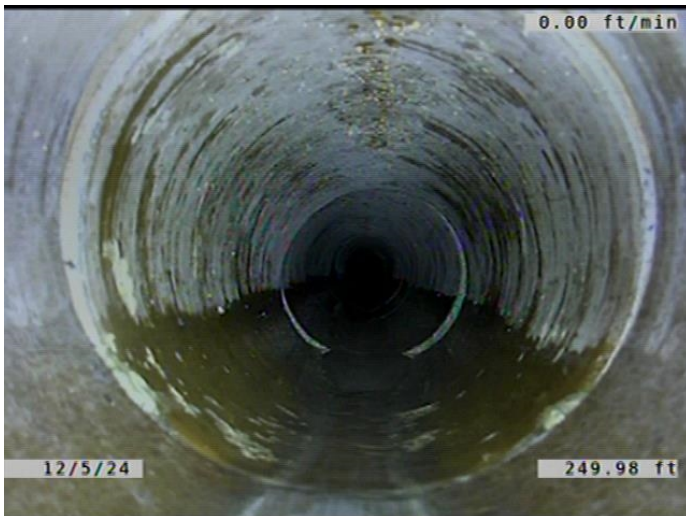
Code: **MWLS**
Description: **Miscellaneous Water Level Sag**

Distance (ft): **250.0**
Structural Grade: **2**
O&M Grade: **0**
Clock Start/From:
Clock To:
1st Value:
2nd Value:
Value Percent: **10.000**
Continuous Index: **F10**
Within 8" of Joint: **NO**
Remarks:

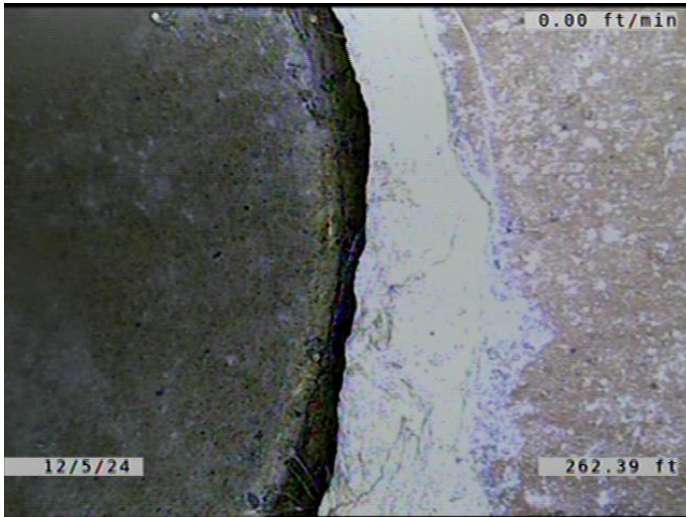
Code: **SSS**
Description: **Surface Damage Surface Spalling**

Distance (ft): **262.4**
Structural Grade: **2**
O&M Grade: **0**
Clock Start/From: **11**
Clock To: **1**
1st Value:
2nd Value:
Value Percent:
Continuous Index:
Within 8" of Joint: **YES**
Remarks:

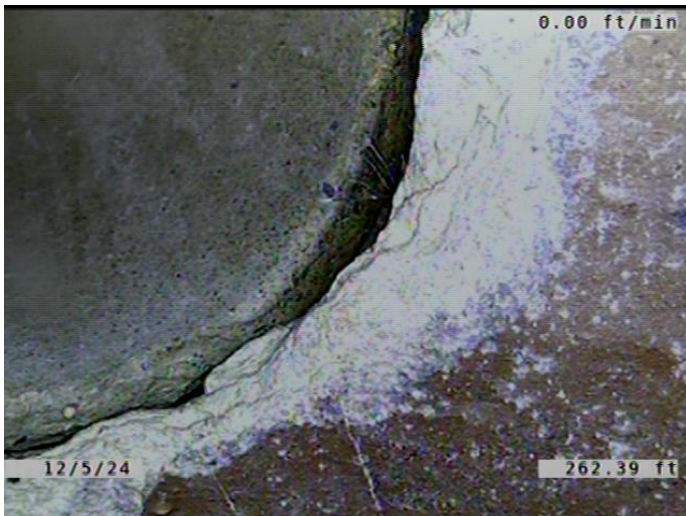
Code: **RFB**
Description: **Roots Fine Barrel**

Distance (ft): **262.4**
Structural Grade: **0**
O&M Grade: **2**
Clock Start/From: **11**
Clock To: **1**
1st Value:
2nd Value:
Value Percent:
Continuous Index:
Within 8" of Joint: **NO**
Remarks:

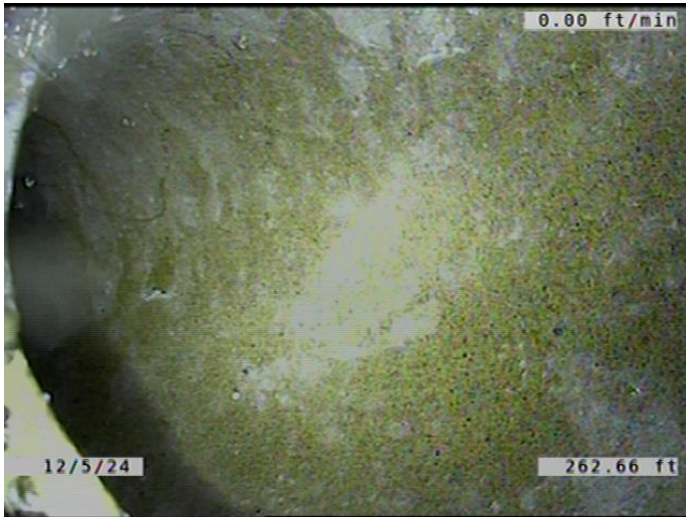
Code: **TBD**
Description: **Tap Break-in/Hammer Defective**

Distance (ft): **262.7**
Structural Grade: **0**
O&M Grade: **3**
Clock Start/From: **11**
Clock To:
1st Value: **6.000**
2nd Value:
Value Percent:
Continuous Index:
Within 8" of Joint: **YES**
Remarks: **Defective**

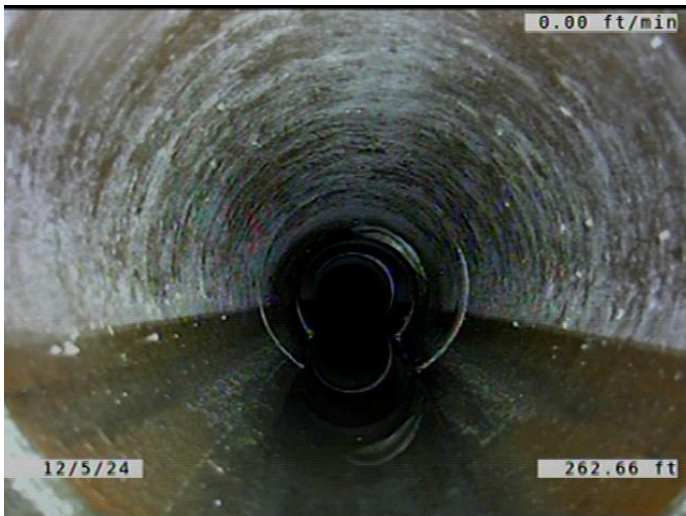
Code: **MWLS**
Description: **Miscellaneous Water Level Sag**

Distance (ft): **262.7**
Structural Grade: **2**
O&M Grade: **0**
Clock Start/From:
Clock To:
1st Value:
2nd Value:
Value Percent: **15.000**
Continuous Index: **S11**
Within 8" of Joint: **NO**
Remarks:

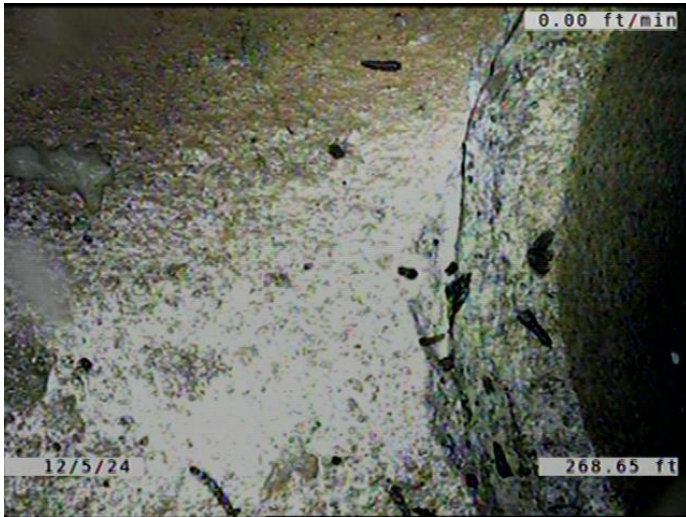
Code: **SSS**
Description: **Surface Damage Surface Spalling**

Distance (ft): **268.6**
Structural Grade: **2**
O&M Grade: **0**
Clock Start/From: **12**
Clock To: **2**
1st Value:
2nd Value:
Value Percent:
Continuous Index:
Within 8" of Joint: **YES**
Remarks:

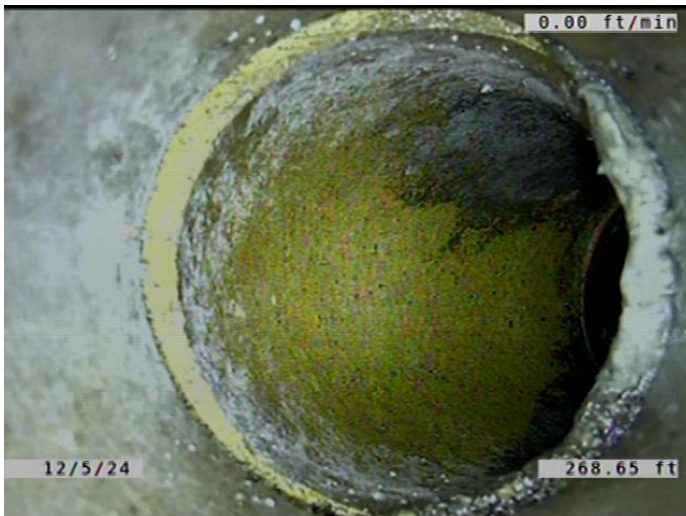
Code: **TBI**
Description: **Tap Break-in Intruding**

Distance (ft): **268.6**
Structural Grade: **0**
O&M Grade: **2**
Clock Start/From: **1**
Clock To:
1st Value: **6.000**
2nd Value: **1.000**
Value Percent:
Continuous Index:
Within 8" of Joint: **YES**
Remarks: **CONSTANTLY RUNNING WATER.**

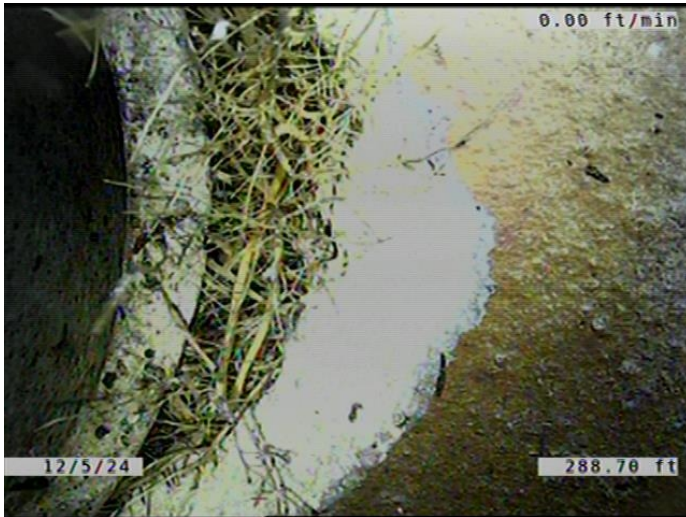
Code: **SSS**
Description: **Surface Damage Surface Spalling**

Distance (ft): **288.7**
Structural Grade: **2**
O&M Grade: **0**
Clock Start/From: **10**
Clock To: **1**
1st Value:
2nd Value:
Value Percent:
Continuous Index:
Within 8" of Joint: **YES**
Remarks:

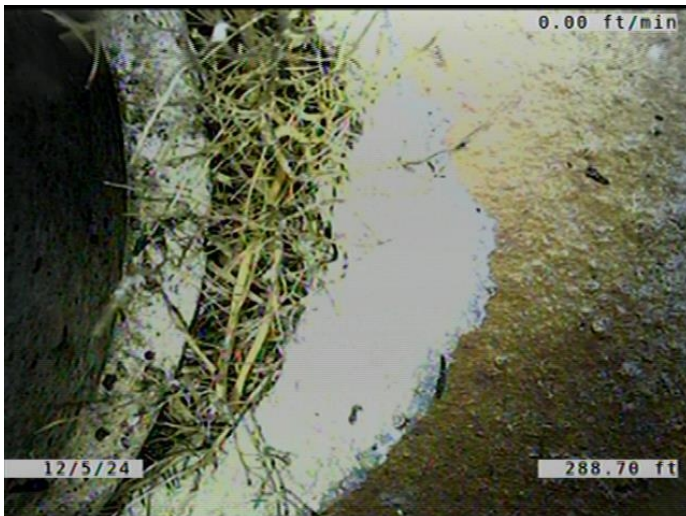
Code: **RFC**
Description: **Roots Fine Connection**

Distance (ft): **288.7**
Structural Grade: **0**
O&M Grade: **1**
Clock Start/From: **10**
Clock To: **1**
1st Value:
2nd Value:
Value Percent:
Continuous Index:
Within 8" of Joint: **NO**
Remarks:

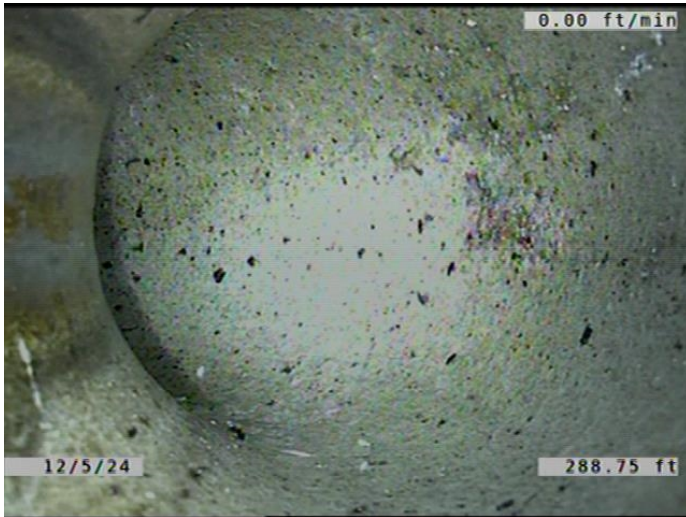
Code: **TBD**
Description: **Tap Break-in/Hammer Defective**

Distance (ft): **288.7**
Structural Grade: **0**
O&M Grade: **3**
Clock Start/From: **11**
Clock To:
1st Value: **6.000**
2nd Value:
Value Percent:
Continuous Index:
Within 8" of Joint: **YES**
Remarks: **CONSTANTLY RUNNING WATER.**

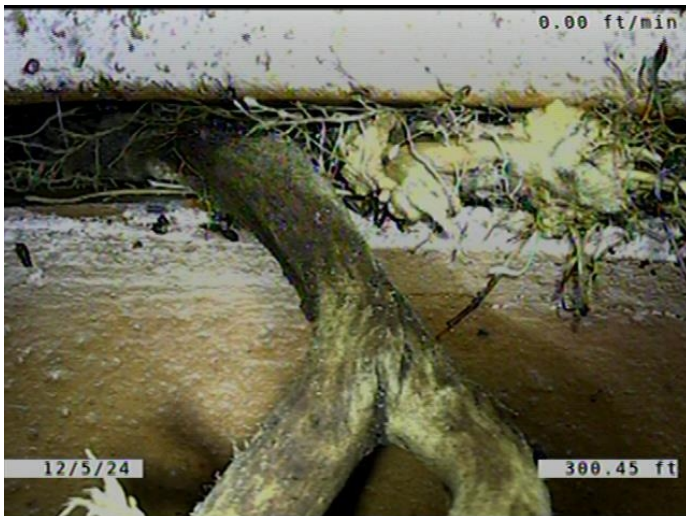
Code: **RTJ**
Description: **Roots Tap Joint**

Distance (ft): **300.4**
Structural Grade: **0**
O&M Grade: **2**
Clock Start/From: **11**
Clock To: **1**
1st Value:
2nd Value:
Value Percent: **5.000**
Continuous Index:
Within 8" of Joint: **YES**
Remarks:

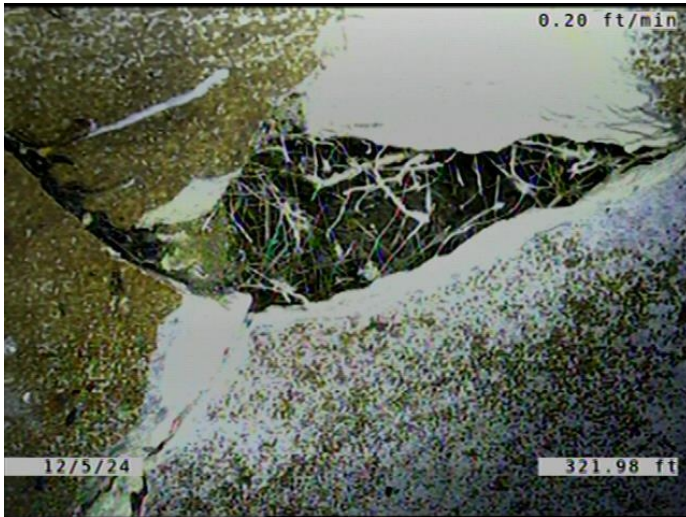
Code: **BSV**
 Description: **Broken Soil Visible**

Distance (ft): **322.0**
 Structural Grade: **5**
 O&M Grade: **0**
 Clock Start/From: **10**
 Clock To: **11**
 1st Value:
 2nd Value:
 Value Percent:
 Continuous Index:
 Within 8" of Joint: **YES**
 Remarks:

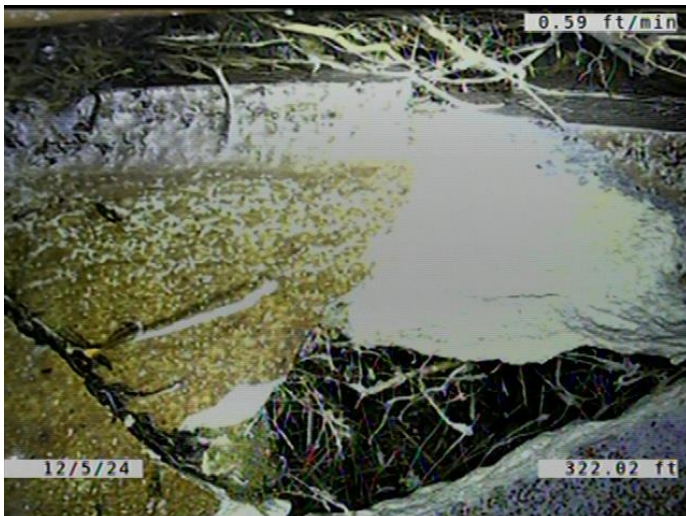
Code: **RFJ**
 Description: **Roots Fine Joint**

Distance (ft): **322.0**
 Structural Grade: **0**
 O&M Grade: **1**
 Clock Start/From: **9**
 Clock To: **11**
 1st Value:
 2nd Value:
 Value Percent:
 Continuous Index:
 Within 8" of Joint: **YES**
 Remarks:

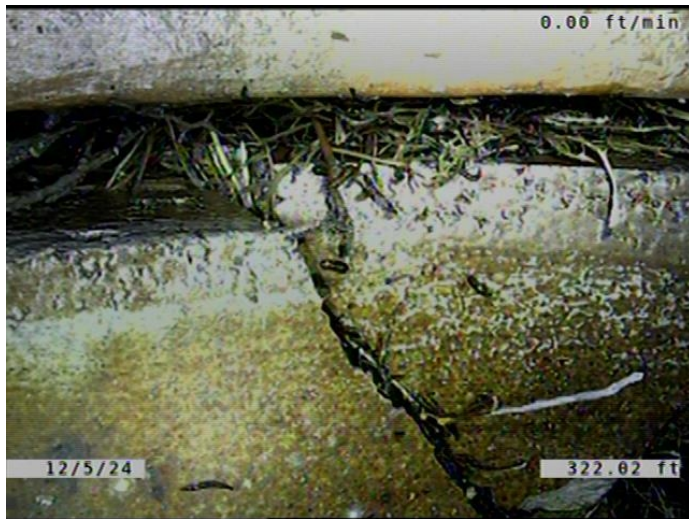
Code: **FM**
 Description: **Fracture Multiple**

Distance (ft): **322.0**
 Structural Grade: **4**
 O&M Grade: **0**
 Clock Start/From: **8**
 Clock To: **4**
 1st Value:
 2nd Value:
 Value Percent:
 Continuous Index:
 Within 8" of Joint: **YES**
 Remarks:

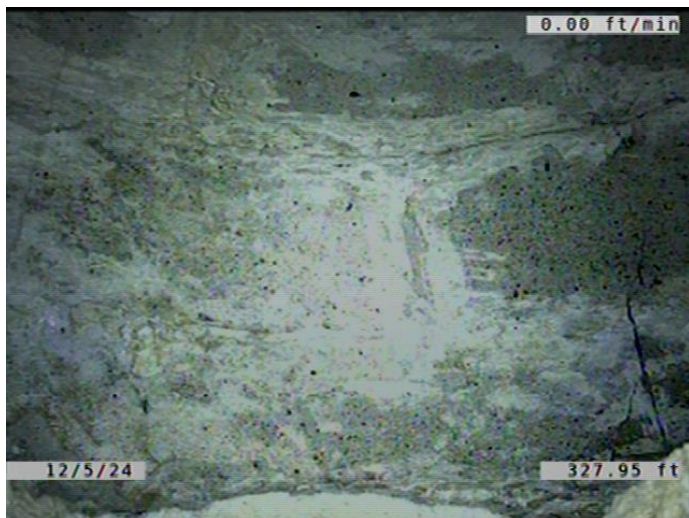
Code: **RFJ**
 Description: **Roots Fine Joint**

Distance (ft): **328.0**
 Structural Grade: **0**
 O&M Grade: **1**
 Clock Start/From: **8**
 Clock To: **4**
 1st Value:
 2nd Value:
 Value Percent:
 Continuous Index: **F09**
 Within 8" of Joint: **YES**
 Remarks:

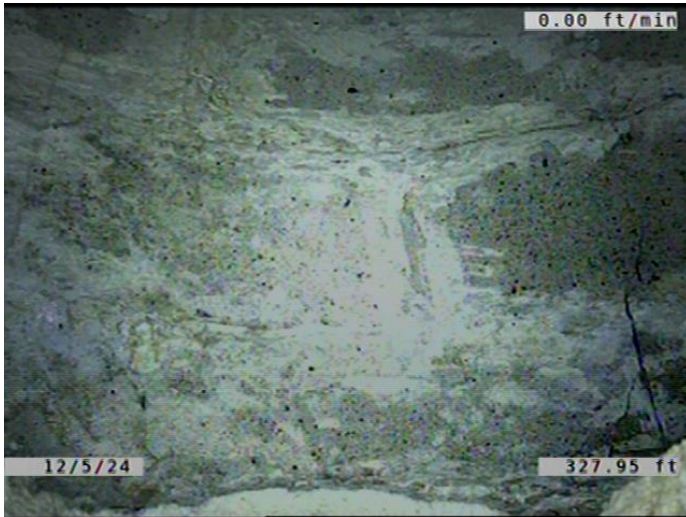
Code: **MWLS**
Description: **Miscellaneous Water Level Sag**

Distance (ft): **328.0**
Structural Grade: **2**
O&M Grade: **0**
Clock Start/From:
Clock To:
1st Value:
2nd Value:
Value Percent: **15.000**
Continuous Index: **F11**
Within 8" of Joint: **NO**
Remarks:

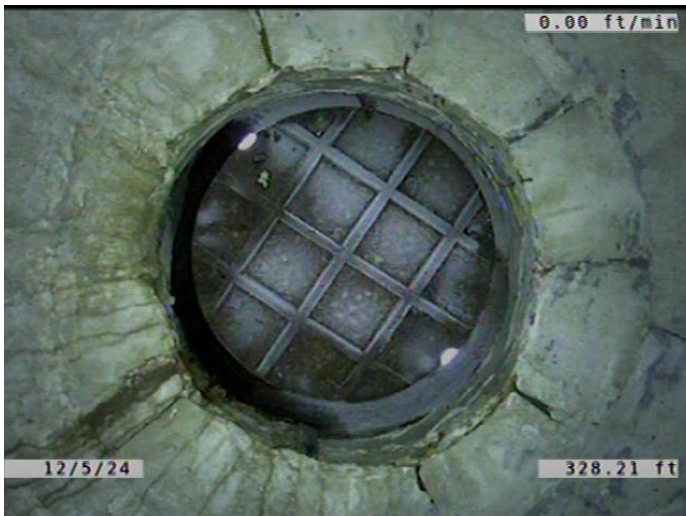
Code: **AMH**
Description: **Manhole**

Distance (ft): **328.2**
Structural Grade: **0**
O&M Grade: **0**
Clock Start/From:
Clock To:
1st Value:
2nd Value:
Value Percent:
Continuous Index:
Within 8" of Joint: **NO**
Remarks: **M-507-075**
