Profile/Photo Observation Report

Date:	12/06/2024	Weather:		Coding:	PACP 7.0
Pipe Length (ft):	172.0	Owner:	City of Hobart	Pre Clean:	Heavy Cleaning
P.O.#:	YES502259	Surveyor:	S. Bucklin	PSR:	P-507-077-078
Customer:	City of Hobart	Clean Date:	08/26/2024	Shape:	C

Street:	West 10th Street	Flow Control:	Not Controlled
City:	Hobart, IN	Year Renewed:	
Location:	Easement/Right of Way	Tape/Media #:	
Purpose:	Sewer System Evaluation Survey (SS	Dia/Height:	10"
Use:	Sanitary Sewage Pipe	Material:	VCP
Drain Area:		Lining:	None
Category:	NA		
Comment:			
Location Details:		Direction of Survey:	Upstream
US MH:	M-507-077	DS MH:	M-507-078
		Total Length Surveyed (ft):	151.2

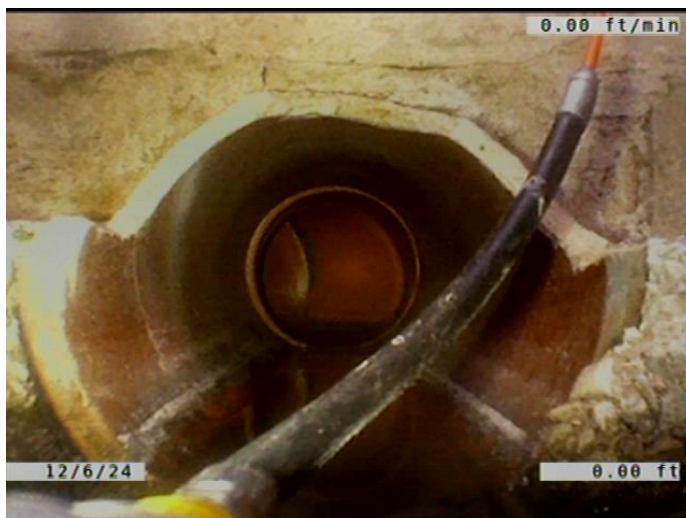
Code: **AMH**
 Description: **Manhole**

Distance (ft): **.0**
 Structural Grade: **0**
 O&M Grade: **0**
 Clock Start/From:
 Clock To:
 1st Value:
 2nd Value:
 Value Percent:
 Continuous Index:
 Within 8" of Joint: **NO**
 Remarks: **M-507-078**

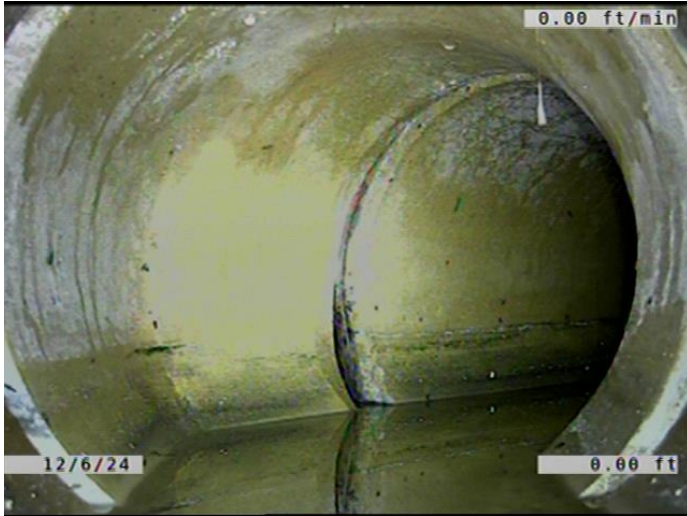
Code: **MWL**
Description: **Miscellaneous Water Level**

Distance (ft): **.0**
Structural Grade: **0**
O&M Grade: **0**
Clock Start/From:
Clock To:
1st Value:
2nd Value:
Value Percent: **5.000**
Continuous Index:
Within 8" of Joint: **NO**
Remarks:

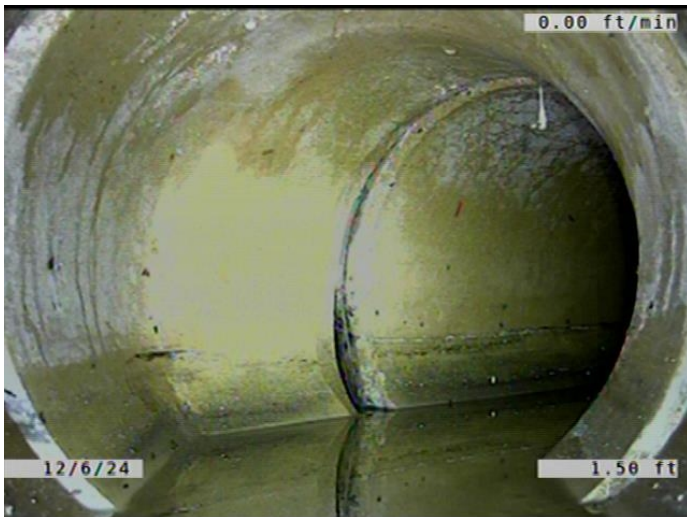
Code: **MGO**
Description: **Miscellaneous General Observation**

Distance (ft): **1.5**
Structural Grade: **0**
O&M Grade: **0**
Clock Start/From:
Clock To:
1st Value:
2nd Value:
Value Percent:
Continuous Index:
Within 8" of Joint: **NO**
Remarks: **NO CHANNEL IN THE MANHOLE.
HAD TO START IN THE PIPE.**

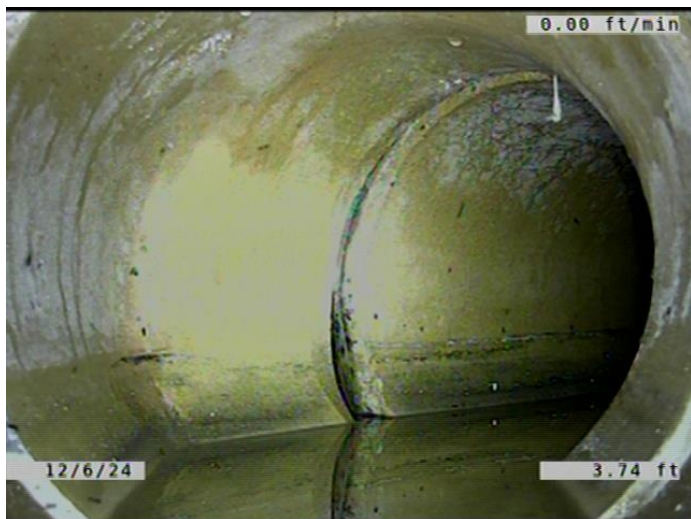
Code: **LR**
 Description: **Line Right**

Distance (ft): **3.7**
 Structural Grade: **0**
 O&M Grade: **4**
 Clock Start/From:
 Clock To:
 1st Value:
 2nd Value:
 Value Percent: **50.000**
 Continuous Index:
 Within 8" of Joint: **NO**
 Remarks:

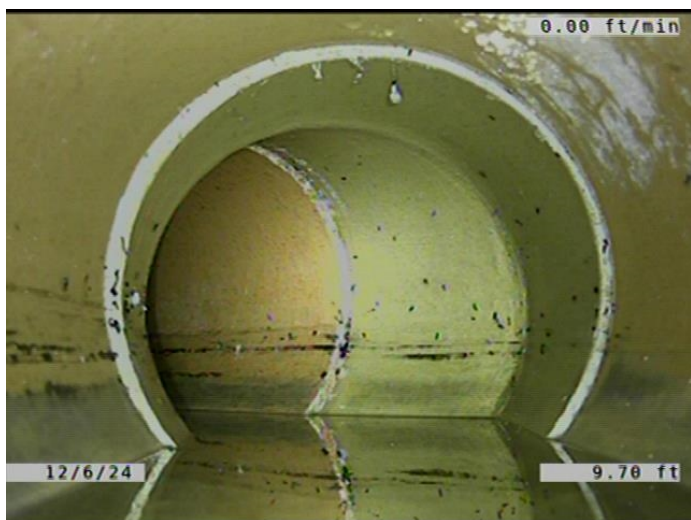
Code: **LL**
 Description: **Line Left**

Distance (ft): **9.7**
 Structural Grade: **0**
 O&M Grade: **4**
 Clock Start/From:
 Clock To:
 1st Value:
 2nd Value:
 Value Percent: **50.000**
 Continuous Index:
 Within 8" of Joint: **NO**
 Remarks:

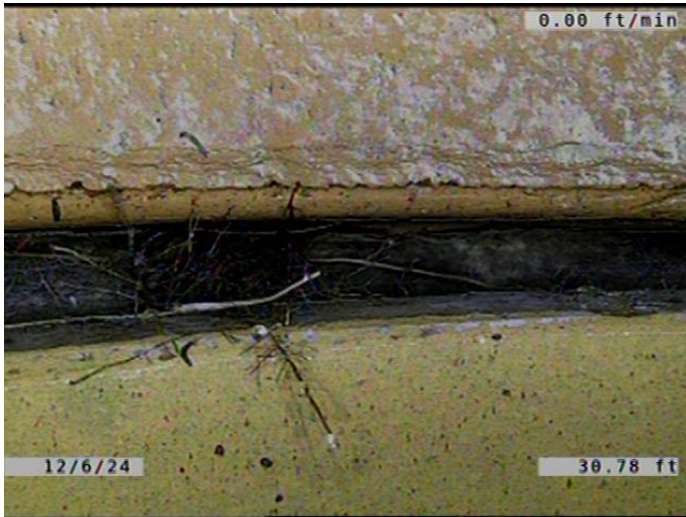
Code: **RFJ**
Description: **Roots Fine Joint**

Distance (ft): **30.8**
Structural Grade: **0**
O&M Grade: **1**
Clock Start/From: **8**
Clock To: **11**
1st Value:
2nd Value:
Value Percent:
Continuous Index:
Within 8" of Joint: **YES**
Remarks:

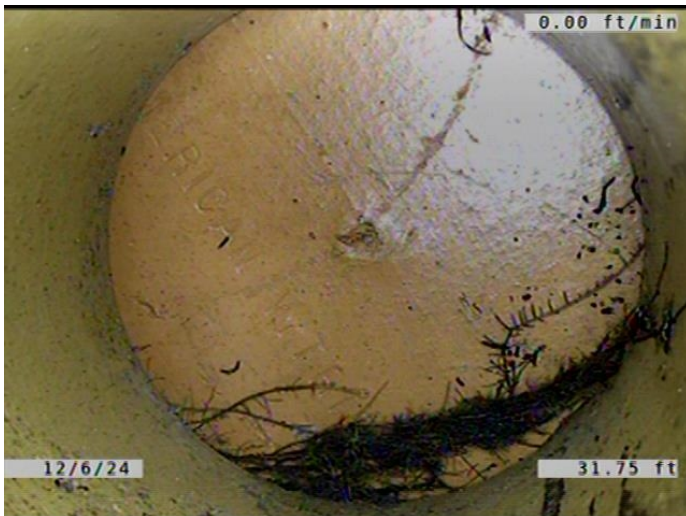
Code: **TFD**
Description: **Tap Factory Defective**

Distance (ft): **31.8**
Structural Grade: **0**
O&M Grade: **3**
Clock Start/From: **3**
Clock To:
1st Value: **6.000**
2nd Value:
Value Percent:
Continuous Index:
Within 8" of Joint: **YES**
Remarks: **CAPPED. ROOTS GROWING AROUND THE CAP.**

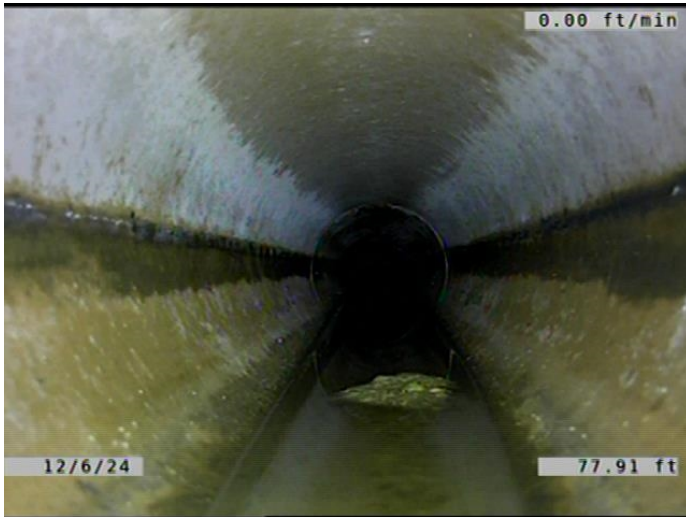
Code: **MWLS**
Description: **Miscellaneous Water Level Sag**

Distance (ft): **77.9**
Structural Grade: **2**
O&M Grade: **0**
Clock Start/From:
Clock To:
1st Value:
2nd Value:
Value Percent: **10.000**
Continuous Index: **S01**
Within 8" of Joint: **NO**
Remarks:

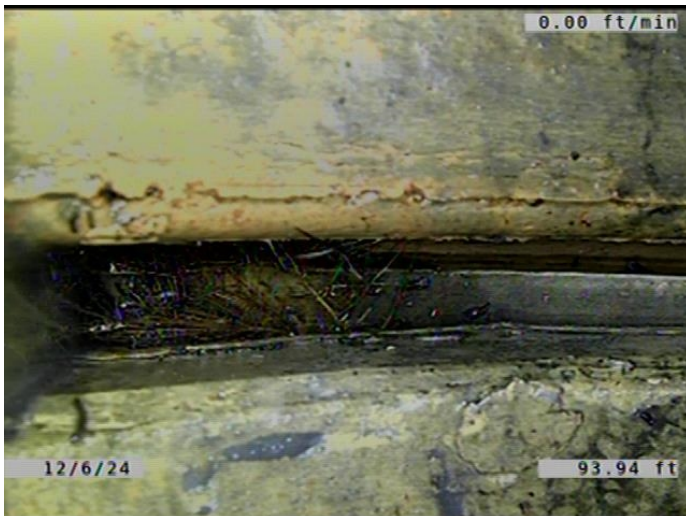
Code: **RFJ**
Description: **Roots Fine Joint**

Distance (ft): **93.9**
Structural Grade: **0**
O&M Grade: **1**
Clock Start/From: **9**
Clock To: **3**
1st Value:
2nd Value:
Value Percent:
Continuous Index: **S02**
Within 8" of Joint: **YES**
Remarks:

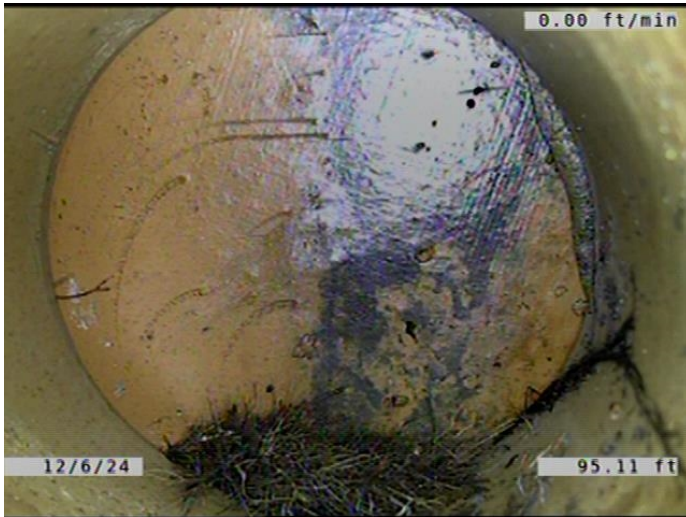
Code:	TFD
Description:	Tap Factory Defective
Distance (ft):	95.1
Structural Grade:	0
O&M Grade:	3
Clock Start/From:	3
Clock To:	
1st Value:	6.000
2nd Value:	
Value Percent:	
Continuous Index:	
Within 8" of Joint:	YES
Remarks:	CAPPED. ROOTS GROWING AROUND THE CAP.

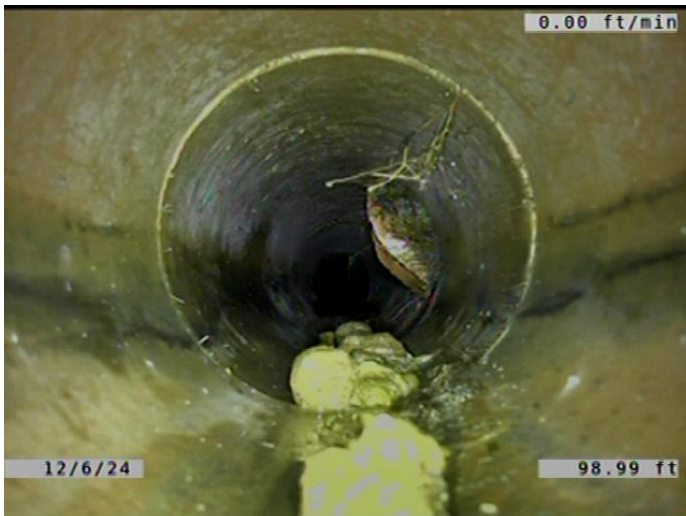
Code:	MWLS
Description:	Miscellaneous Water Level Sag
Distance (ft):	99.0
Structural Grade:	2
O&M Grade:	0
Clock Start/From:	
Clock To:	
1st Value:	
2nd Value:	
Value Percent:	10.000
Continuous Index:	F01
Within 8" of Joint:	NO
Remarks:

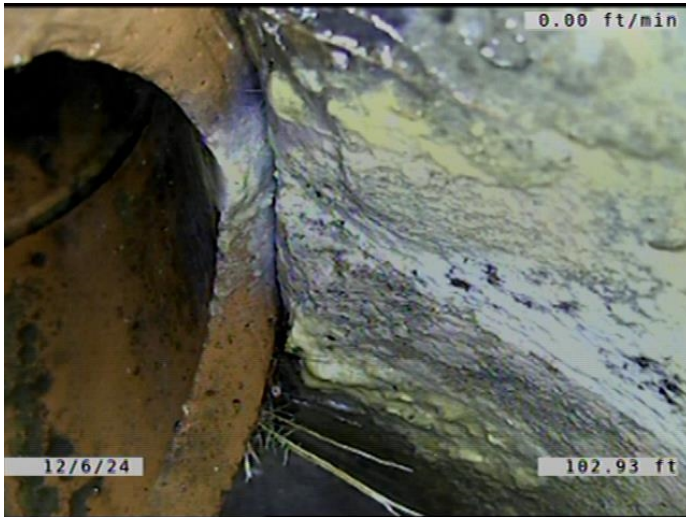
Code: **SSS**
 Description: **Surface Damage Surface Spalling**

Distance (ft): **102.9**
 Structural Grade: **2**
 O&M Grade: **0**
 Clock Start/From: **12**
 Clock To: **4**
 1st Value:
 2nd Value:
 Value Percent:
 Continuous Index:
 Within 8" of Joint: **NO**
 Remarks:

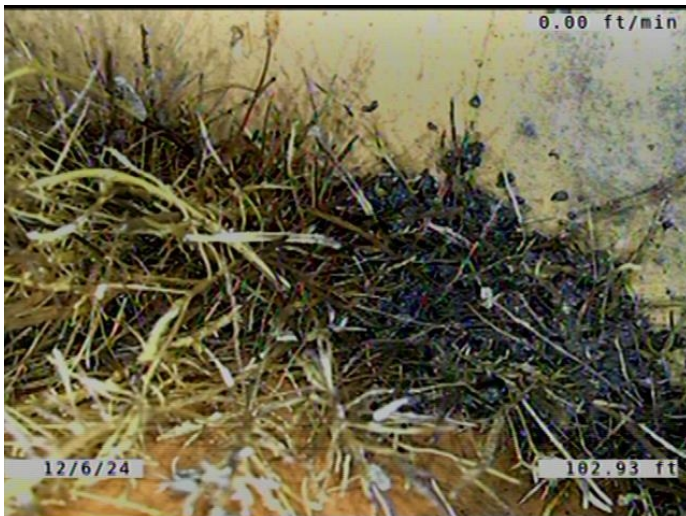
Code: **RMC**
 Description: **Roots Medium Connection**

Distance (ft): **102.9**
 Structural Grade: **0**
 O&M Grade: **3**
 Clock Start/From: **12**
 Clock To: **4**
 1st Value:
 2nd Value:
 Value Percent: **5.000**
 Continuous Index:
 Within 8" of Joint: **NO**
 Remarks:

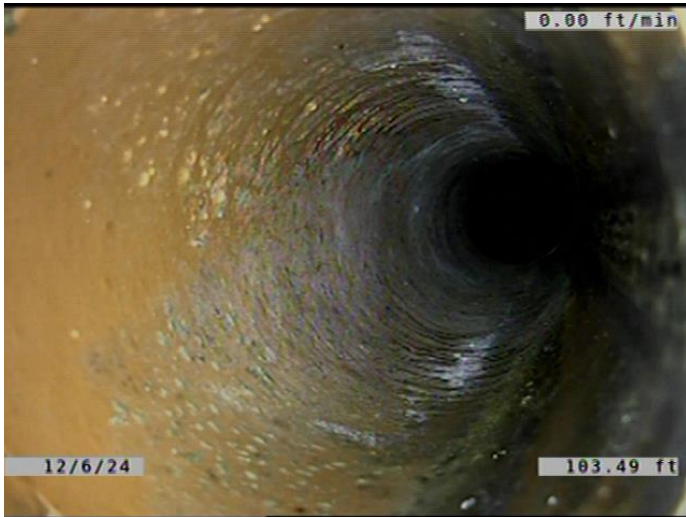
Code: **TBI**
Description: **Tap Break-in Intruding**

Distance (ft): **103.5**
Structural Grade: **0**
O&M Grade: **2**
Clock Start/From: **3**
Clock To:
1st Value: **6.000**
2nd Value: **3.000**
Value Percent:
Continuous Index:
Within 8" of Joint: **YES**
Remarks:

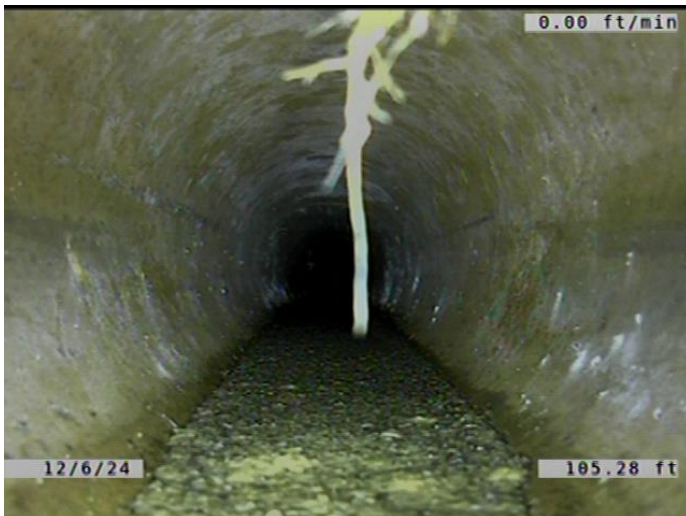
Code: **DSF**
Description: **Deposits Settled Fine**

Distance (ft): **105.2**
Structural Grade: **0**
O&M Grade: **2**
Clock Start/From: **5**
Clock To: **7**
1st Value:
2nd Value:
Value Percent: **5.000**
Continuous Index: **S03**
Within 8" of Joint: **YES**
Remarks:

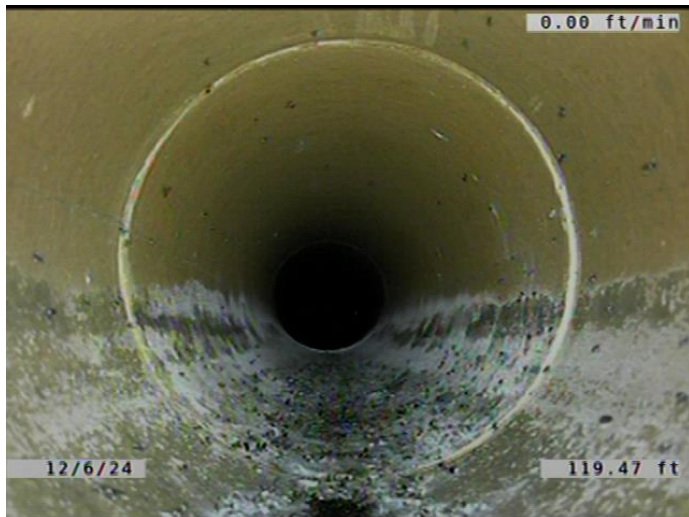
Code: **DSF**
Description: **Deposits Settled Fine**

Distance (ft): **119.5**
Structural Grade: **0**
O&M Grade: **2**
Clock Start/From: **5**
Clock To: **7**
1st Value:
2nd Value:
Value Percent: **5.000**
Continuous Index: **F03**
Within 8" of Joint: **YES**
Remarks:

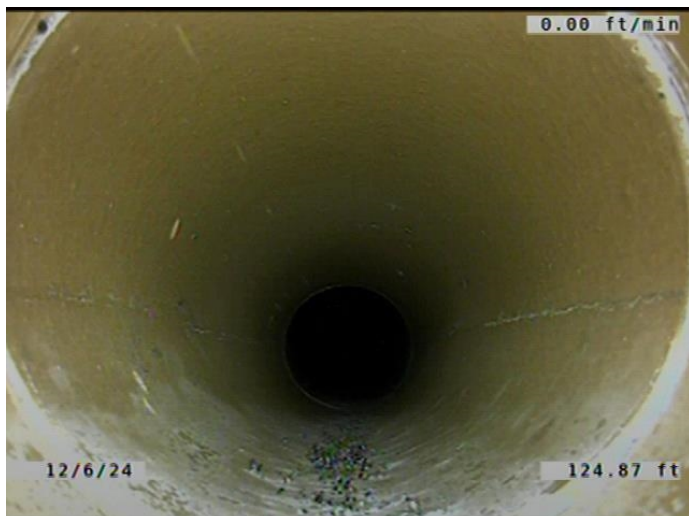
Code: **MWL**
Description: **Miscellaneous Water Level**

Distance (ft): **124.9**
Structural Grade: **0**
O&M Grade: **0**
Clock Start/From:
Clock To:
1st Value:
2nd Value:
Value Percent: **0.000**
Continuous Index:
Within 8" of Joint: **NO**
Remarks:

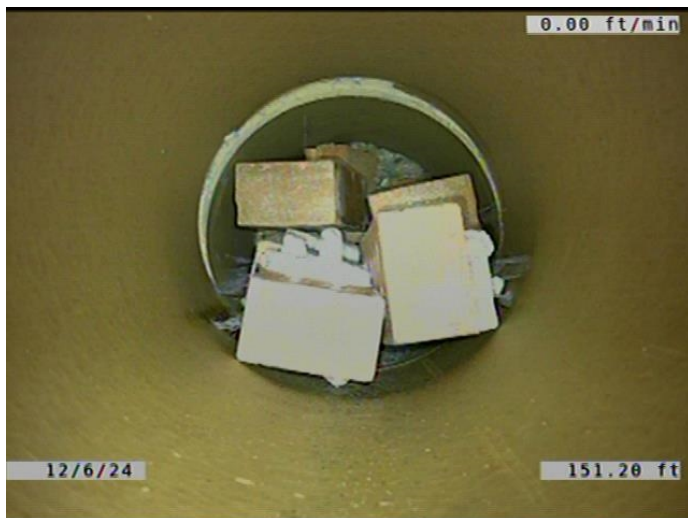
Code: **AEP**
 Description: **Access Point End of Pipe**

Distance (ft): **151.2**
 Structural Grade: **0**
 O&M Grade: **0**
 Clock Start/From:
 Clock To:
 1st Value:
 2nd Value:
 Value Percent:
 Continuous Index:
 Within 8" of Joint: **NO**
 Remarks: **PIPE HAS BEEN BRICKED OFF.**
