Profile/Photo Observation Report

Date:	12/06/2024	Weather:		Coding:	PACP 7.0
Pipe Length (ft):	238.0	Owner:	City of Hobart	Pre Clean:	Heavy Cleaning
P.O.#:	YES502259	Surveyor:	S. Bucklin	PSR:	P-507-079-078
Customer:	City of Hobart	Clean Date:	08/24/2024	Shape:	C

Street:	West 10th Street	Flow Control:	Not Controlled
City:	Hobart, IN	Year Renewed:	
Location:	Easement/Right of Way	Tape/Media #:	
Purpose:	Sewer System Evaluation Survey (SS)	Dia/Height:	10"
Use:	Sanitary Sewage Pipe	Material:	VCP
Drain Area:		Lining:	None
Category:	NA		
Comment:			
Location Details:		Direction of Survey:	Upstream
US MH:	M-507-079	DS MH:	M-507-078
		Total Length Surveyed (ft):	249.3

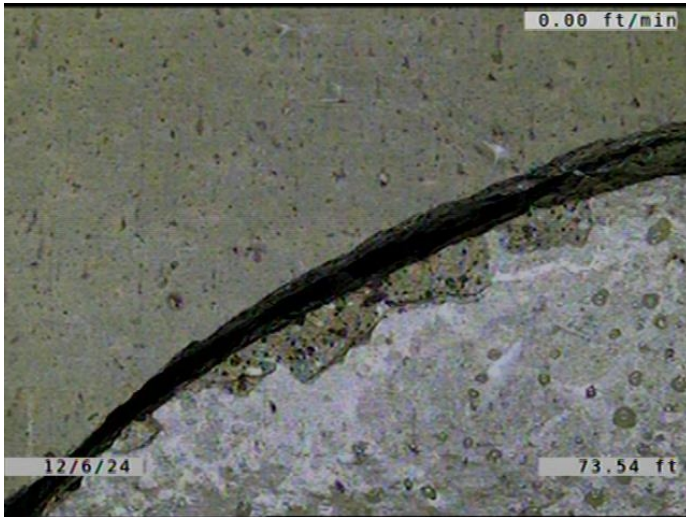
Code: **B**
Description: **Broken**

Distance (ft): **73.5**
Structural Grade: **4**
O&M Grade: **0**
Clock Start/From: **10**
Clock To: **1**
1st Value:
2nd Value:
Value Percent:
Continuous Index:
Within 8" of Joint: **YES**
Remarks:

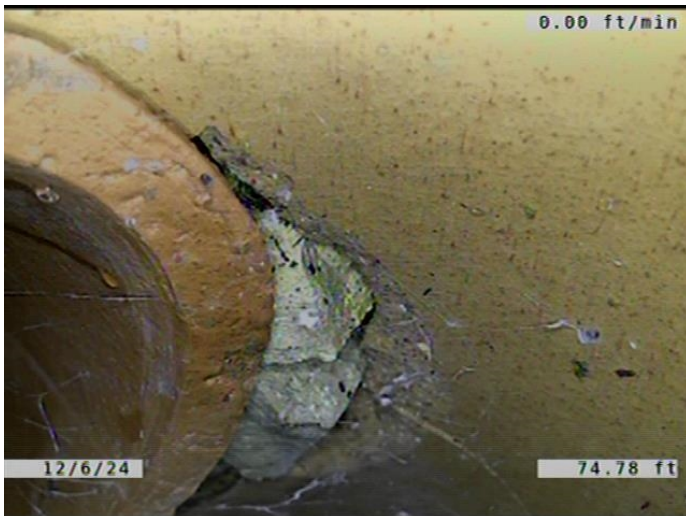
Code: **B**
Description: **Broken**

Distance (ft): **74.8**
Structural Grade: **4**
O&M Grade: **0**
Clock Start/From: **12**
Clock To: **12**
1st Value:
2nd Value:
Value Percent:
Continuous Index:
Within 8" of Joint: **YES**
Remarks:

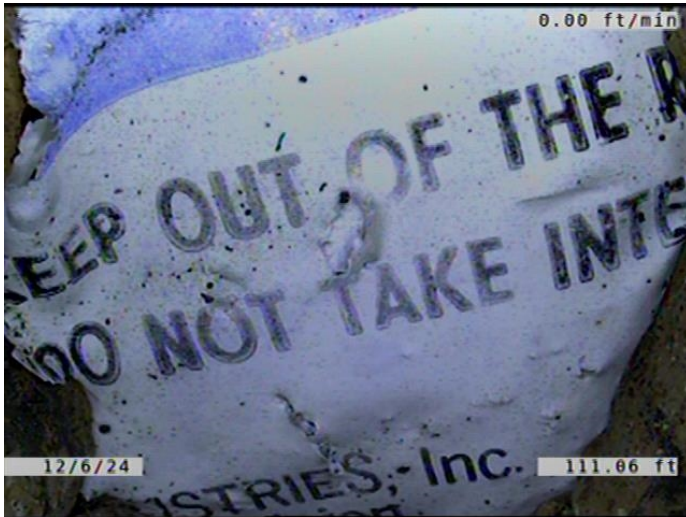
Code:	RPPD
Description:	Point Repair Patch Patch Defective
Distance (ft):	111.1
Structural Grade:	4
O&M Grade:	0
Clock Start/From:	11
Clock To:	1
1st Value:	
2nd Value:	
Value Percent:	
Continuous Index:	
Within 8" of Joint:	NO
Remarks:	REPAIRED WITH A BAG OF CONCRETE.

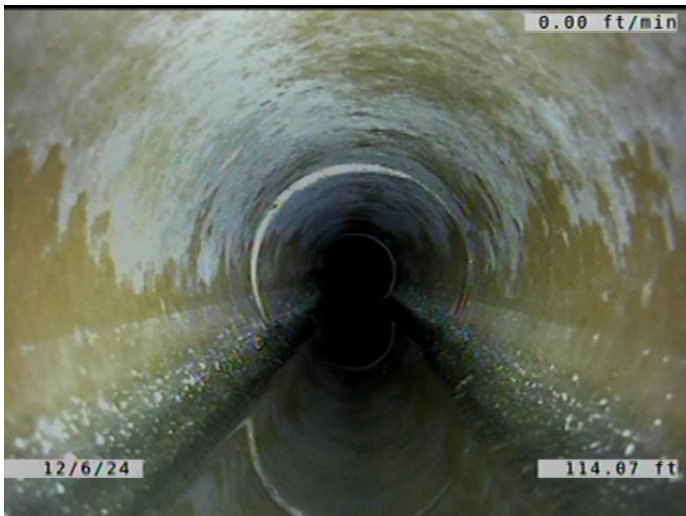
Code:	MWLS
Description:	Miscellaneous Water Level Sag
Distance (ft):	114.1
Structural Grade:	2
O&M Grade:	0
Clock Start/From:	
Clock To:	
1st Value:	
2nd Value:	
Value Percent:	10.000
Continuous Index:	S03
Within 8" of Joint:	NO
Remarks:

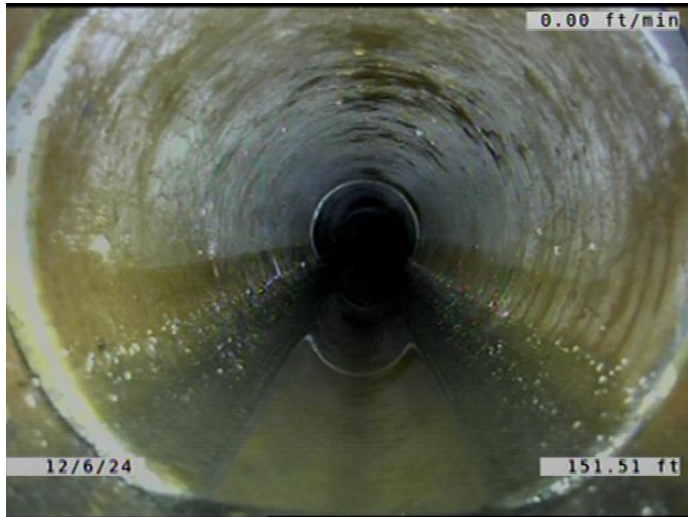
Code: **MWLS**
Description: **Miscellaneous Water Level Sag**

Distance (ft): **151.5**
Structural Grade: **2**
O&M Grade: **0**
Clock Start/From:
Clock To:
1st Value:
2nd Value:
Value Percent: **10.000**
Continuous Index: **F04**
Within 8" of Joint: **NO**
Remarks:

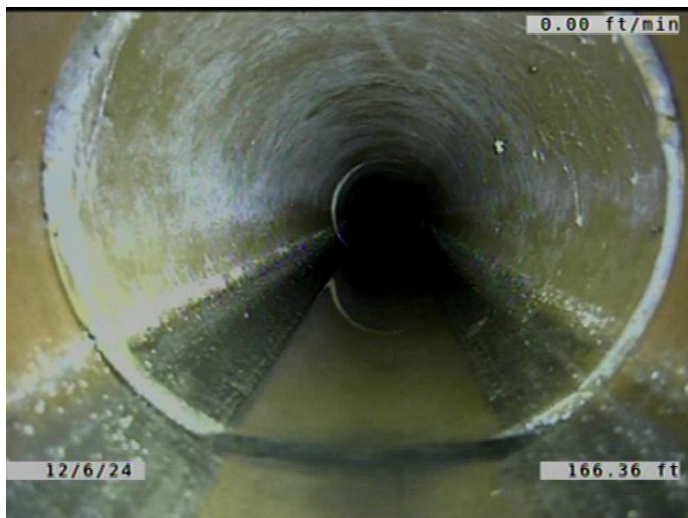
Code: **LR**
Description: **Line Right**

Distance (ft): **166.4**
Structural Grade: **0**
O&M Grade: **1**
Clock Start/From:
Clock To:
1st Value:
2nd Value:
Value Percent: **5.000**
Continuous Index:
Within 8" of Joint: **NO**
Remarks:

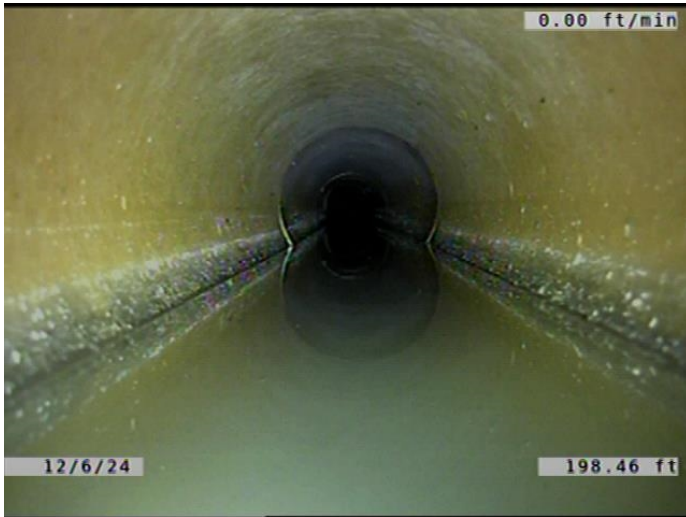
Code: **MWLS**
Description: **Miscellaneous Water Level Sag**

Distance (ft): **198.5**
Structural Grade: **2**
O&M Grade: **0**
Clock Start/From:
Clock To:
1st Value:
2nd Value:
Value Percent: **15.000**
Continuous Index: **S06**
Within 8" of Joint: **NO**
Remarks:

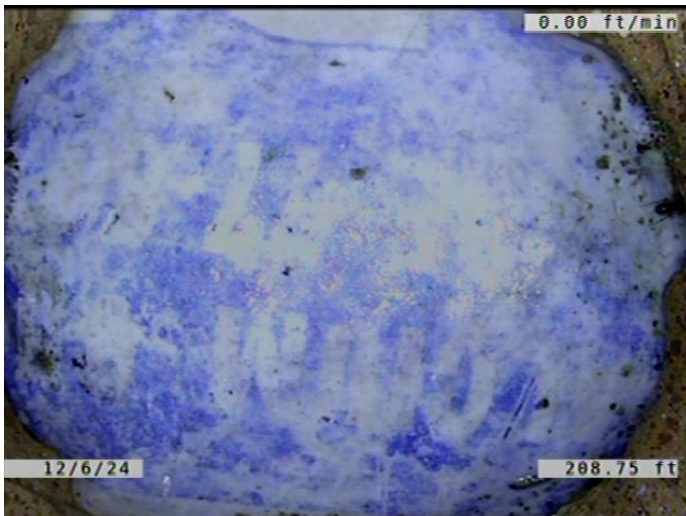
Code: **RPPD**
Description: **Point Repair Patch Patch Defective**

Distance (ft): **208.8**
Structural Grade: **4**
O&M Grade: **0**
Clock Start/From: **11**
Clock To: **1**
1st Value:
2nd Value:
Value Percent:
Continuous Index:
Within 8" of Joint: **NO**
Remarks: **REPAIRED WITH A BAG OF CONCRETE.**

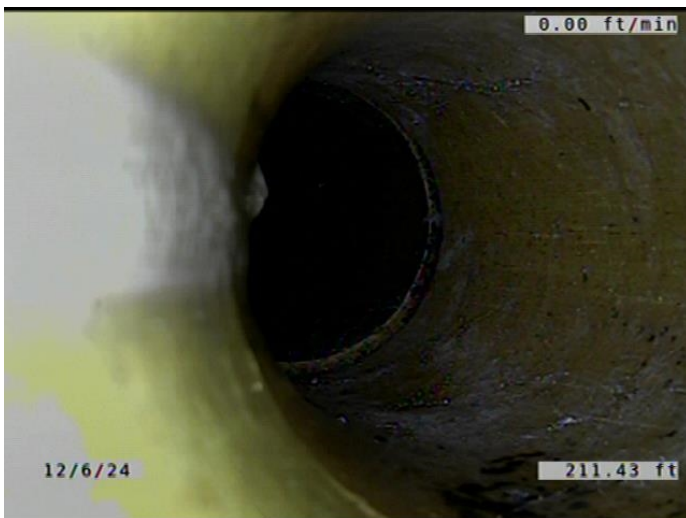
Code:	TBI
Description:	Tap Break-in Intruding
Distance (ft):	211.4
Structural Grade:	0
O&M Grade:	2
Clock Start/From:	10
Clock To:	
1st Value:	6.000
2nd Value:	1.000
Value Percent:	
Continuous Index:	
Within 8" of Joint:	YES
Remarks:	CONSTANTLY RUNNING WATER.
