## Profile/Photo Observation Report

Date:	<b>03/26/2018</b>	Weather:		Coding:	<b>PACP 6.0</b>
Pipe Length (ft):	<b>56.8</b>	Owner:	<b>NA</b>	Pre Clean:	<b>No Pre-Cleaning</b>
P.O.#:		Surveyor:	<b>Jen Costello</b>	PSR:	<b>P-507-081-050</b>
Customer:		Clean Date:	<b>01/01/1900</b>	Shape:	<b>C</b>

Street:	<b>S VIRGINIA ST</b>	Flow Control:	<b>Not Controlled</b>
City:	<b>Hobart, IN</b>	Year Renewed:	
Location:	<b>Light Highway</b>	Tape/Media #:	
Purpose:	<b>Routine Assessment</b>	Dia/Height:	<b>8"</b>
Use:	<b>Sanitary</b>	Material:	<b>PVC</b>
Drain Area:	<b>NA</b>	Lining:	
Category:	<b>NA</b>		
Comment:	<b>P_C at 45 ft debris</b>		
Location Details:		Direction of Survey:	<b>Downstream</b>
US MH:	<b>M-507-081</b>	DS MH:	<b>M-507-050</b>
		Total Length Surveyed (ft):	<b>46.1</b>

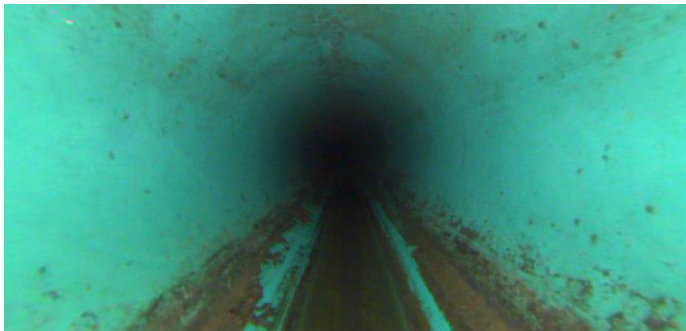
Code: **AMH**  
Description: **Manhole**

Distance (ft): **.0**  
Structural Grade: **0**  
O&M Grade: **0**  
Clock Start/From:  
Clock To:  
1st Value:  
2nd Value:  
Value Percent:  
Continuous Index:  
Within 8" of Joint: **NO**  
Remarks: **M-507-081**

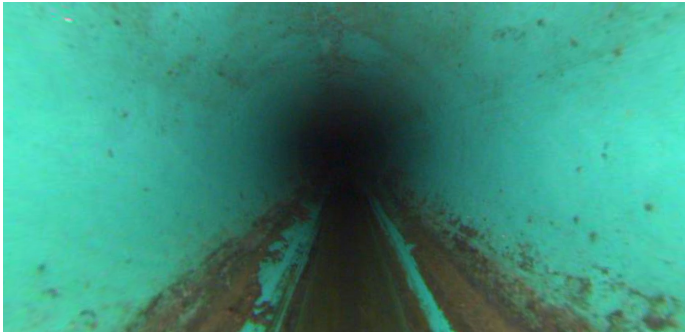
Code:	<b>MWL</b>
Description:	<b>Water Level</b>

Distance (ft):	<b>.0</b>
Structural Grade:	<b>0</b>
O&M Grade:	<b>0</b>
Clock Start/From:	
Clock To:	
1st Value:	
2nd Value:	
Value Percent:	<b>5.000</b>
Continuous Index:	
Within 8" of Joint:	<b>NO</b>
Remarks:

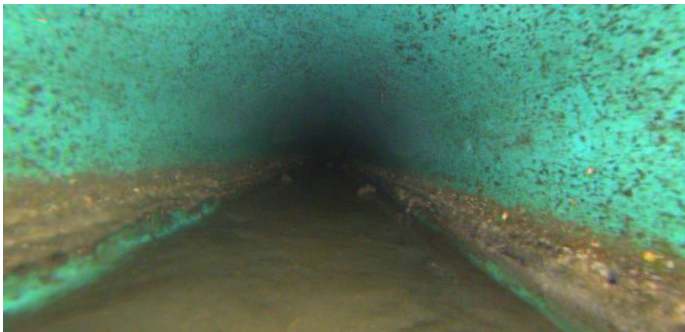
Code:	<b>MWL</b>
Description:	<b>Water Level</b>

Distance (ft):	<b>46.1</b>
Structural Grade:	<b>0</b>
O&M Grade:	<b>0</b>
Clock Start/From:	
Clock To:	
1st Value:	
2nd Value:	
Value Percent:	<b>20.000</b>
Continuous Index:	
Within 8" of Joint:	<b>NO</b>
Remarks:

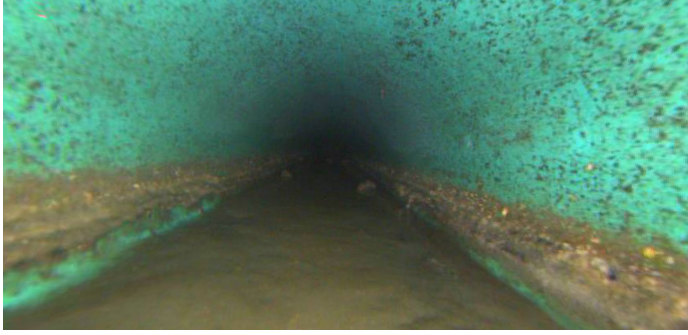
Code:	<b>MSA</b>
Description:	<b>Abandoned Survey</b>
Distance (ft):	<b>46.1</b>
Structural Grade:	<b>0</b>
O&M Grade:	<b>0</b>
Clock Start/From:	
Clock To:	
1st Value:	
2nd Value:	
Value Percent:	
Continuous Index:	
Within 8" of Joint:	<b>NO</b>
Remarks:	<b>DEBRIS UNDER WATER</b>
