Profile/Photo Observation Report

Date:	03/26/2018	Weather:		Coding:	PACP 6.0
Pipe Length (ft):	56.8	Owner:	NA	Pre Clean:	No Pre-Cleaning
P.O.#:		Surveyor:	Jen Costello	PSR:	P-507-081-050
Customer:		Clean Date:	01/01/1900	Shape:	C

Street:	FOXCROFT STREET	Flow Control:	Not Controlled
City:	Hobart, IN	Year Renewed:	
Location:	Light Highway	Tape/Media #:	
Purpose:	Routine Assessment	Dia/Height:	8"
Use:	Sanitary	Material:	PVC
Drain Area:	NA	Lining:	
Category:	NA		
Comment:	P_C at 45 ft debris

Location Details:		Direction of Survey:	Downstream
US MH:	M-507-081	DS MH:	M-507-050
		Total Length Surveyed (ft):	46.1

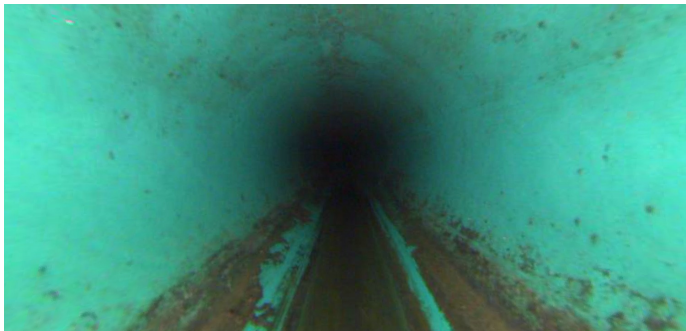
Code: **AMH**
Description: **Manhole**

Distance (ft): **.0**
Structural Grade: **0**
O&M Grade: **0**
Clock Start/From:
Clock To:
1st Value:
2nd Value:
Value Percent:
Continuous Index:
Within 8" of Joint: **NO**
Remarks: **M-507-081**

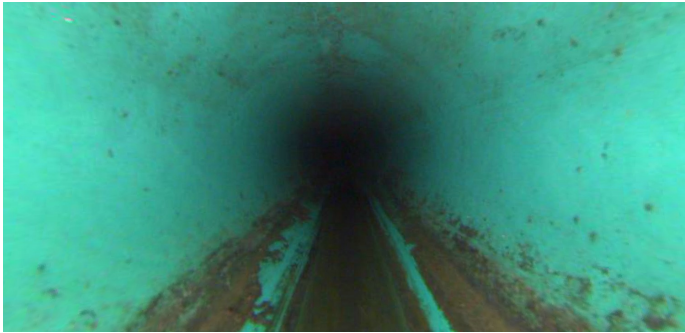
Code:	MWL
Description:	Water Level

Distance (ft):	.0
Structural Grade:	0
O&M Grade:	0
Clock Start/From:	
Clock To:	
1st Value:	
2nd Value:	
Value Percent:	5.000
Continuous Index:	
Within 8" of Joint:	NO
Remarks:

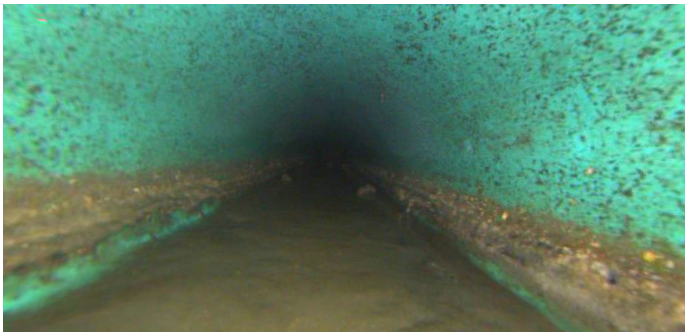
Code:	MWL
Description:	Water Level

Distance (ft):	46.1
Structural Grade:	0
O&M Grade:	0
Clock Start/From:	
Clock To:	
1st Value:	
2nd Value:	
Value Percent:	20.000
Continuous Index:	
Within 8" of Joint:	NO
Remarks:

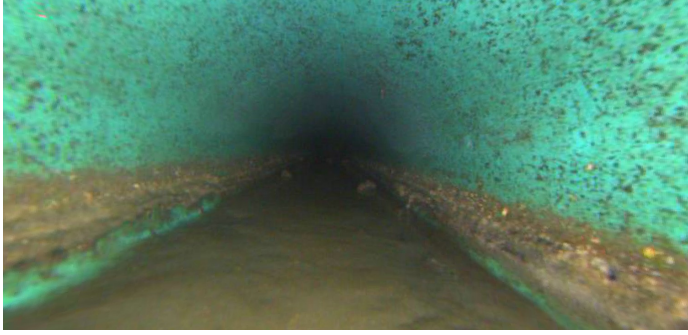
Code:	MSA
Description:	Abandoned Survey
Distance (ft):	46.1
Structural Grade:	0
O&M Grade:	0
Clock Start/From:	
Clock To:	
1st Value:	
2nd Value:	
Value Percent:	
Continuous Index:	
Within 8" of Joint:	NO
Remarks:	DEBRIS UNDER WATER
