Profile/Photo Observation Report

Street:	W 10TH PL	Flow Control:	Not Controlled
City:	Hobart, IN	Year Renewed:	
Location:	Yard	Tape/Media #:	
Purpose:	Routine Assessment	Dia/Height:	12"
Use:	Sanitary	Material:	VCP
Drain Area:	NA	Lining:	
Category:	NA		
Comment:

Location Details:		Direction of Survey:	Downstream
US MH:	M-507-083	DS MH:	M-507-086
		Total Length Surveyed (ft):	2.7

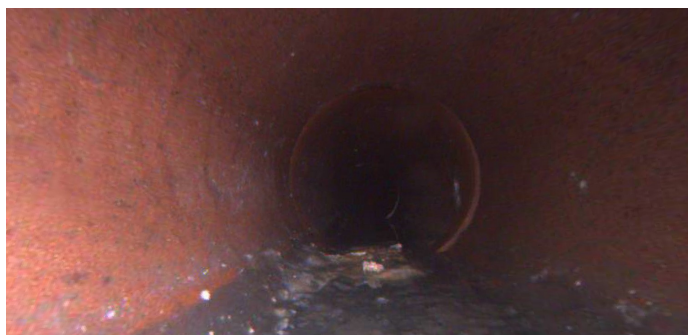
Code: **AMH**
Description: **Manhole**

Distance (ft): **.0**
Structural Grade: **0**
O&M Grade: **0**
Clock Start/From:
Clock To:
1st Value:
2nd Value:
Value Percent:
Continuous Index:
Within 8" of Joint: **NO**
Remarks: **M-507-083**

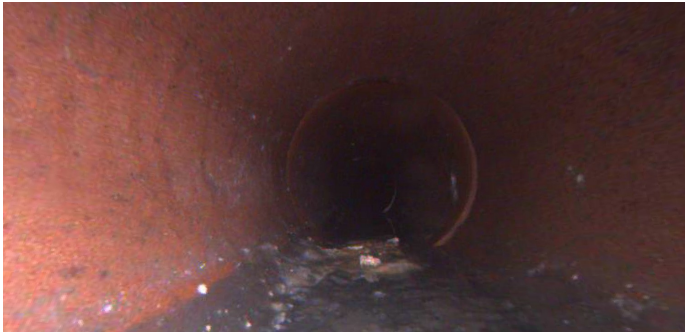
Code:	MWL
Description:	Water Level

Distance (ft):	.0
Structural Grade:	0
O&M Grade:	0
Clock Start/From:	
Clock To:	
1st Value:	
2nd Value:	
Value Percent:	10.000
Continuous Index:	
Within 8" of Joint:	NO
Remarks:

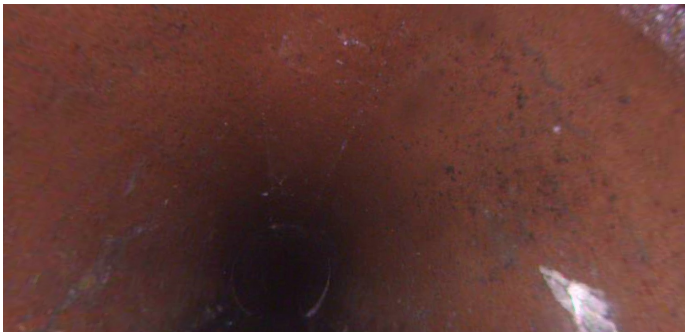
Code:	MSA
Description:	Abandoned Survey

Distance (ft):	2.7
Structural Grade:	0
O&M Grade:	0
Clock Start/From:	
Clock To:	
1st Value:	
2nd Value:	
Value Percent:	
Continuous Index:	
Within 8" of Joint:	NO
Remarks:	debris under water
