## Profile/Photo Observation Report

Date:	<b>01/30/2025</b>	Weather:		Coding:	<b>PACP 7.0</b>
Pipe Length (ft):	<b>125.0</b>	Owner:	<b>City of Hobart</b>	Pre Clean:	<b>Heavy Cleaning</b>
P.O.#:	<b>YES502259</b>	Surveyor:	<b>S. Bucklin</b>	PSR:	<b>P-507-086-083</b>
Customer:	<b>City of Hobart</b>	Clean Date:	<b>09/26/2024</b>	Shape:	<b>C</b>

Street:	<b>West 10th Place</b>	Flow Control:	<b>Not Controlled</b>
City:	<b>Hobart, IN</b>	Year Renewed:	
Location:	<b>Local rural streets with light traffic, t</b>	Tape/Media #:	
Purpose:	<b>Sewer System Evaluation Survey (SS</b>	Dia/Height:	<b>12"</b>
Use:	<b>Sanitary Sewage Pipe</b>	Material:	<b>VCP</b>
Drain Area:		Lining:	<b>None</b>
Category:	<b>NA</b>		
Comment:			
Location Details:		Direction of Survey:	<b>Downstream</b>
US MH:	<b>M-507-083</b>	DS MH:	<b>M-507-086</b>
		Total Length Surveyed (ft):	<b>124.0</b>

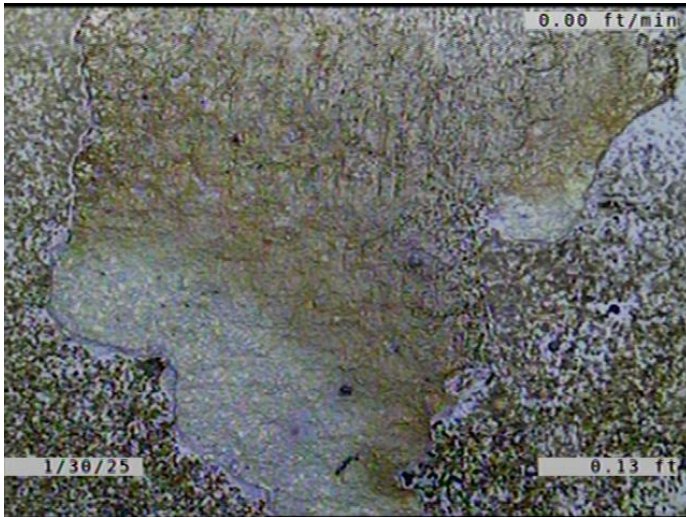
Code: **SSC**  
 Description: **Surface Spalling of Damage Coating**

Distance (ft): **.1**  
 Structural Grade: **1**  
 O&M Grade: **0**  
 Clock Start/From: **1**  
 Clock To: **2**  
 1st Value:  
 2nd Value:  
 Value Percent:  
 Continuous Index:  
 Within 8" of Joint: **YES**  
 Remarks:

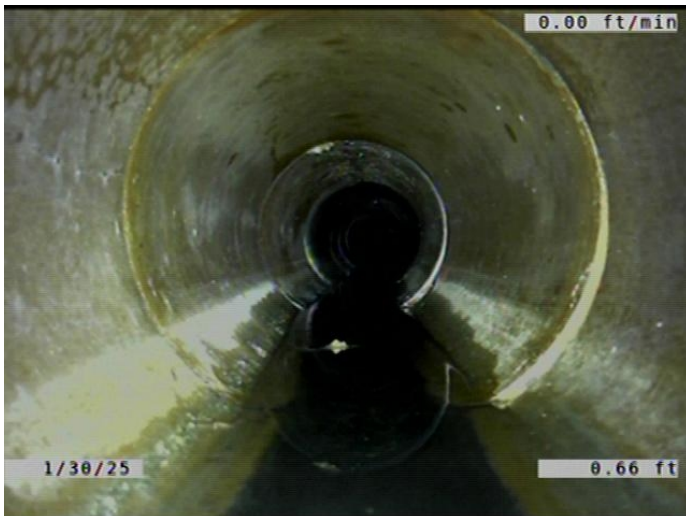
Code: **DSF**  
 Description: **Deposits Settled Fine**

Distance (ft): **.7**  
 Structural Grade: **0**  
 O&M Grade: **2**  
 Clock Start/From: **5**  
 Clock To: **7**  
 1st Value:  
 2nd Value:  
 Value Percent: **5.000**  
 Continuous Index: **S01**  
 Within 8" of Joint: **YES**  
 Remarks:

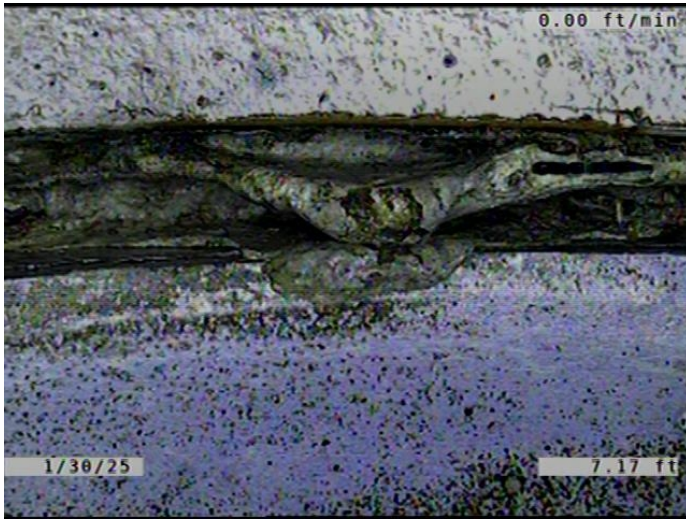
Code: **DAE**  
Description: **Deposits Attached Encrustation**

Distance (ft): **7.2**  
Structural Grade: **0**  
O&M Grade: **2**  
Clock Start/From: **8**  
Clock To: **4**  
1st Value:  
2nd Value:  
Value Percent: **5.000**  
Continuous Index:  
Within 8" of Joint: **YES**  
Remarks:

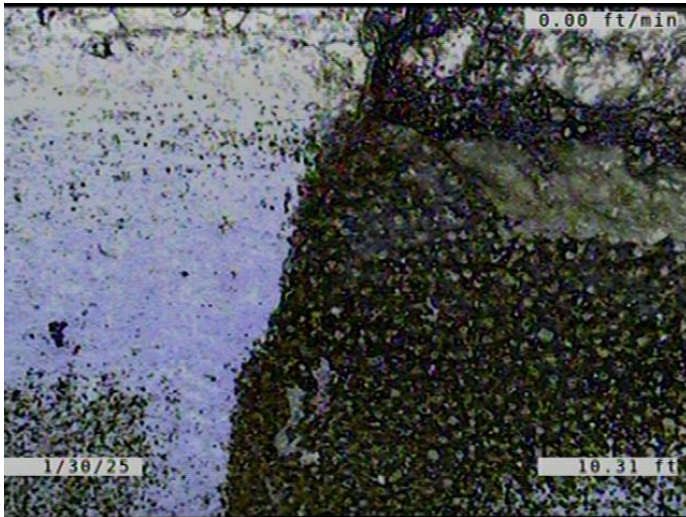
Code: **CS**  
Description: **Crack Spiral**

Distance (ft): **10.3**  
Structural Grade: **2**  
O&M Grade: **0**  
Clock Start/From: **12**  
Clock To: **1**  
1st Value:  
2nd Value:  
Value Percent:  
Continuous Index:  
Within 8" of Joint: **YES**  
Remarks:

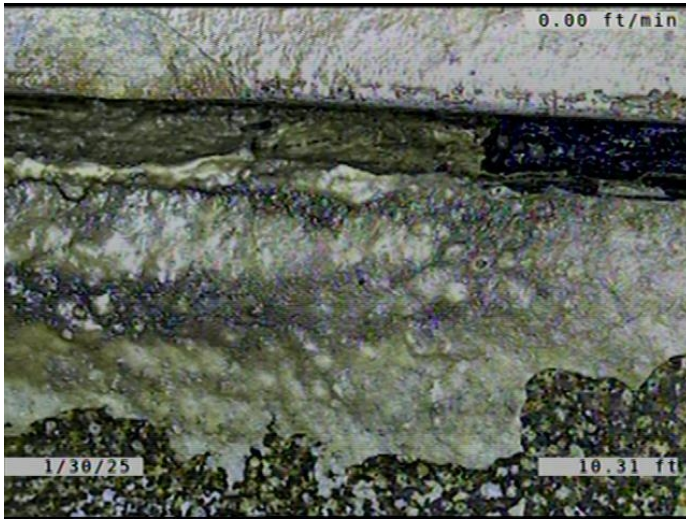
Code: **DAE**  
 Description: **Deposits Attached Encrustation**

Distance (ft): **10.3**  
 Structural Grade: **0**  
 O&M Grade: **2**  
 Clock Start/From: **9**  
 Clock To: **4**  
 1st Value:  
 2nd Value:  
 Value Percent: **5.000**  
 Continuous Index:  
 Within 8" of Joint: **YES**  
 Remarks:

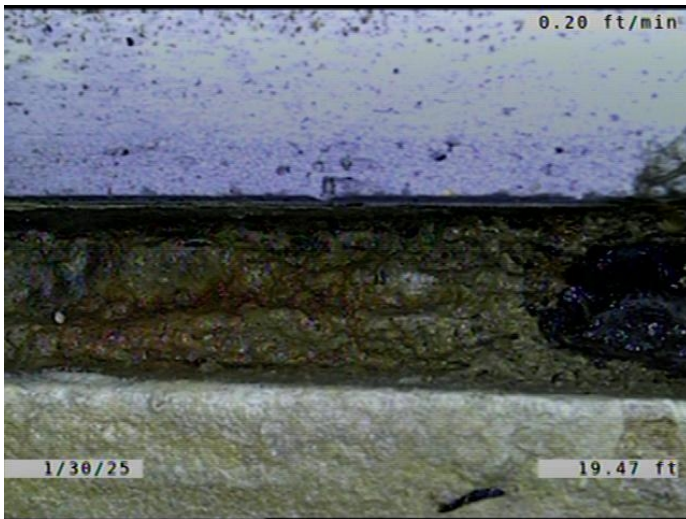
Code: **DAE**  
 Description: **Deposits Attached Encrustation**

Distance (ft): **19.5**  
 Structural Grade: **0**  
 O&M Grade: **2**  
 Clock Start/From: **8**  
 Clock To: **4**  
 1st Value:  
 2nd Value:  
 Value Percent: **5.000**  
 Continuous Index: **S02**  
 Within 8" of Joint: **YES**  
 Remarks:

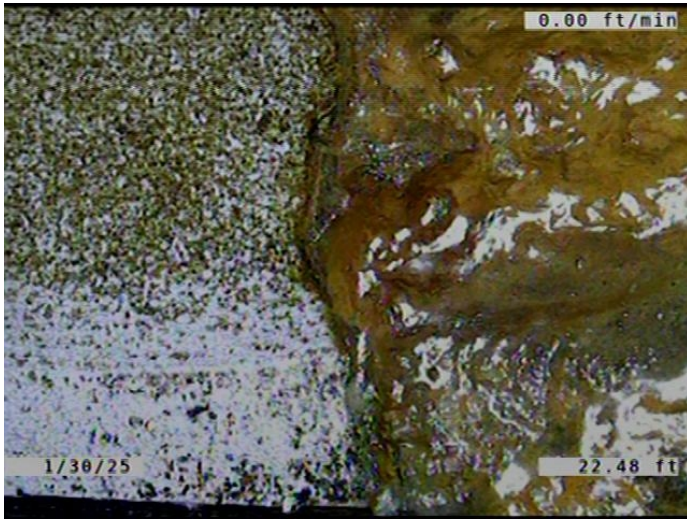
Code: **CS**  
Description: **Crack Spiral**

Distance (ft): **22.5**  
Structural Grade: **2**  
O&M Grade: **0**  
Clock Start/From: **7**  
Clock To: **8**  
1st Value:  
2nd Value:  
Value Percent:  
Continuous Index:  
Within 8" of Joint: **YES**  
Remarks:

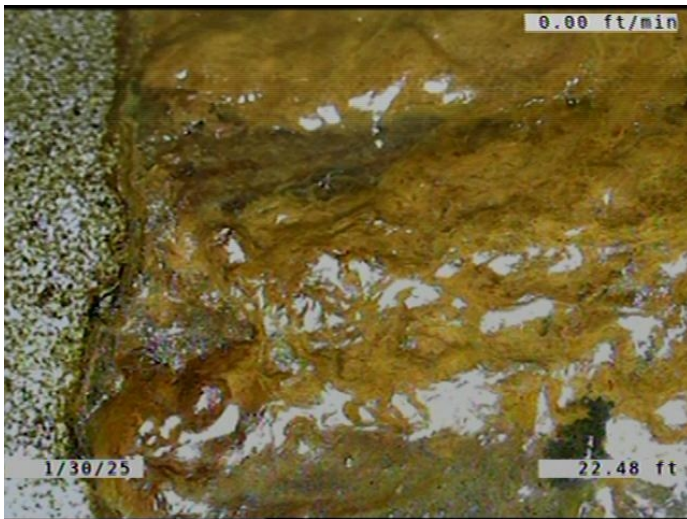
Code: **DAE**  
Description: **Deposits Attached Encrustation**

Distance (ft): **22.5**  
Structural Grade: **0**  
O&M Grade: **2**  
Clock Start/From: **6**  
Clock To: **8**  
1st Value:  
2nd Value:  
Value Percent: **5.000**  
Continuous Index:  
Within 8" of Joint: **YES**  
Remarks:

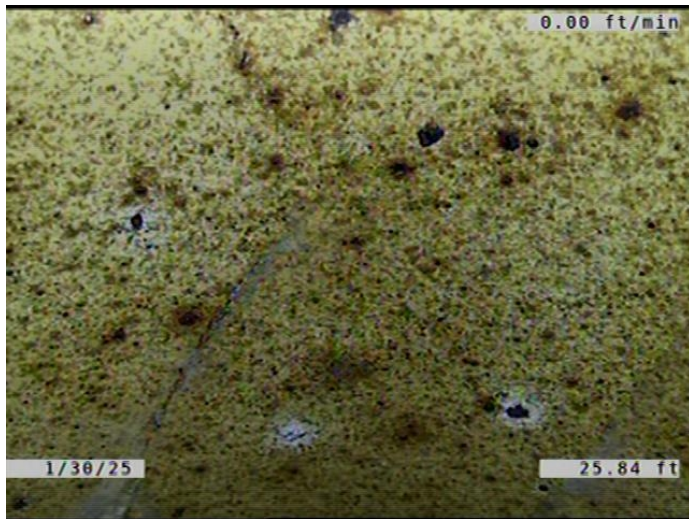
Code: **CS**  
 Description: **Crack Spiral**

Distance (ft): **25.8**  
 Structural Grade: **2**  
 O&M Grade: **0**  
 Clock Start/From: **11**  
 Clock To: **1**  
 1st Value:  
 2nd Value:  
 Value Percent:  
 Continuous Index:  
 Within 8" of Joint: **YES**  
 Remarks:

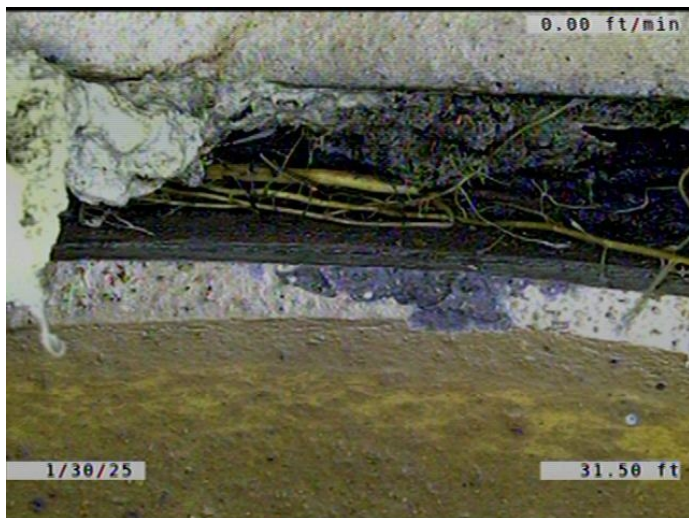
Code: **RFJ**  
 Description: **Roots Fine Joint**

Distance (ft): **31.5**  
 Structural Grade: **0**  
 O&M Grade: **1**  
 Clock Start/From: **1**  
 Clock To: **4**  
 1st Value:  
 2nd Value:  
 Value Percent:  
 Continuous Index:  
 Within 8" of Joint: **YES**  
 Remarks:

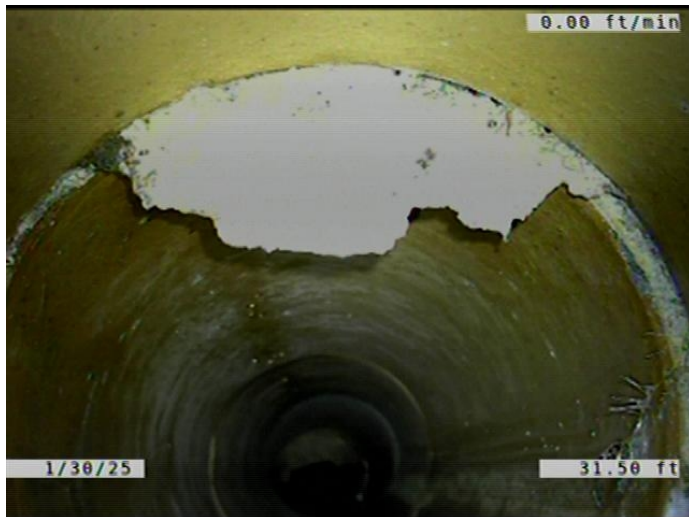
Code:	<b>DAE</b>
Description:	<b>Deposits Attached Encrustation</b>
Distance (ft):	<b>31.5</b>
Structural Grade:	<b>0</b>
O&M Grade:	<b>2</b>
Clock Start/From:	<b>11</b>
Clock To:	<b>2</b>
1st Value:	
2nd Value:	
Value Percent:	<b>10.000</b>
Continuous Index:	
Within 8" of Joint:	<b>YES</b>
Remarks:

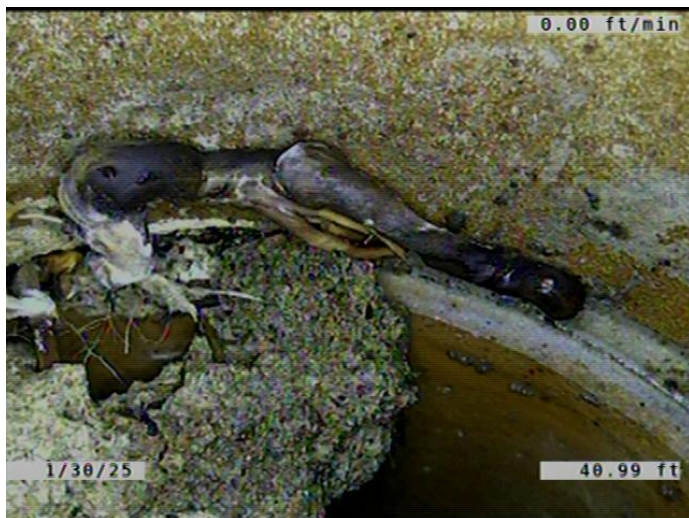
Code:	<b>RTJ</b>
Description:	<b>Roots Tap Joint</b>
Distance (ft):	<b>41.0</b>
Structural Grade:	<b>0</b>
O&M Grade:	<b>2</b>
Clock Start/From:	<b>10</b>
Clock To:	<b>3</b>
1st Value:	
2nd Value:	
Value Percent:	<b>5.000</b>
Continuous Index:	
Within 8" of Joint:	<b>YES</b>
Remarks:

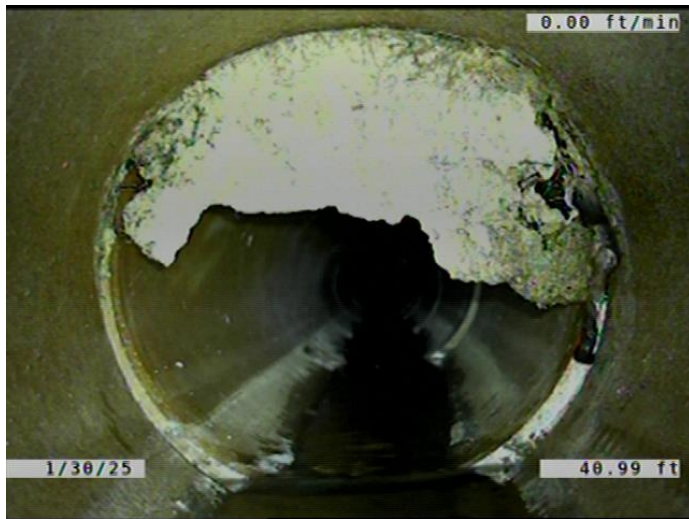
Code: **DAE**  
 Description: **Deposits Attached Encrustation**

Distance (ft): **41.0**  
 Structural Grade: **0**  
 O&M Grade: **5**  
 Clock Start/From: **10**  
 Clock To: **3**  
 1st Value:  
 2nd Value:  
 Value Percent: **40.000**  
 Continuous Index:  
 Within 8" of Joint: **YES**  
 Remarks:

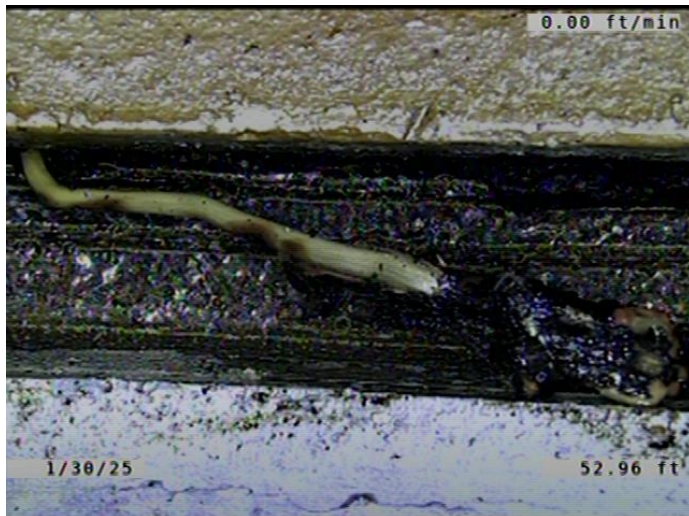
Code: **RFJ**  
 Description: **Roots Fine Joint**

Distance (ft): **53.0**  
 Structural Grade: **0**  
 O&M Grade: **1**  
 Clock Start/From: **10**  
 Clock To: **2**  
 1st Value:  
 2nd Value:  
 Value Percent:  
 Continuous Index:  
 Within 8" of Joint: **YES**  
 Remarks:

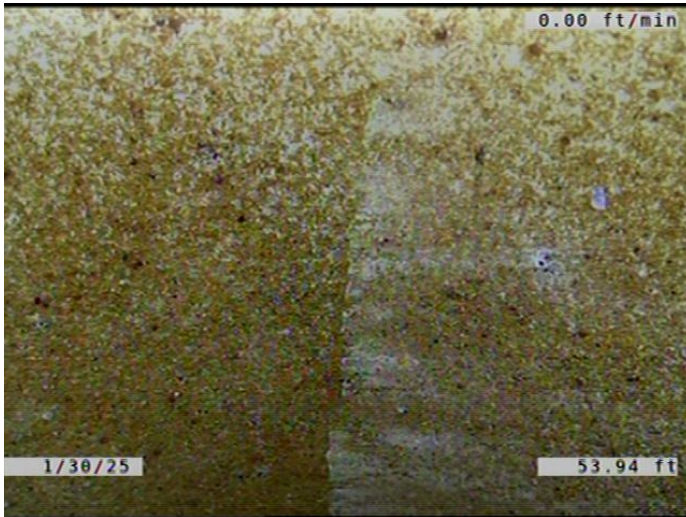
Code: **CM**  
Description: **Crack Multiple**

Distance (ft): **53.9**  
Structural Grade: **3**  
O&M Grade: **0**  
Clock Start/From: **10**  
Clock To: **4**  
1st Value:  
2nd Value:  
Value Percent:  
Continuous Index:  
Within 8" of Joint: **YES**  
Remarks:

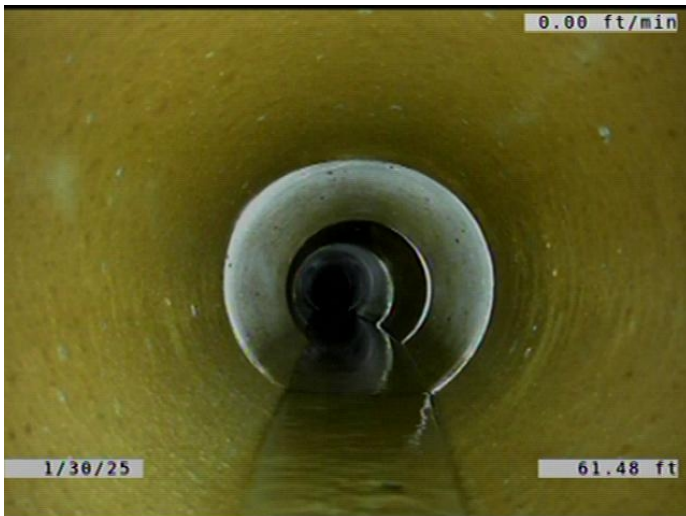
Code: **MWLS**  
Description: **Miscellaneous Water Level Sag**

Distance (ft): **61.5**  
Structural Grade: **2**  
O&M Grade: **0**  
Clock Start/From:  
Clock To:  
1st Value:  
2nd Value:  
Value Percent: **10.000**  
Continuous Index: **S03**  
Within 8" of Joint: **NO**  
Remarks:

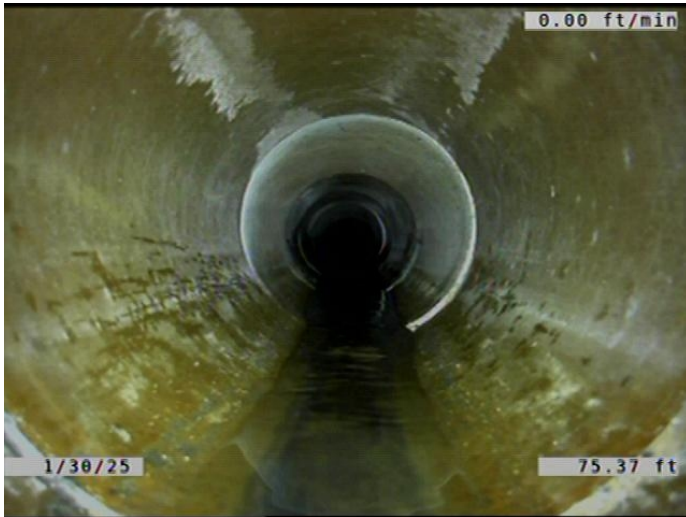
Code: **MWLS**  
Description: **Miscellaneous Water Level Sag**

Distance (ft): **75.4**  
Structural Grade: **2**  
O&M Grade: **0**  
Clock Start/From:  
Clock To:  
1st Value:  
2nd Value:  
Value Percent: **10.000**  
Continuous Index: **F03**  
Within 8" of Joint: **NO**  
Remarks:

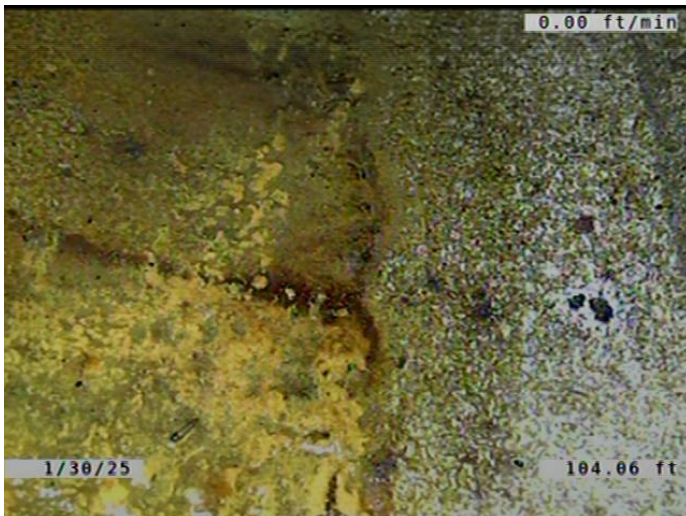
Code: **CL**  
Description: **Crack Longitudinal**

Distance (ft): **104.0**  
Structural Grade: **2**  
O&M Grade: **0**  
Clock Start/From: **4**  
Clock To:  
1st Value:  
2nd Value:  
Value Percent:  
Continuous Index:  
Within 8" of Joint: **YES**  
Remarks:

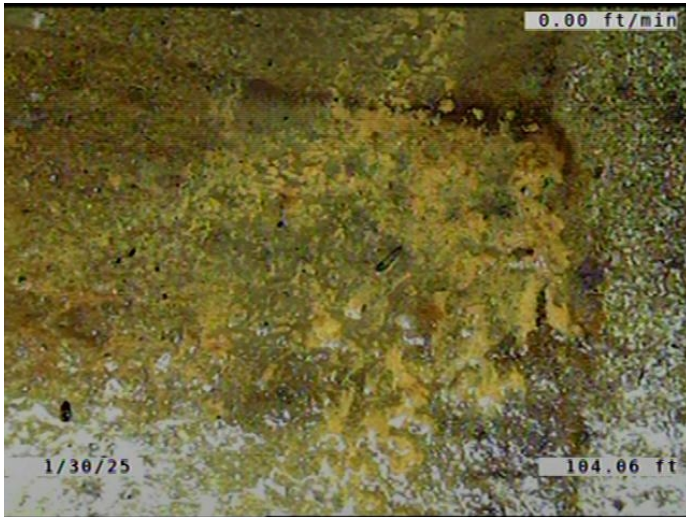
Code: **DAE**  
 Description: **Deposits Attached Encrustation**

Distance (ft): **104.1**  
 Structural Grade: **0**  
 O&M Grade: **2**  
 Clock Start/From: **4**  
 Clock To: **6**  
 1st Value:  
 2nd Value:  
 Value Percent: **5.000**  
 Continuous Index:  
 Within 8" of Joint: **YES**  
 Remarks:

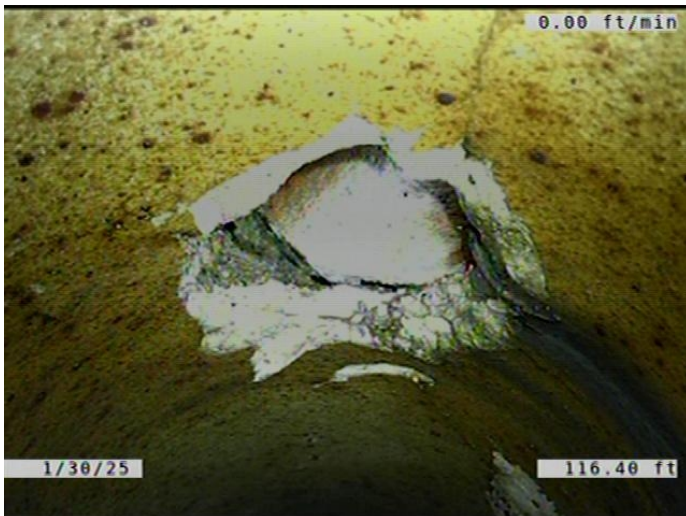
Code: **FM**  
 Description: **Fracture Multiple**

Distance (ft): **116.4**  
 Structural Grade: **4**  
 O&M Grade: **0**  
 Clock Start/From: **12**  
 Clock To: **2**  
 1st Value:  
 2nd Value:  
 Value Percent:  
 Continuous Index:  
 Within 8" of Joint: **YES**  
 Remarks:

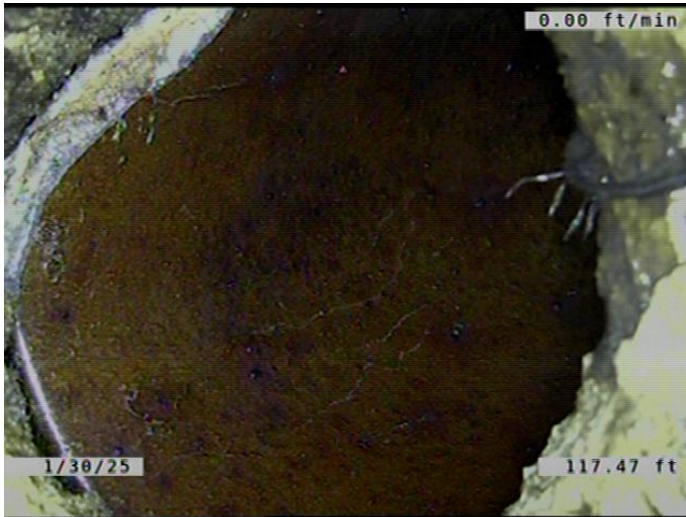
Code:	<b>TBD</b>
Description:	<b>Tap Break-in/Hammer Defective</b>
Distance (ft):	<b>117.5</b>
Structural Grade:	<b>0</b>
O&M Grade:	<b>3</b>
Clock Start/From:	<b>1</b>
Clock To:	
1st Value:	<b>6.000</b>
2nd Value:	
Value Percent:	
Continuous Index:	
Within 8" of Joint:	<b>YES</b>
Remarks:	<b>Defective</b>

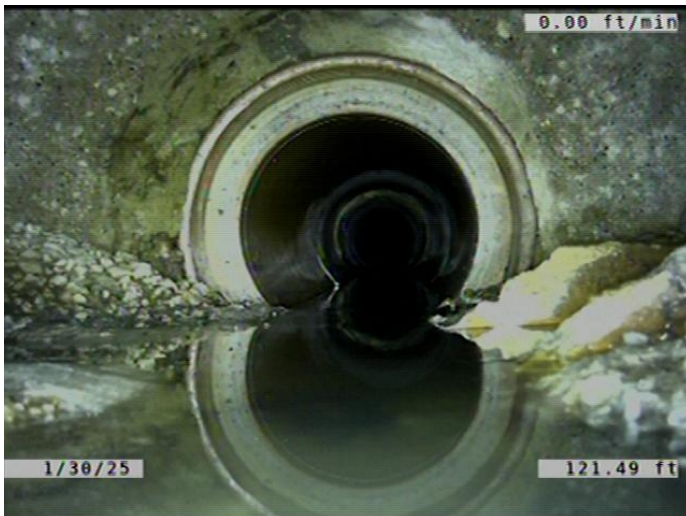
Code:	<b>DSF</b>
Description:	<b>Deposits Settled Fine</b>
Distance (ft):	<b>121.5</b>
Structural Grade:	<b>0</b>
O&M Grade:	<b>2</b>
Clock Start/From:	<b>5</b>
Clock To:	<b>7</b>
1st Value:	
2nd Value:	
Value Percent:	<b>5.000</b>
Continuous Index:	<b>F01</b>
Within 8" of Joint:	<b>YES</b>
Remarks:

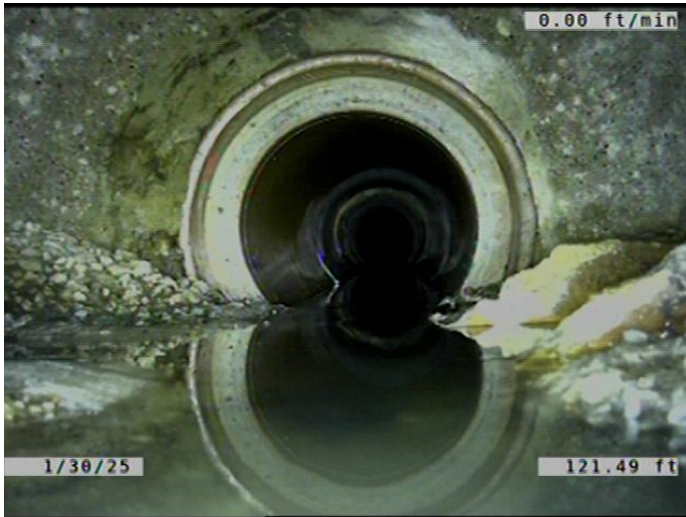
Code: **DAE**  
 Description: **Deposits Attached Encrustation**

Distance (ft): **121.5**  
 Structural Grade: **0**  
 O&M Grade: **2**  
 Clock Start/From: **8**  
 Clock To: **4**  
 1st Value:  
 2nd Value:  
 Value Percent: **5.000**  
 Continuous Index: **F02**  
 Within 8" of Joint: **YES**  
 Remarks:
