Profile/Photo Observation Report

Street:	S COLORADO ST	Flow Control:	Not Controlled
City:	Hobart, IN	Year Renewed:	
Location:	Yard	Tape/Media #:	
Purpose:	Routine Assessment	Dia/Height:	10"
Use:	Sanitary	Material:	PVC
Drain Area:	NA	Lining:	
Category:	NA		
Comment:	.

Location Details:		Direction of Survey:	Upstream
US MH:	M-507-084	DS MH:	M-507-085
		Total Length Surveyed (ft):	11.5

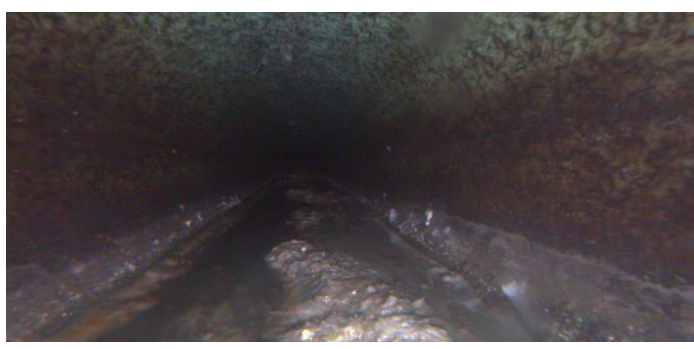
Code: **AMH**
Description: **Manhole**

Distance (ft): **.0**
Structural Grade: **0**
O&M Grade: **0**
Clock Start/From:
Clock To:
1st Value:
2nd Value:
Value Percent:
Continuous Index:
Within 8" of Joint: **NO**
Remarks: **M-507-085**

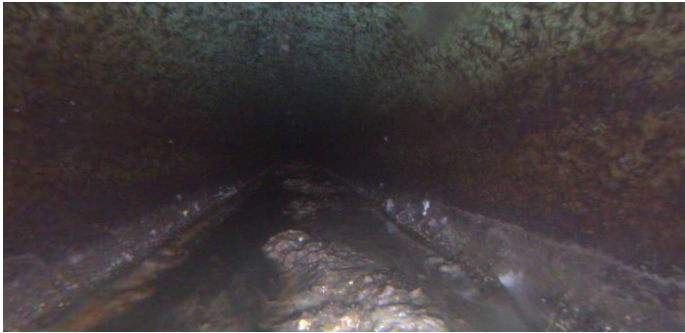
Code:	MWL
Description:	Water Level

Distance (ft):	.0
Structural Grade:	0
O&M Grade:	0
Clock Start/From:	
Clock To:	
1st Value:	
2nd Value:	
Value Percent:	20.000
Continuous Index:	
Within 8" of Joint:	NO
Remarks:

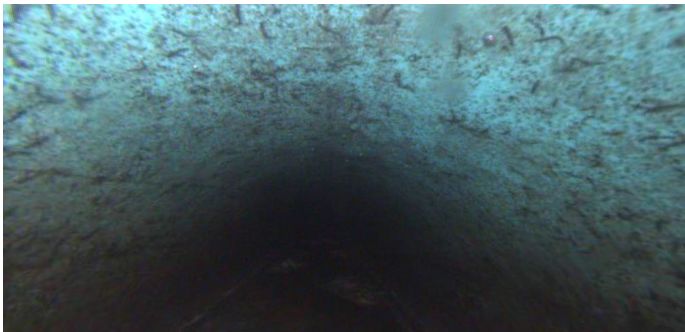
Code:	MSA
Description:	Abandoned Survey

Distance (ft):	11.5
Structural Grade:	0
O&M Grade:	0
Clock Start/From:	
Clock To:	
1st Value:	
2nd Value:	
Value Percent:	
Continuous Index:	
Within 8" of Joint:	NO
Remarks:	debris under water
