## Profile/Photo Observation Report

Street:	<b>FOXCROFT STREET</b>	Flow Control:	<b>Not Controlled</b>
City:	<b>Hobart, IN</b>	Year Renewed:	
Location:	<b>Yard</b>	Tape/Media #:	
Purpose:	<b>Routine Assessment</b>	Dia/Height:	<b>10"</b>
Use:	<b>Sanitary</b>	Material:	<b>PVC</b>
Drain Area:	<b>NA</b>	Lining:	
Category:	<b>NA</b>		
Comment:	<b>.</b>

Location Details:		Direction of Survey:	<b>Upstream</b>
US MH:	<b>M-507-084</b>	DS MH:	<b>M-507-085</b>
		Total Length Surveyed (ft):	<b>11.5</b>

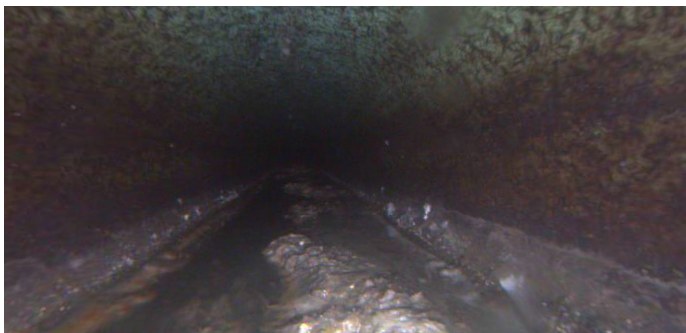
Code: **AMH**  
Description: **Manhole**

Distance (ft): **.0**  
Structural Grade: **0**  
O&M Grade: **0**  
Clock Start/From:  
Clock To:  
1st Value:  
2nd Value:  
Value Percent:  
Continuous Index:  
Within 8" of Joint: **NO**  
Remarks: **M-507-085**

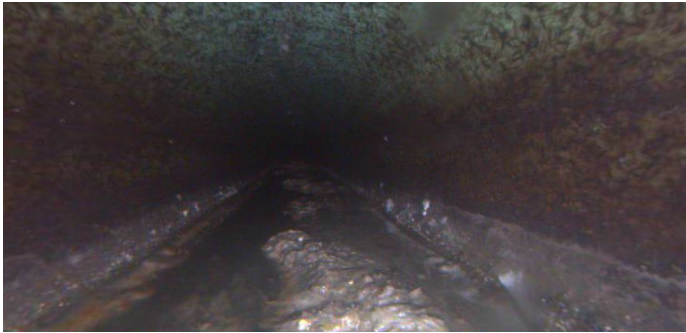
Code:	<b>MWL</b>
Description:	<b>Water Level</b>

Distance (ft):	<b>.0</b>
Structural Grade:	<b>0</b>
O&M Grade:	<b>0</b>
Clock Start/From:	
Clock To:	
1st Value:	
2nd Value:	
Value Percent:	<b>20.000</b>
Continuous Index:	
Within 8" of Joint:	<b>NO</b>
Remarks:

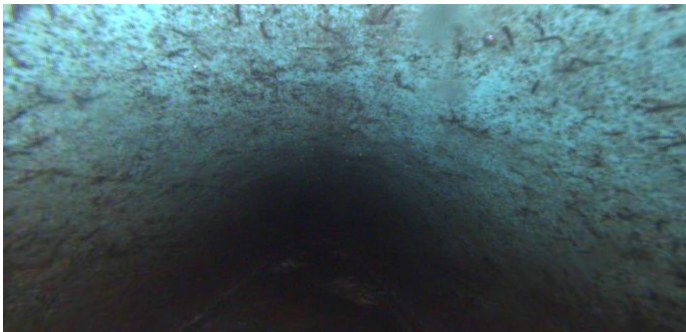
Code:	<b>MSA</b>
Description:	<b>Abandoned Survey</b>

Distance (ft):	<b>11.5</b>
Structural Grade:	<b>0</b>
O&M Grade:	<b>0</b>
Clock Start/From:	
Clock To:	
1st Value:	
2nd Value:	
Value Percent:	
Continuous Index:	
Within 8" of Joint:	<b>NO</b>
Remarks:	<b>debris under water</b>
