## Profile/Photo Observation Report

Street:	<b>S COLORADO ST</b>	Flow Control:	<b>Not Controlled</b>
City:	<b>Hobart, IN</b>	Year Renewed:	
Location:	<b>Yard</b>	Tape/Media #:	
Purpose:	<b>Routine Assessment</b>	Dia/Height:	<b>10"</b>
Use:	<b>Sanitary</b>	Material:	<b>PVC</b>
Drain Area:	<b>NA</b>	Lining:	
Category:	<b>NA</b>		
Comment:	<b>.</b>

Location Details:		Direction of Survey:	<b>Downstream</b>
US MH:	<b>M-507-084</b>	DS MH:	<b>M-507-085</b>
		Total Length Surveyed (ft):	<b>6.6</b>

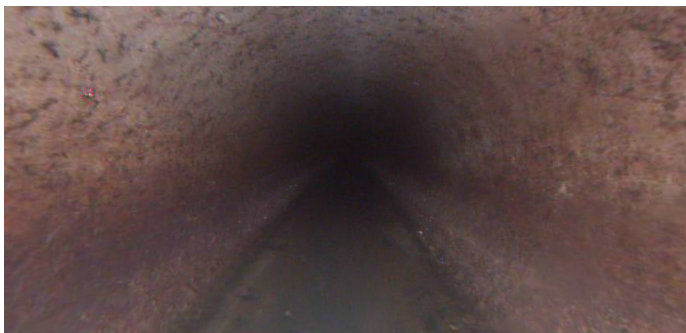
Code: **AMH**  
Description: **Manhole**

Distance (ft): **.0**  
Structural Grade: **0**  
O&M Grade: **0**  
Clock Start/From:  
Clock To:  
1st Value:  
2nd Value:  
Value Percent:  
Continuous Index:  
Within 8" of Joint: **NO**  
Remarks: **M-507-084**

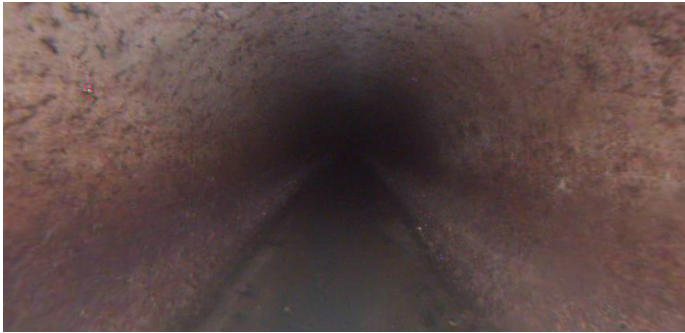
Code:	<b>MWL</b>
Description:	<b>Water Level</b>

Distance (ft):	<b>.0</b>
Structural Grade:	<b>0</b>
O&M Grade:	<b>0</b>
Clock Start/From:	
Clock To:	
1st Value:	
2nd Value:	
Value Percent:	<b>10.000</b>
Continuous Index:	
Within 8" of Joint:	<b>NO</b>
Remarks:

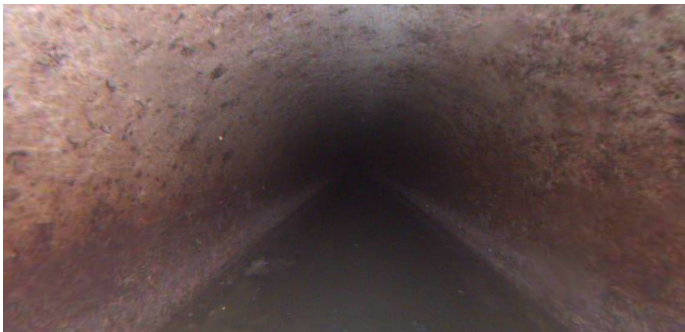
Code:	<b>MSA</b>
Description:	<b>Abandoned Survey</b>

Distance (ft):	<b>6.6</b>
Structural Grade:	<b>0</b>
O&M Grade:	<b>0</b>
Clock Start/From:	
Clock To:	
1st Value:	
2nd Value:	
Value Percent:	
Continuous Index:	
Within 8" of Joint:	<b>NO</b>
Remarks:	<b>debris under water</b>
