Profile/Photo Observation Report RedZone						
Date: Pipe Length (ft) P.O.#: Customer:	04/12/2018): 173.3	Weather: Owner: Surveyor: Clean Date:	NA Jen Costell 01/01/190		Coding: Pre Clean: PSR: Shape:	PACP 6.0 No Pre-Cleaning P-507-085-084 C
Street:	FOXCROFT STREET		Flow Contro	l:	Not Controlled	
City:	Hobart, IN	Year Rene		ed:		
Location:	Yard		Tape/Media	#:		
Purpose:	Routine Assessmen	t	Dia/Height:		10"	
Use:	Sanitary		Material:		PVC	
Drain Area:	NA		Lining:			
Category:	NA					
Comment:						
Location Detail	s:		Direction of	Survey:	Downstream	
US MH:	M-507-084	DS MH:	M-507-085	-	Total Length Surveyed (ft):	6.6
O&M Index:	0.00	O&M Quick:		0000	O&M Rating:	0.00
Structural Index:	0.00	Structural Qu	uick:	0000	Structural Rating:	0.00
Overall Index:	0.00	Overall Quick	<:	0000	Overall Rating:	0.00

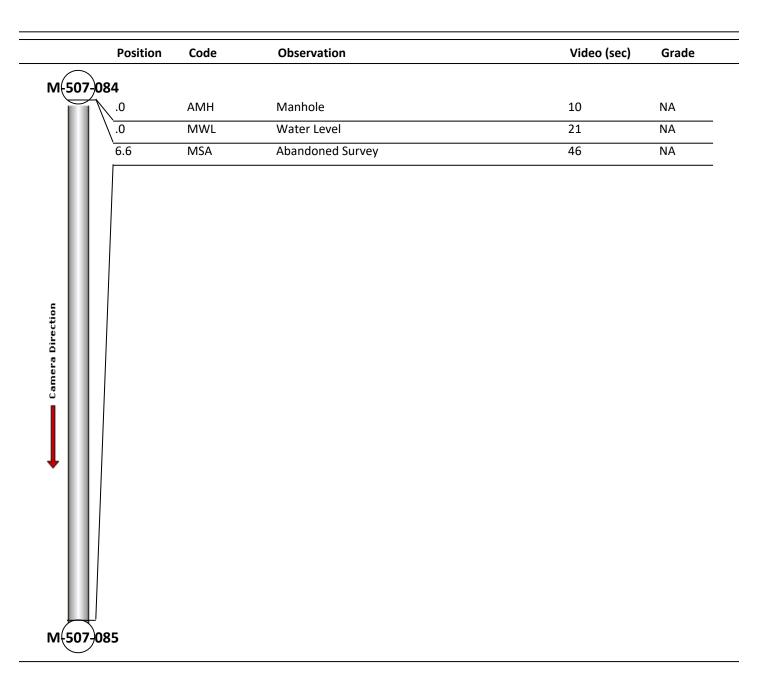
Code: Description:	AMH Manhole
Distance (ft):	.0
Structural Grade:	0
O&M Grade:	0
Clock Start/From:	
Clock To:	
1st Value:	
2nd Value:	
Value Percent:	
Continuous Index:	
Within 8" of Joint:	NO
Remarks:	M-507-084

Code: MWL Description: Water Level

Distance (ft):	.0
Structural Grade:	0
O&M Grade:	0
Clock Start/From:	
Clock To:	
1st Value:	
2nd Value:	
Value Percent:	10.000
Continuous Index:	
Within 8" of Joint:	NO
Remarks:

Description:	Abandoned Survey	
Distance (ft):	6.6	
Structural Grade:	0	
O&M Grade:	0	
Clock Start/From:		
Clock To:		
1st Value:		
2nd Value:		
Value Percent:		
Continuous Index:		
Within 8" of Joint:	NO	
Remarks:	debris under water
