Profile/Photo Observation Report

Street:	S COLORADO ST	Flow Control:	Not Controlled
City:	Hobart, IN	Year Renewed:	
Location:	Yard	Tape/Media #:	
Purpose:	Routine Assessment	Dia/Height:	12"
Use:	Sanitary	Material:	VCP
Drain Area:	NA	Lining:	
Category:	NA		
Comment:	.

Location Details:		Direction of Survey:	Downstream
US MH:	M-507-085	DS MH:	M-507-027
		Total Length Surveyed (ft):	15.2

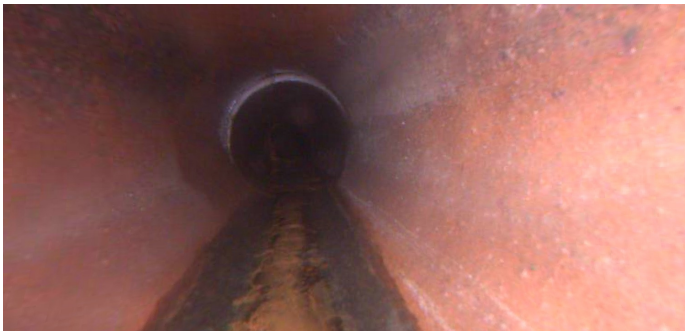
Code: **AMH**
Description: **Manhole**

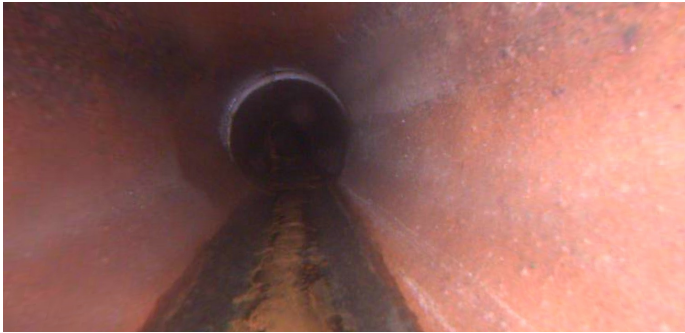
Code:	MWL
Description:	Water Level

Distance (ft):	.0
Structural Grade:	0
O&M Grade:	0
Clock Start/From:	
Clock To:	
1st Value:	
2nd Value:	
Value Percent:	5.000
Continuous Index:	
Within 8" of Joint:	NO
Remarks:

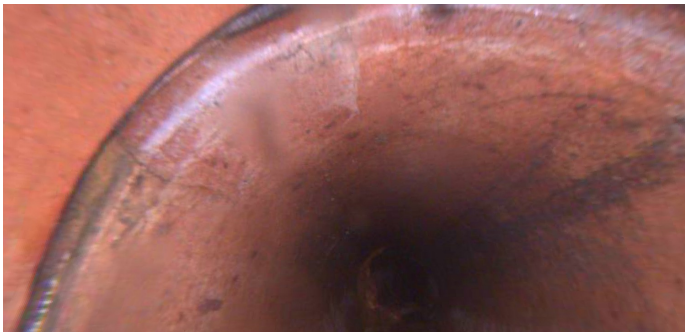
Code:	CL
Description:	Crack Longitudinal

Distance (ft):	2.9
Structural Grade:	2
O&M Grade:	0
Clock Start/From:	10
Clock To:	
1st Value:	
2nd Value:	
Value Percent:	
Continuous Index:	
Within 8" of Joint:	YES
Remarks:

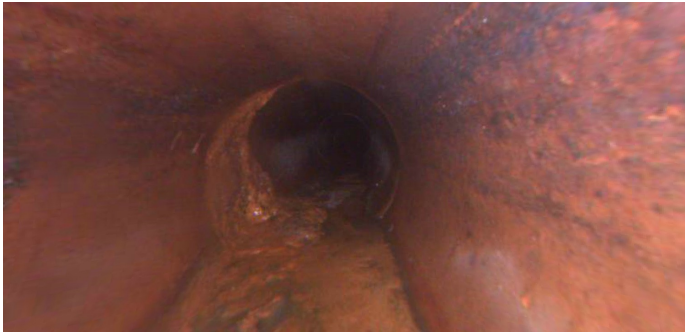
Code: **DSF**
Description: **Deposits Settled Fine**

Distance (ft): **4.7**
Structural Grade: **0**
O&M Grade: **2**
Clock Start/From: **4**
Clock To: **8**
1st Value:
2nd Value:
Value Percent: **10.000**
Continuous Index:
Within 8" of Joint: **NO**
Remarks:

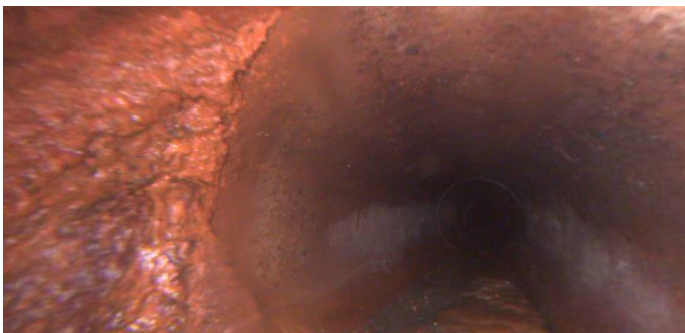
Code: **DAE**
Description: **Deposits Attached Encrustation**

Distance (ft): **5.8**
Structural Grade: **0**
O&M Grade: **2**
Clock Start/From: **7**
Clock To: **11**
1st Value:
2nd Value:
Value Percent: **10.000**
Continuous Index:
Within 8" of Joint: **YES**
Remarks:

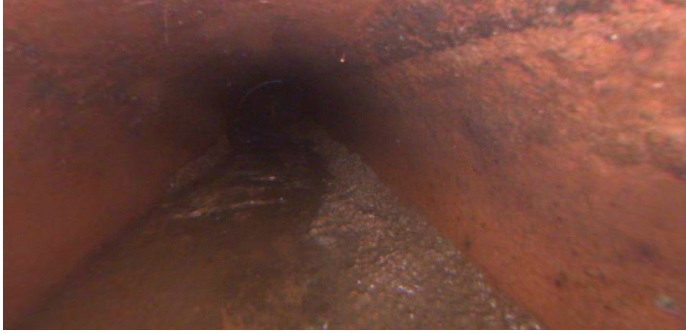
Code: **DSF**
Description: **Deposits Settled Fine**

Distance (ft): **15.2**
Structural Grade: **0**
O&M Grade: **3**
Clock Start/From: **4**
Clock To: **8**
1st Value:
2nd Value:
Value Percent: **20.000**
Continuous Index:
Within 8" of Joint: **NO**
Remarks:

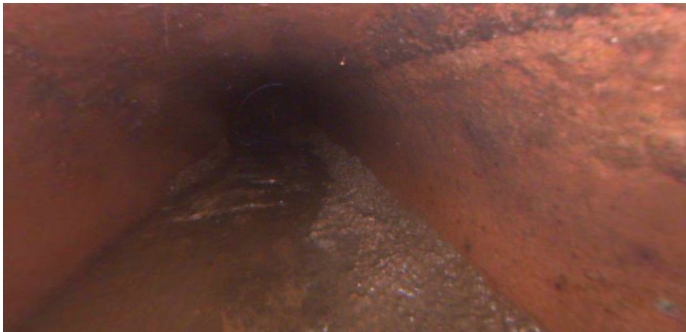
Code: **MSA**
Description: **Abandoned Survey**

Distance (ft): **15.2**
Structural Grade: **0**
O&M Grade: **0**
Clock Start/From:
Clock To:
1st Value:
2nd Value:
Value Percent:
Continuous Index:
Within 8" of Joint: **NO**
Remarks: **debris under water**
