# Profile/Photo Observation Report

Date:	<b>12/11/2024</b>	Weather:		Coding:	<b>PACP 7.0</b>
Pipe Length (ft):	<b>165.0</b>	Owner:	<b>City of Hobart</b>	Pre Clean:	<b>Heavy Cleaning</b>
P.O.#:	<b>YES502259</b>	Surveyor:	<b>S. Bucklin</b>	PSR:	<b>P-507-027-085</b>
Customer:	<b>City of Hobart</b>	Clean Date:	<b>09/25/2024</b>	Shape:	<b>C</b>

Street:	<b>South Dekalb Street</b>	Flow Control:	<b>Not Controlled</b>
City:	<b>Hobart, IN</b>	Year Renewed:	
Location:	<b>Easement/Right of Way</b>	Tape/Media #:	
Purpose:	<b>Sewer System Evaluation Survey (SS)</b>	Dia/Height:	<b>10"</b>
Use:	<b>Sanitary Sewage Pipe</b>	Material:	<b>VCP</b>
Drain Area:		Lining:	<b>None</b>
Category:	<b>NA</b>		
Comment:			
Location Details:		Direction of Survey:	<b>Upstream</b>
US MH:	<b>M-507-027</b>	DS MH:	<b>M-507-085</b>
		Total Length Surveyed (ft):	<b>170.6</b>

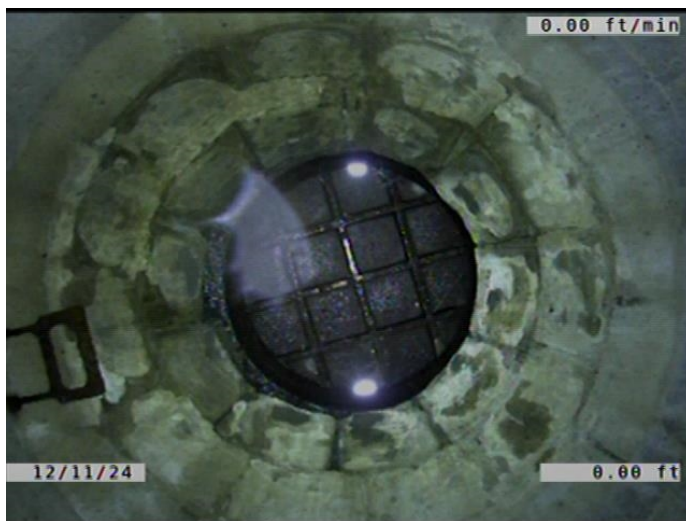
Code: **AMH**  
Description: **Manhole**

Distance (ft): **.0**  
Structural Grade: **0**  
O&M Grade: **0**  
Clock Start/From:  
Clock To:  
1st Value:  
2nd Value:  
Value Percent:  
Continuous Index:  
Within 8" of Joint: **NO**  
Remarks: **M-507-085**

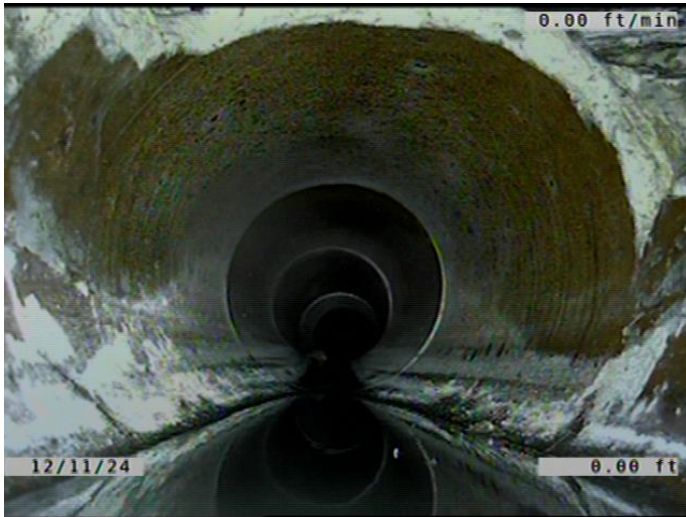
Code: **MWL**  
Description: **Miscellaneous Water Level**

Distance (ft): **.0**  
Structural Grade: **0**  
O&M Grade: **0**  
Clock Start/From:  
Clock To:  
1st Value:  
2nd Value:  
Value Percent: **5.000**  
Continuous Index:  
Within 8" of Joint: **NO**  
Remarks:

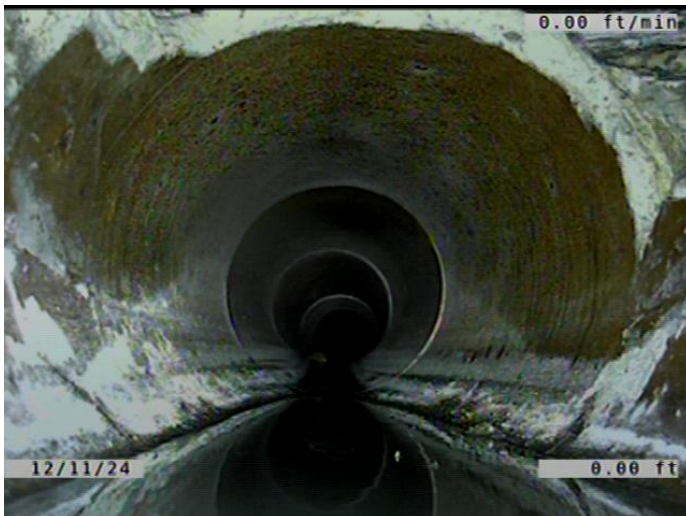
Code: **MWLS**  
Description: **Miscellaneous Water Level Sag**

Distance (ft): **.0**  
Structural Grade: **2**  
O&M Grade: **0**  
Clock Start/From:  
Clock To:  
1st Value:  
2nd Value:  
Value Percent: **10.000**  
Continuous Index: **S01**  
Within 8" of Joint: **NO**  
Remarks:

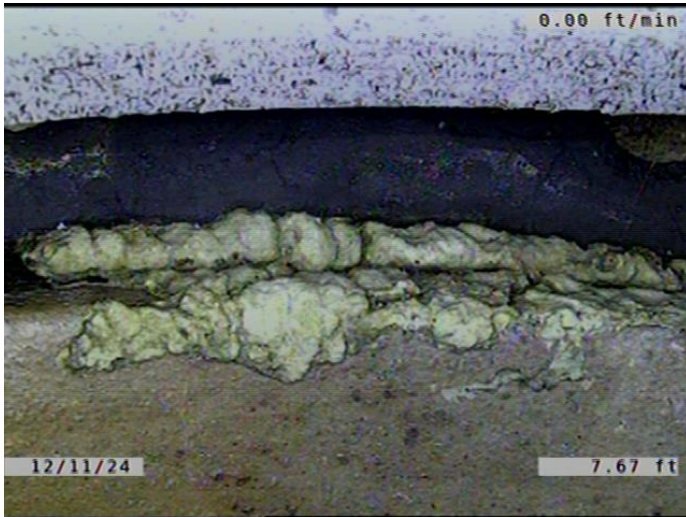
Code: **DAE**  
Description: **Deposits Attached Encrustation**

Distance (ft): **7.7**  
Structural Grade: **0**  
O&M Grade: **2**  
Clock Start/From: **8**  
Clock To: **4**  
1st Value:  
2nd Value:  
Value Percent: **5.000**  
Continuous Index:  
Within 8" of Joint: **YES**  
Remarks:

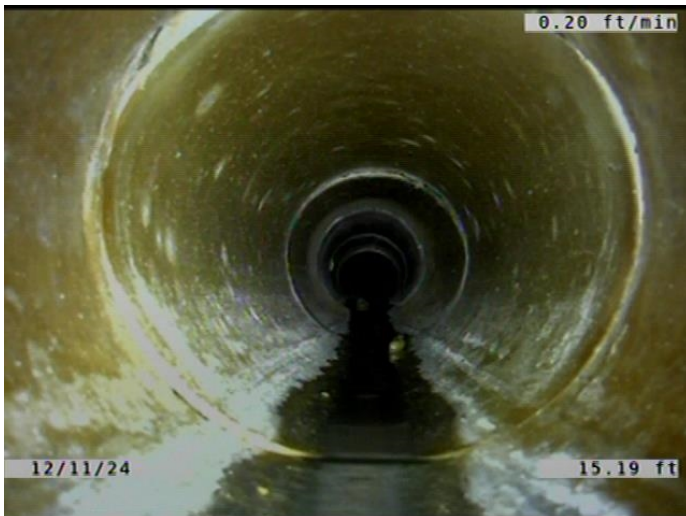
Code: **MWLS**  
Description: **Miscellaneous Water Level Sag**

Distance (ft): **15.2**  
Structural Grade: **2**  
O&M Grade: **0**  
Clock Start/From:  
Clock To:  
1st Value:  
2nd Value:  
Value Percent: **10.000**  
Continuous Index: **F02**  
Within 8" of Joint: **NO**  
Remarks:

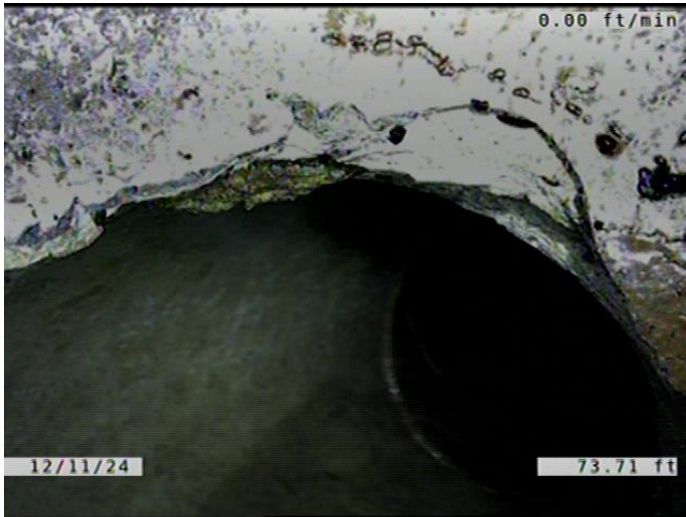
Code: **SSS**  
Description: **Surface Damage Surface Spalling**

Distance (ft): **73.7**  
Structural Grade: **2**  
O&M Grade: **0**  
Clock Start/From: **11**  
Clock To: **1**  
1st Value:  
2nd Value:  
Value Percent:  
Continuous Index:  
Within 8" of Joint: **YES**  
Remarks:

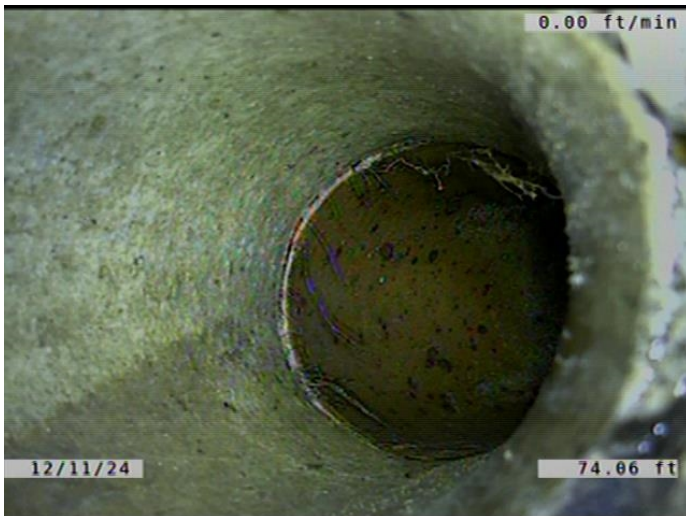
Code: **TBD**  
Description: **Tap Break-in/Hammer Defective**

Distance (ft): **74.1**  
Structural Grade: **0**  
O&M Grade: **3**  
Clock Start/From: **12**  
Clock To:  
1st Value: **6.000**  
2nd Value:  
Value Percent:  
Continuous Index:  
Within 8" of Joint: **NO**  
Remarks: **SERVICE COMES FROM THE RIGHT (SOUTH). ROOTS GROWING IN THE J**

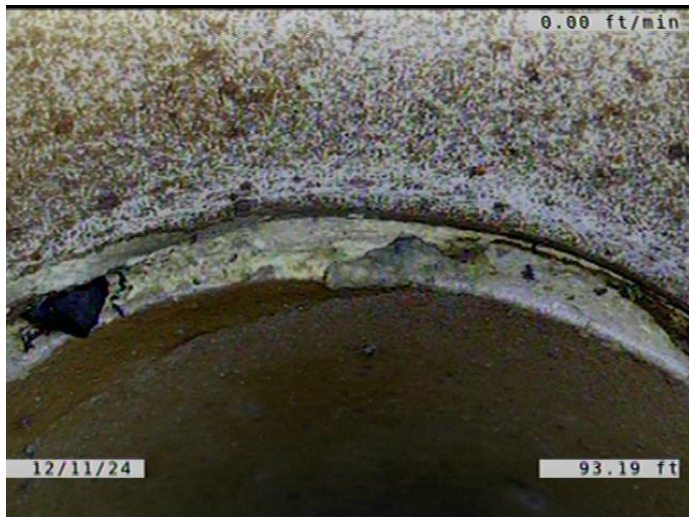
Code: **JOMD**  
 Description: **Joint Offset Medium Defective**

Distance (ft): **93.2**  
 Structural Grade: **3**  
 O&M Grade: **0**  
 Clock Start/From:  
 Clock To:  
 1st Value:  
 2nd Value:  
 Value Percent:  
 Continuous Index:  
 Within 8" of Joint: **YES**  
 Remarks:

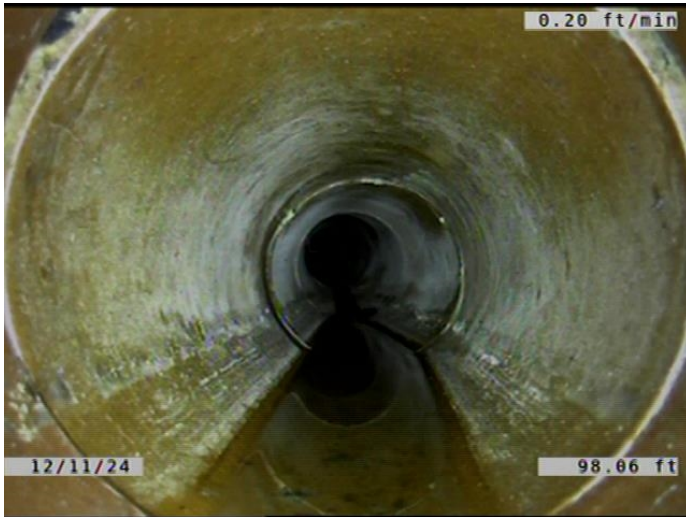
Code: **MWLS**  
Description: **Miscellaneous Water Level Sag**

Distance (ft): **98.1**  
Structural Grade: **2**  
O&M Grade: **0**  
Clock Start/From:  
Clock To:  
1st Value:  
2nd Value:  
Value Percent: **10.000**  
Continuous Index: **S10**  
Within 8" of Joint: **NO**  
Remarks:

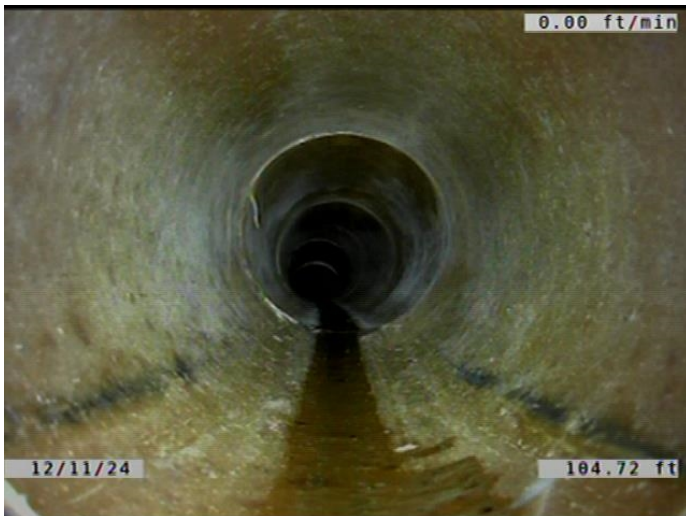
Code: **MWLS**  
Description: **Miscellaneous Water Level Sag**

Distance (ft): **104.7**  
Structural Grade: **2**  
O&M Grade: **0**  
Clock Start/From:  
Clock To:  
1st Value:  
2nd Value:  
Value Percent: **10.000**  
Continuous Index: **F10**  
Within 8" of Joint: **NO**  
Remarks:

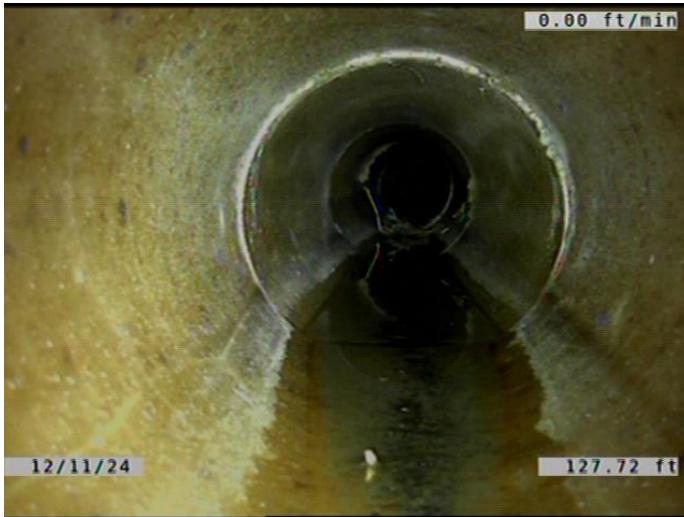
Code: **MWLS**  
Description: **Miscellaneous Water Level Sag**

Distance (ft): **127.7**  
Structural Grade: **2**  
O&M Grade: **0**  
Clock Start/From:  
Clock To:  
1st Value:  
2nd Value:  
Value Percent: **10.000**  
Continuous Index: **S12**  
Within 8" of Joint: **NO**  
Remarks:

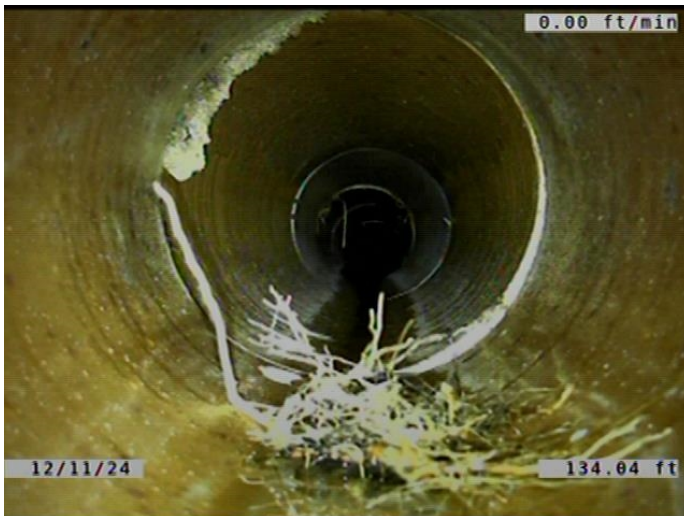
Code: **MWLS**  
Description: **Miscellaneous Water Level Sag**

Distance (ft): **134.0**  
Structural Grade: **2**  
O&M Grade: **0**  
Clock Start/From:  
Clock To:  
1st Value:  
2nd Value:  
Value Percent: **10.000**  
Continuous Index: **F12**  
Within 8" of Joint: **NO**  
Remarks:

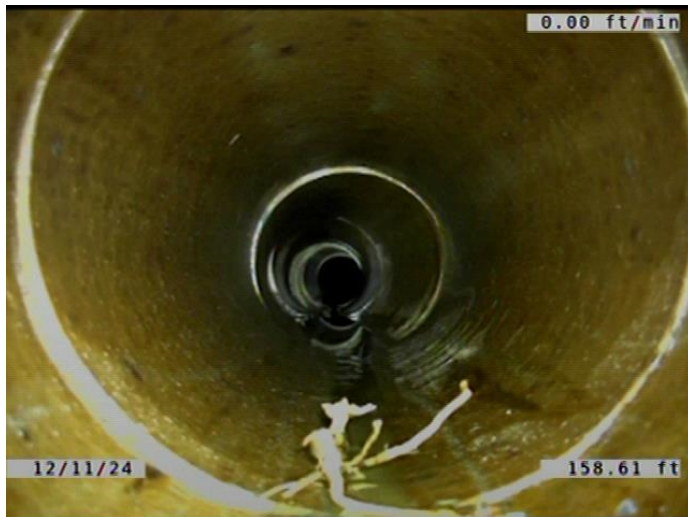
Code: **MWLS**  
Description: **Miscellaneous Water Level Sag**

Distance (ft): **158.6**  
Structural Grade: **2**  
O&M Grade: **0**  
Clock Start/From:  
Clock To:  
1st Value:  
2nd Value:  
Value Percent: **15.000**  
Continuous Index: **F13**  
Within 8" of Joint: **NO**  
Remarks:

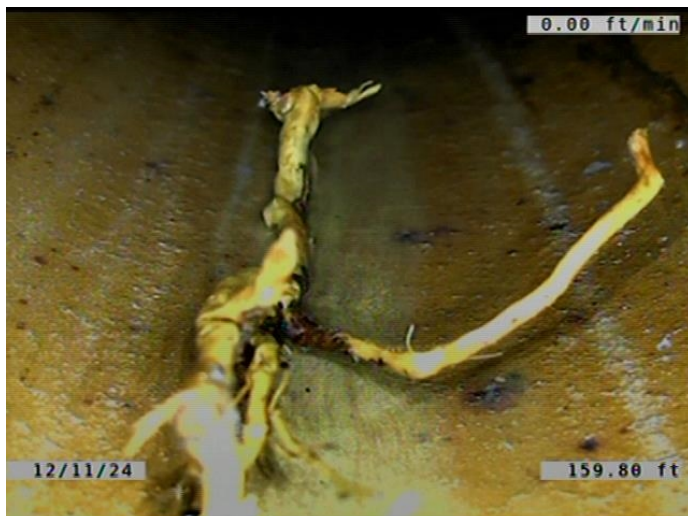
Code: **OBZ**  
Description: **Obstruction Other**

Distance (ft): **159.8**  
Structural Grade: **0**  
O&M Grade: **2**  
Clock Start/From: **6**  
Clock To:  
1st Value:  
2nd Value:  
Value Percent: **5.000**  
Continuous Index:  
Within 8" of Joint: **YES**  
Remarks: **ROOTS THAT HAVE BEEN CUT FROM THE PIPE.**

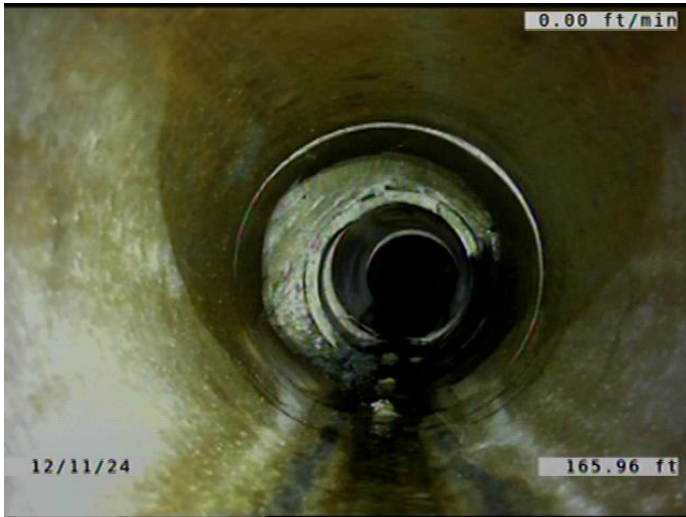
Code: **MWLS**  
Description: **Miscellaneous Water Level Sag**

Distance (ft): **166.0**  
Structural Grade: **2**  
O&M Grade: **0**  
Clock Start/From:  
Clock To:  
1st Value:  
2nd Value:  
Value Percent: **10.000**  
Continuous Index: **F14**  
Within 8" of Joint: **NO**  
Remarks:

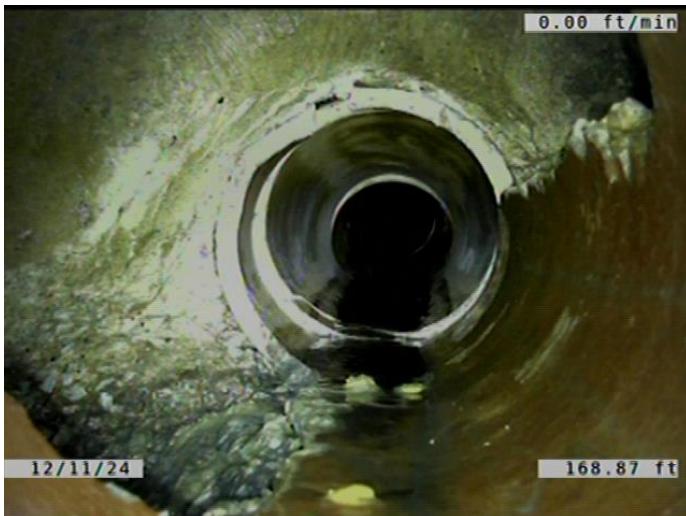
Code: **DAE**  
Description: **Deposits Attached Encrustation**

Distance (ft): **168.9**  
Structural Grade: **0**  
O&M Grade: **2**  
Clock Start/From: **7**  
Clock To: **5**  
1st Value:  
2nd Value:  
Value Percent: **5.000**  
Continuous Index: **F03**  
Within 8" of Joint: **YES**  
Remarks:

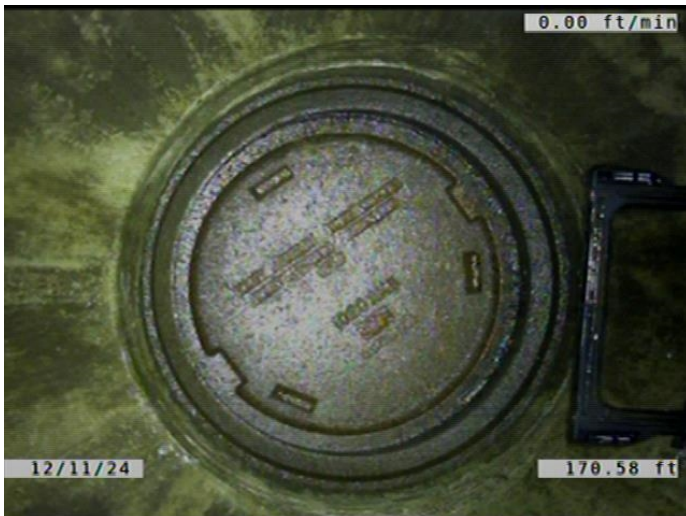
Code: **AMH**  
 Description: **Manhole**

Distance (ft): **170.6**  
 Structural Grade: **0**  
 O&M Grade: **0**  
 Clock Start/From:  
 Clock To:  
 1st Value:  
 2nd Value:  
 Value Percent:  
 Continuous Index:  
 Within 8" of Joint: **NO**  
 Remarks: **M-507-027**
