## Profile/Photo Observation Report

Street:	<b>W 10TH PL</b>	Flow Control:	<b>Not Controlled</b>
City:	<b>Hobart, IN</b>	Year Renewed:	
Location:	<b>Yard</b>	Tape/Media #:	
Purpose:	<b>Routine Assessment</b>	Dia/Height:	<b>8"</b>
Use:	<b>Sanitary</b>	Material:	<b>PVC</b>
Drain Area:	<b>NA</b>	Lining:	
Category:	<b>NA</b>		
Comment:

Location Details:		Direction of Survey:	<b>Downstream</b>
US MH:	<b>M-507-087</b>	DS MH:	<b>M-507-040</b>
		Total Length Surveyed (ft):	<b>233.3</b>

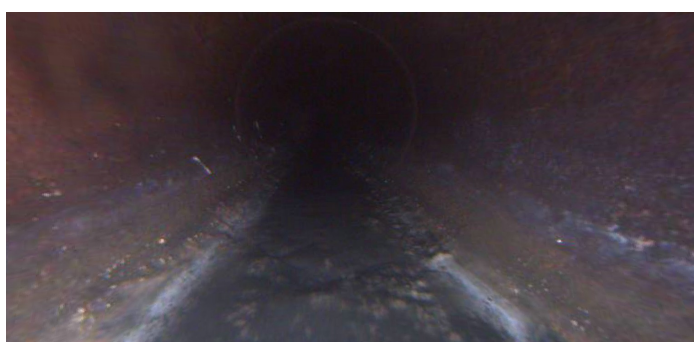
Code: **AMH**  
Description: **Manhole**

Distance (ft): **.0**  
Structural Grade: **0**  
O&M Grade: **0**  
Clock Start/From:  
Clock To:  
1st Value:  
2nd Value:  
Value Percent:  
Continuous Index:  
Within 8" of Joint: **NO**  
Remarks: **M-507-087**

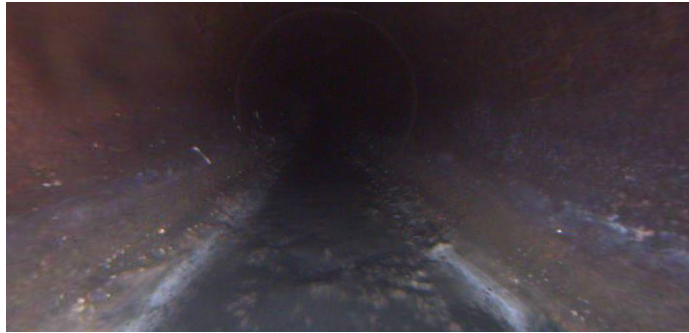
Code:	<b>MWL</b>
Description:	<b>Water Level</b>
Distance (ft):	<b>.0</b>
Structural Grade:	<b>0</b>
O&M Grade:	<b>0</b>
Clock Start/From:	
Clock To:	
1st Value:	
2nd Value:	
Value Percent:	<b>5.000</b>
Continuous Index:	
Within 8" of Joint:	<b>NO</b>
Remarks:

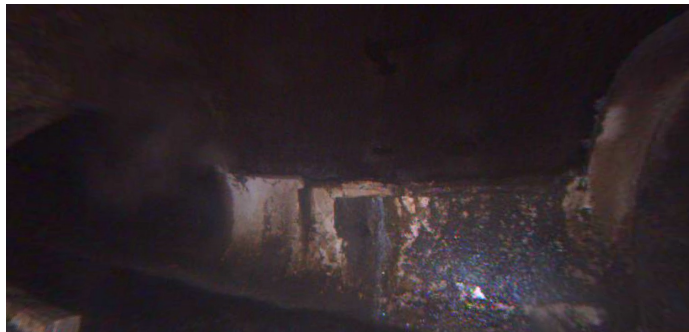
Code:	<b>AMH</b>
Description:	<b>Manhole</b>
Distance (ft):	<b>233.3</b>
Structural Grade:	<b>0</b>
O&M Grade:	<b>0</b>
Clock Start/From:	
Clock To:	
1st Value:	
2nd Value:	
Value Percent:	
Continuous Index:	
Within 8" of Joint:	<b>NO</b>
Remarks:	<b>M-507-040</b>
