Profile/Photo Observation Report

Date:	12/12/2024	Weather:		Coding:	PACP 7.0
Pipe Length (ft):	394.0	Owner:	City of Hobart	Pre Clean:	Heavy Cleaning
P.O.#:	YES502259	Surveyor:	S. Bucklin	PSR:	P-507-084-087
Customer:	City of Hobart	Clean Date:	09/16/2024	Shape:	C

Street:	West 10th Place	Flow Control:	Not Controlled
City:	Hobart, IN	Year Renewed:	
Location:	Local rural streets with light traffic, t	Tape/Media #:	
Purpose:	Sewer System Evaluation Survey (SS	Dia/Height:	8"
Use:	Sanitary Sewage Pipe	Material:	PVC
Drain Area:		Lining:	None
Category:	NA		
Comment:			
Location Details:		Direction of Survey:	Downstream
US MH:	M-507-084	DS MH:	M-507-087
		Total Length Surveyed (ft):	381.6

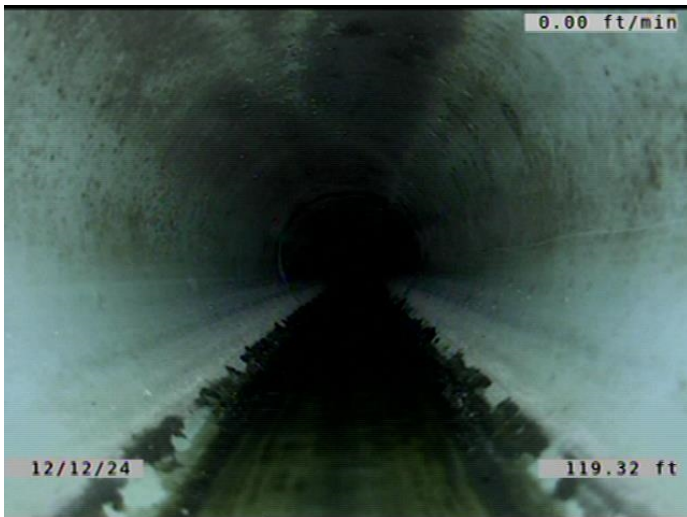
Code:	MWLS
Description:	Miscellaneous Water Level Sag
Distance (ft):	119.3
Structural Grade:	2
O&M Grade:	0
Clock Start/From:	
Clock To:	
1st Value:	
2nd Value:	
Value Percent:	10.000
Continuous Index:	S01
Within 8" of Joint:	NO
Remarks:

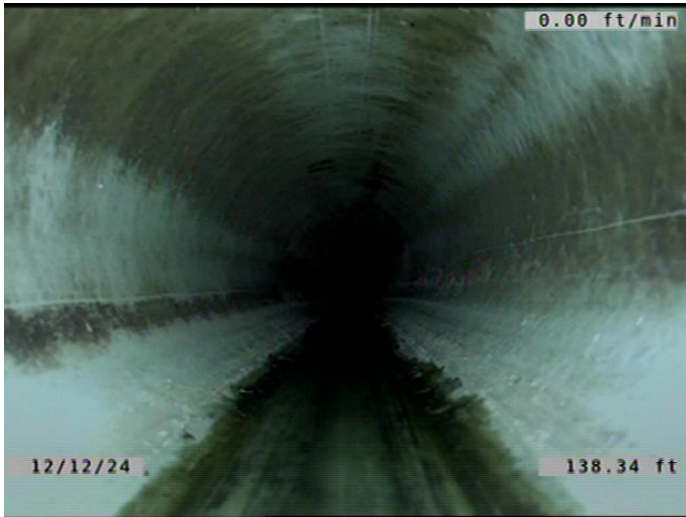
Code: **MWLS**
Description: **Miscellaneous Water Level Sag**

Distance (ft): **138.3**
Structural Grade: **2**
O&M Grade: **0**
Clock Start/From:
Clock To:
1st Value:
2nd Value:
Value Percent: **10.000**
Continuous Index: **F01**
Within 8" of Joint: **NO**
Remarks:

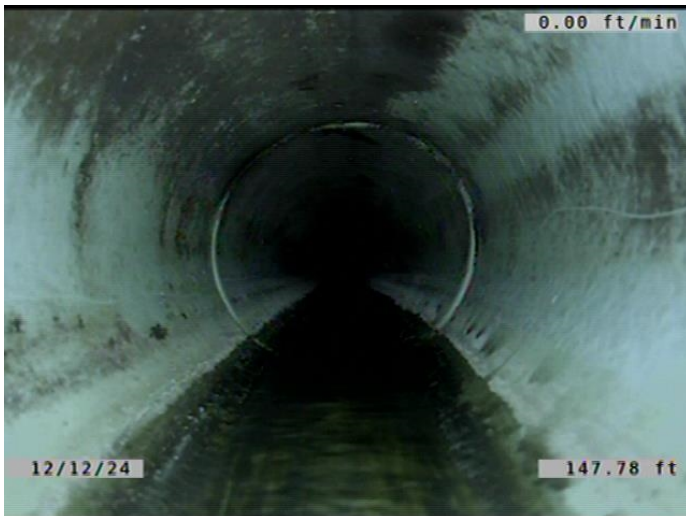
Code: **MWLS**
Description: **Miscellaneous Water Level Sag**

Distance (ft): **147.8**
Structural Grade: **2**
O&M Grade: **0**
Clock Start/From:
Clock To:
1st Value:
2nd Value:
Value Percent: **10.000**
Continuous Index: **S02**
Within 8" of Joint: **NO**
Remarks:

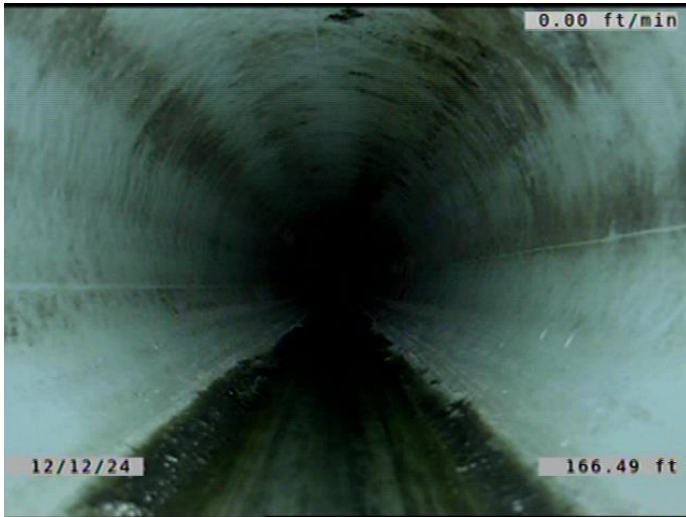
Code: **MWLS**
Description: **Miscellaneous Water Level Sag**

Distance (ft): **166.5**
Structural Grade: **2**
O&M Grade: **0**
Clock Start/From:
Clock To:
1st Value:
2nd Value:
Value Percent: **10.000**
Continuous Index: **F02**
Within 8" of Joint: **NO**
Remarks:

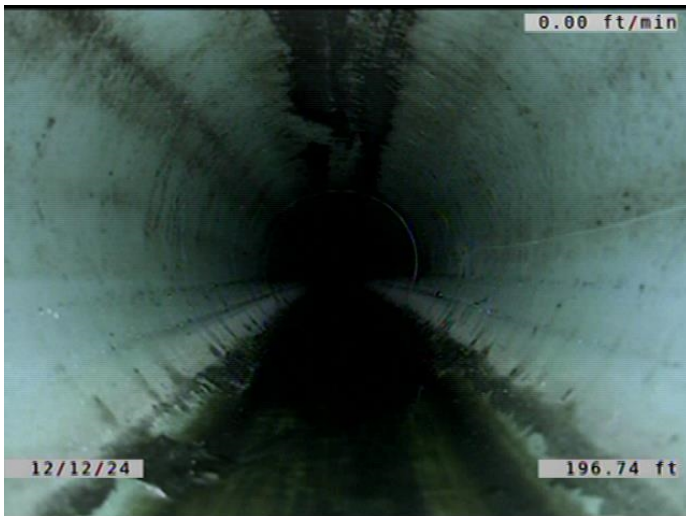
Code: **MWLS**
Description: **Miscellaneous Water Level Sag**

Distance (ft): **196.7**
Structural Grade: **2**
O&M Grade: **0**
Clock Start/From:
Clock To:
1st Value:
2nd Value:
Value Percent: **10.000**
Continuous Index: **S03**
Within 8" of Joint: **NO**
Remarks:

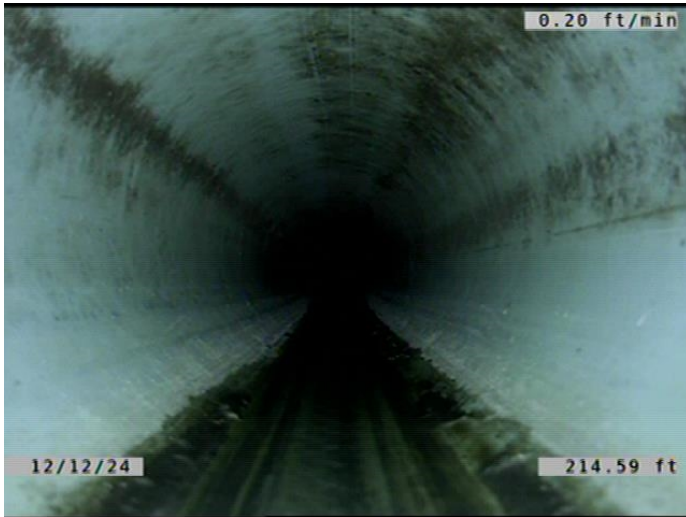
Code: **MWLS**
 Description: **Miscellaneous Water Level Sag**

Distance (ft): **214.6**
 Structural Grade: **2**
 O&M Grade: **0**
 Clock Start/From:
 Clock To:
 1st Value:
 2nd Value:
 Value Percent: **10.000**
 Continuous Index: **F03**
 Within 8" of Joint: **NO**
 Remarks:

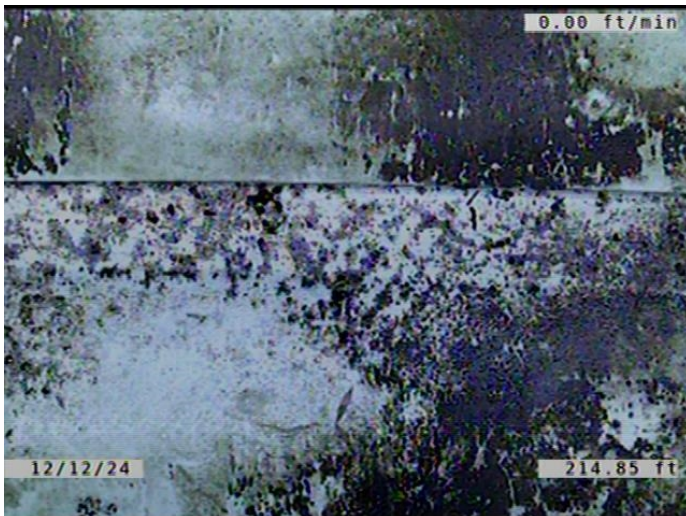
Code: **MGO**
 Description: **Miscellaneous General Observation**

Distance (ft): **214.8**
 Structural Grade: **0**
 O&M Grade: **0**
 Clock Start/From:
 Clock To:
 1st Value:
 2nd Value:
 Value Percent:
 Continuous Index:
 Within 8" of Joint: **NO**
 Remarks: **PIPES/ JOINT NOT PUSHED
 TOGETHER ALL THE WAY WHEN INS**

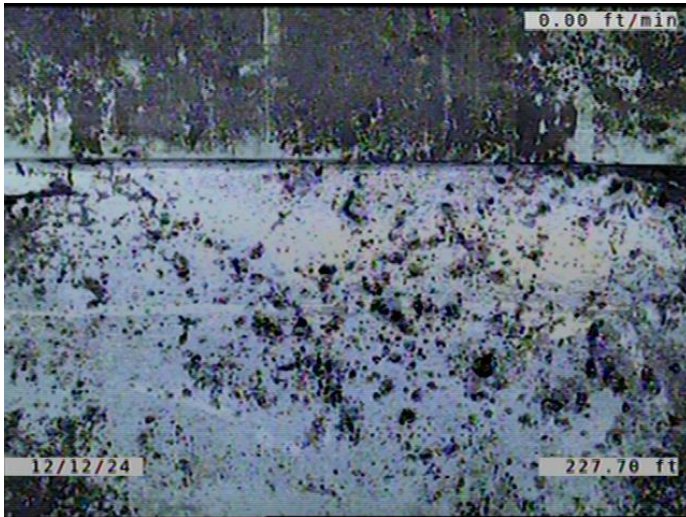
Code: **MGO**
Description: **Miscellaneous General Observation**

Distance (ft): **227.7**
Structural Grade: **0**
O&M Grade: **0**
Clock Start/From:
Clock To:
1st Value:
2nd Value:
Value Percent:
Continuous Index:
Within 8" of Joint: **NO**
Remarks: **PIPES/ JOINT NOT PUSHED
TOGETHER ALL THE WAY WHEN INS**

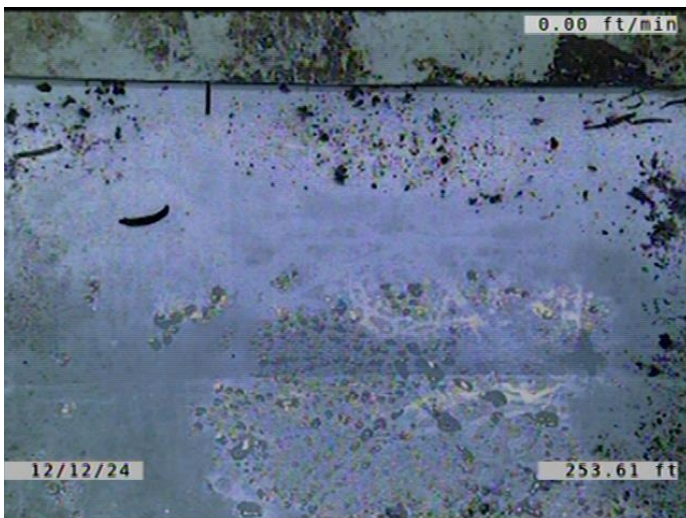
Code: **MGO**
Description: **Miscellaneous General Observation**

Distance (ft): **253.6**
Structural Grade: **0**
O&M Grade: **0**
Clock Start/From:
Clock To:
1st Value:
2nd Value:
Value Percent:
Continuous Index:
Within 8" of Joint: **NO**
Remarks: **PIPES/ JOINT NOT PUSHED
TOGETHER ALL THE WAY WHEN INS**

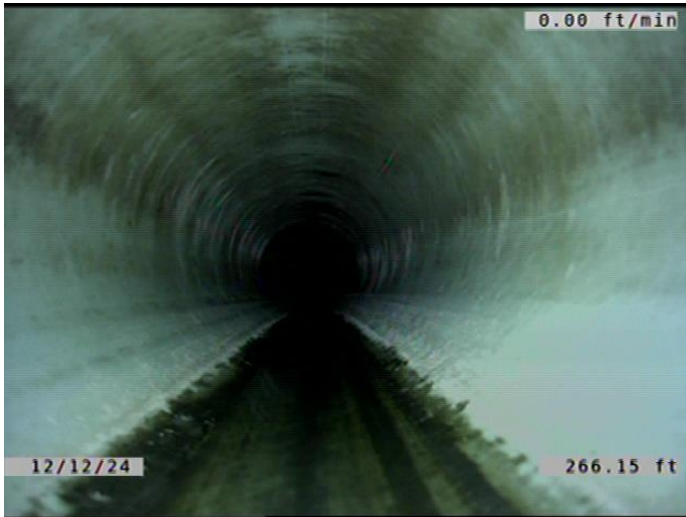
Code: **LL**
Description: **Line Left**

Distance (ft): **266.2**
Structural Grade: **0**
O&M Grade: **1**
Clock Start/From:
Clock To:
1st Value:
2nd Value:
Value Percent: **5.000**
Continuous Index: **S04**
Within 8" of Joint: **NO**
Remarks:

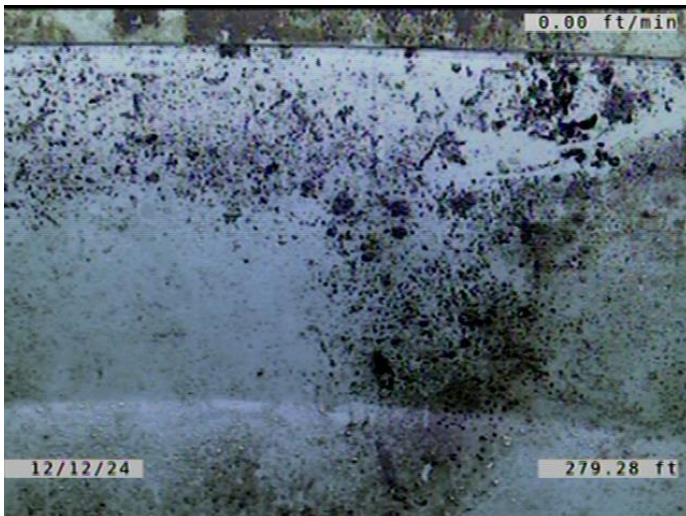
Code: **MGO**
Description: **Miscellaneous General Observation**

Distance (ft): **279.3**
Structural Grade: **0**
O&M Grade: **0**
Clock Start/From:
Clock To:
1st Value:
2nd Value:
Value Percent:
Continuous Index:
Within 8" of Joint: **NO**
Remarks: **PIPES/ JOINT NOT PUSHED
TOGETHER ALL THE WAY WHEN INS**

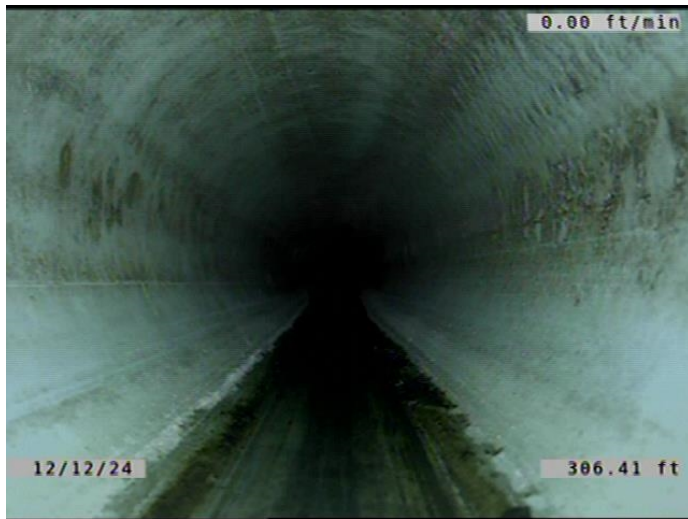
Code: **LL**
Description: **Line Left**

Distance (ft): **306.4**
Structural Grade: **0**
O&M Grade: **1**
Clock Start/From:
Clock To:
1st Value:
2nd Value:
Value Percent: **5.000**
Continuous Index: **F04**
Within 8" of Joint: **NO**
Remarks:

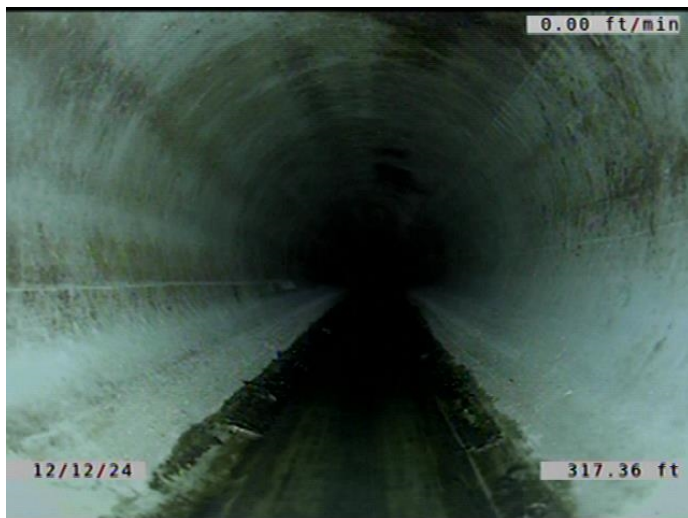
Code: **LR**
Description: **Line Right**

Distance (ft): **317.4**
Structural Grade: **0**
O&M Grade: **1**
Clock Start/From:
Clock To:
1st Value:
2nd Value:
Value Percent: **5.000**
Continuous Index: **S05**
Within 8" of Joint: **NO**
Remarks:

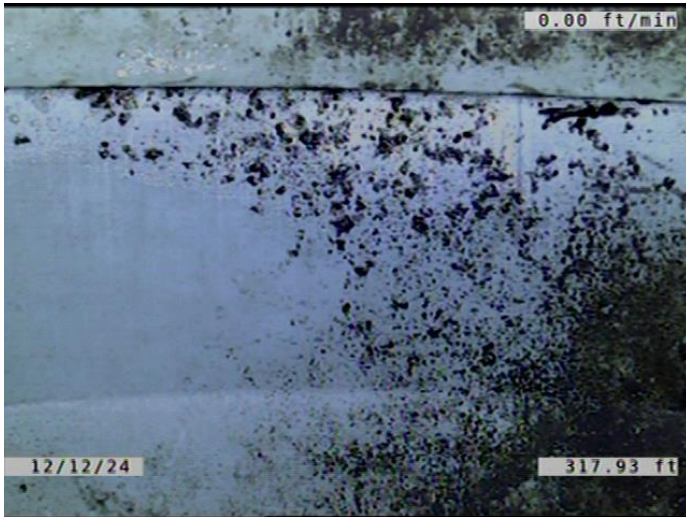
Code: **MGO**
Description: **Miscellaneous General Observation**

Distance (ft): **317.9**
Structural Grade: **0**
O&M Grade: **0**
Clock Start/From:
Clock To:
1st Value:
2nd Value:
Value Percent:
Continuous Index:
Within 8" of Joint: **NO**
Remarks: **PIPES/ JOINT NOT PUSHED
TOGETHER ALL THE WAY WHEN INS**

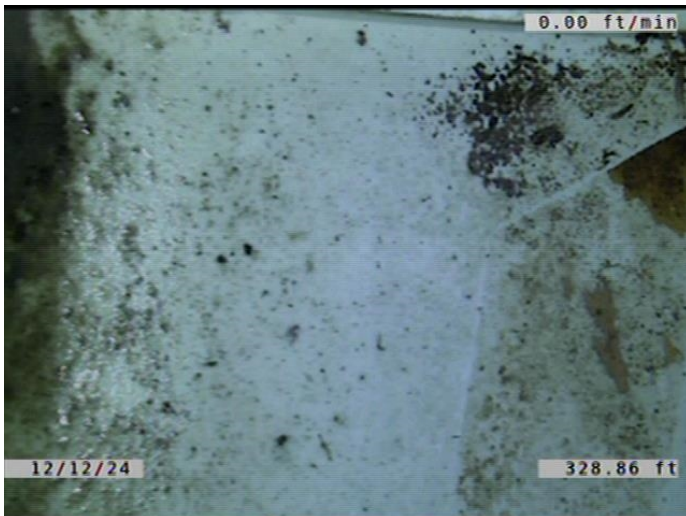
Code: **JAL**
Description: **Joint Angular Large**

Distance (ft): **328.9**
Structural Grade: **4**
O&M Grade: **0**
Clock Start/From:
Clock To:
1st Value:
2nd Value:
Value Percent:
Continuous Index:
Within 8" of Joint: **YES**
Remarks: **PIPES/ JOINT NOT PUSHED
TOGETHER ALL THE WAY WHEN INS**

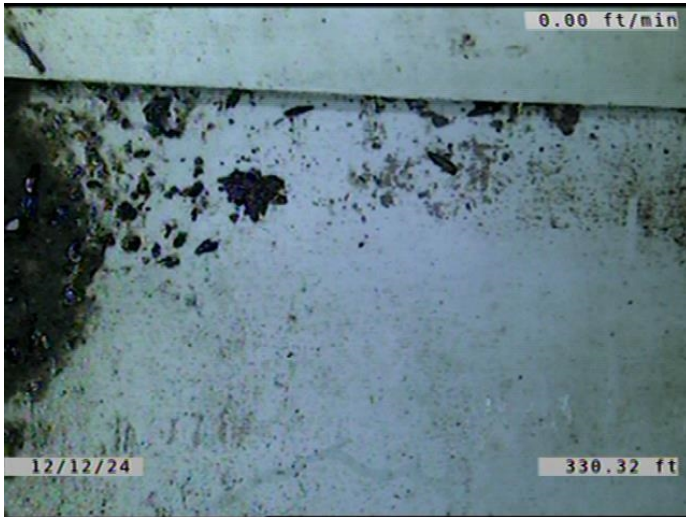
Code:	JAM
Description:	Joint Angular Medium
Distance (ft):	330.3
Structural Grade:	3
O&M Grade:	0
Clock Start/From:	
Clock To:	
1st Value:	
2nd Value:	
Value Percent:	
Continuous Index:	
Within 8" of Joint:	YES
Remarks:	PIPES/ JOINT NOT PUSHED TOGETHER ALL THE WAY WHEN INS

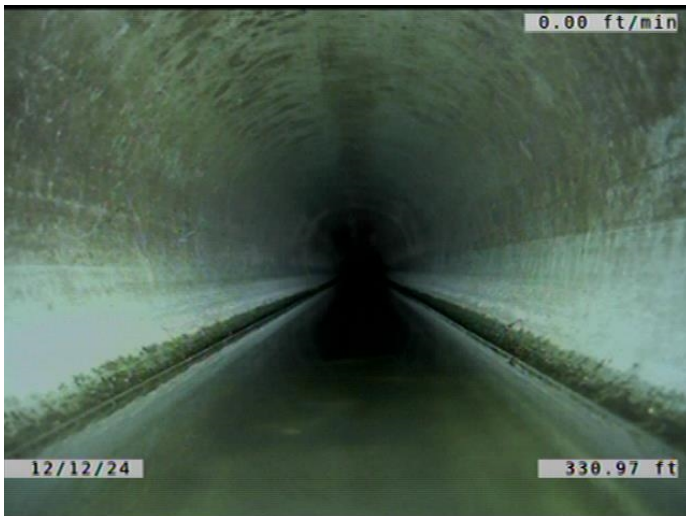
Code:	LR
Description:	Line Right
Distance (ft):	331.0
Structural Grade:	0
O&M Grade:	1
Clock Start/From:	
Clock To:	
1st Value:	
2nd Value:	
Value Percent:	5.000
Continuous Index:	F05
Within 8" of Joint:	NO
Remarks:

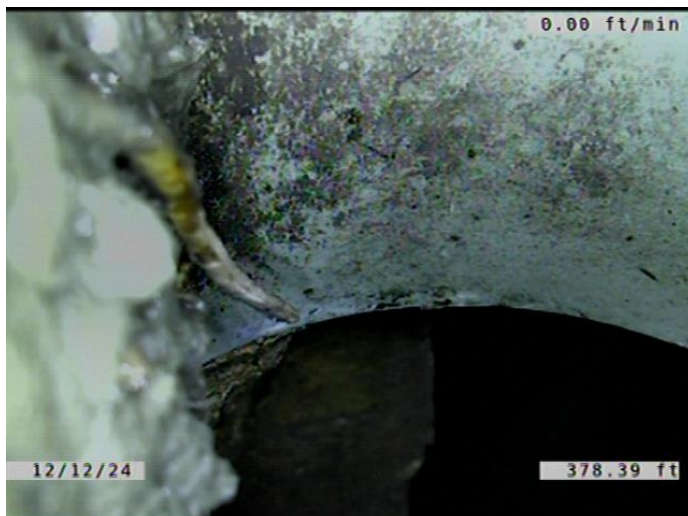
Code: **OBZ**
Description: **Obstruction Other**

Distance (ft): **378.4**
Structural Grade: **0**
O&M Grade: **2**
Clock Start/From: **5**
Clock To: **7**
1st Value:
2nd Value:
Value Percent: **10.000**
Continuous Index:
Within 8" of Joint: **NO**
Remarks: **ROOTS THAT HAVE BEEN CUT FROM THE PIPE.**
