Profile/Photo Observation Report

Date:	10/24/2021	Weather:		Coding:	PACP 6.0
Pipe Length (ft):		Owner:	Hobart, IN	Pre Clean:	Not Known
P.O.#:	1001_1	Surveyor:	M. Pielacha	PSR:	P-507-091-092
Customer:	Hobart, IN	Clean Date:		Shape:	C

Street:	Off Wisconsin Street	Flow Control:	
City:	Hobart, IN	Year Renewed:	
Location:	Sidewalk	Tape/Media #:	1001
Purpose:	Routine Assessment	Dia/Height:	8"
Use:	Sanitary	Material:	PVC
Drain Area:		Lining:

US MH: **M-507-91** DS MH: **M-507-92** Total Length Surveyed (ft): **317.6**

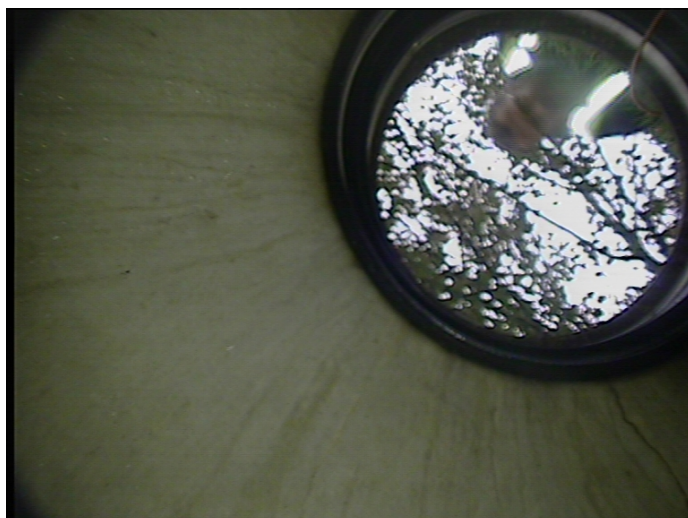
Code: **AMH**
 Description: **Manhole**

Distance (ft): **.0**
 Structural Grade: **0**
 O&M Grade: **0**
 Clock Start/From:
 Clock To:
 1st Value:
 2nd Value:
 Value Percent:
 Continuous Index:
 Within 8" of Joint: **NO**
 Remarks: **M-507-91**

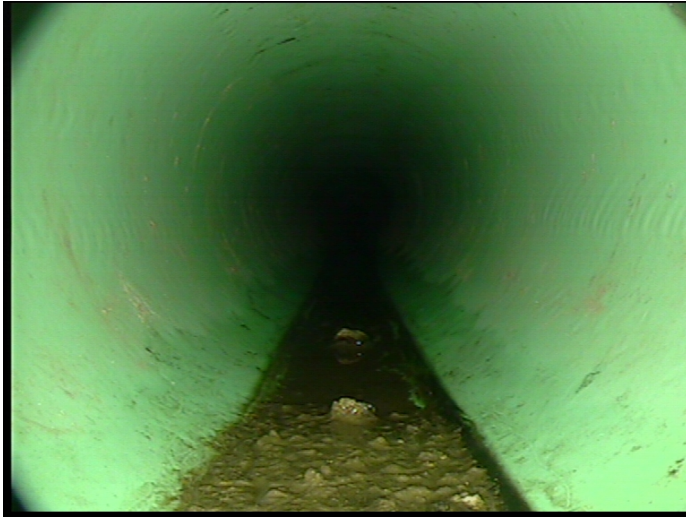
Code: **MWL**
Description: **Water Level**

Distance (ft): **.0**
Structural Grade: **0**
O&M Grade: **0**
Clock Start/From:
Clock To:
1st Value:
2nd Value:
Value Percent: **5.000**
Continuous Index:
Within 8" of Joint: **NO**
Remarks:

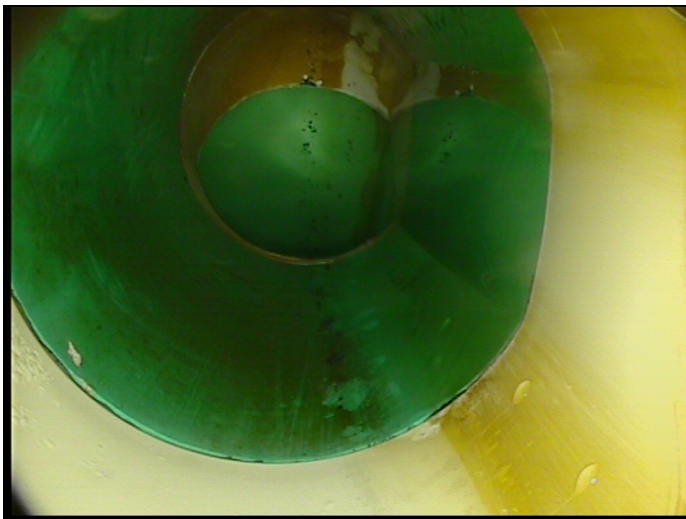
Code: **TFA**
Description: **Tap Factory Active**

Distance (ft): **76.5**
Structural Grade: **0**
O&M Grade: **0**
Clock Start/From: **3**
Clock To:
1st Value: **4.000**
2nd Value:
Value Percent:
Continuous Index:
Within 8" of Joint: **NO**
Remarks:

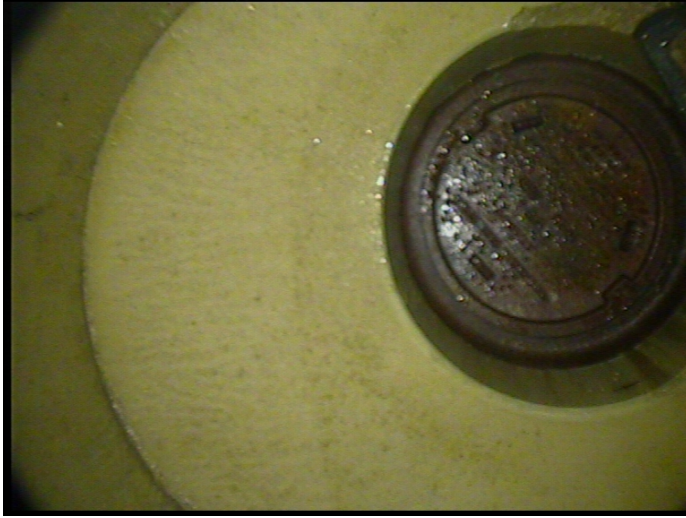
Code:	AMH
Description:	Manhole
Distance (ft):	317.6
Structural Grade:	0
O&M Grade:	0
Clock Start/From:	
Clock To:	
1st Value:	
2nd Value:	
Value Percent:	
Continuous Index:	
Within 8" of Joint:	NO
Remarks:	M-507-92
