## Profile/Photo Observation Report

Date:	<b>10/23/2021</b>	Weather:		Coding:	<b>PACP 6.0</b>
Pipe Length (ft):		Owner:	<b>Hobart, IN</b>	Pre Clean:	<b>Not Known</b>
P.O.#:	<b>985_1</b>	Surveyor:	<b>M. Pielacha</b>	PSR:	<b>P-507-092-001</b>
Customer:	<b>Hobart, IN</b>	Clean Date:		Shape:	<b>C</b>

Street:	<b>14th Street</b>	Flow Control:	
City:	<b>Hobart, IN</b>	Year Renewed:	
Location:	<b>Light Highway</b>	Tape/Media #:	<b>985</b>
Purpose:	<b>Routine Assessment</b>	Dia/Height:	<b>8"</b>
Use:	<b>Sanitary</b>	Material:	<b>PVC</b>
Drain Area:		Lining:	
Category:	<b>NA</b>		
Comment:

Location Details:		Direction of Survey:	<b>Upstream</b>
US MH:	<b>M-507-92</b>	DS MH:	<b>M-508-1</b>
		Total Length Surveyed (ft):	<b>65.0</b>

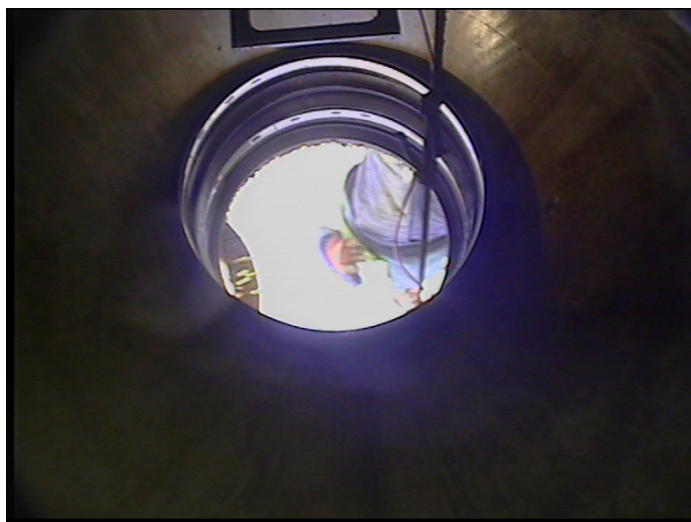
Code: **AMH**  
Description: **Manhole**

Distance (ft): **.0**  
Structural Grade: **0**  
O&M Grade: **0**  
Clock Start/From:  
Clock To:  
1st Value:  
2nd Value:  
Value Percent:  
Continuous Index:  
Within 8" of Joint: **NO**  
Remarks: **M-508-1**

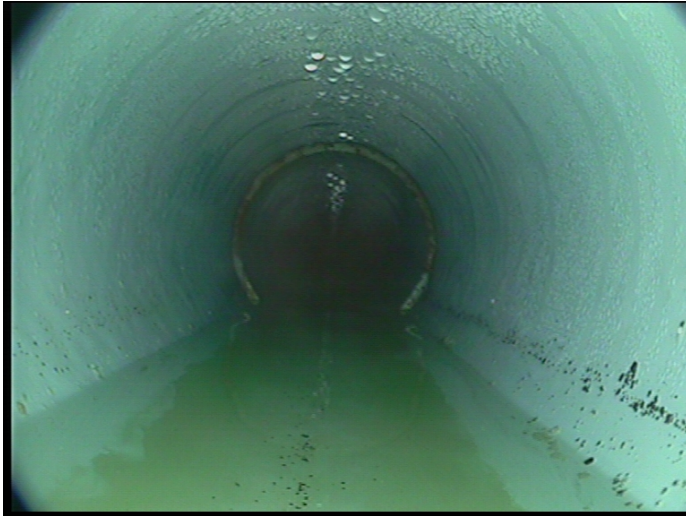
Code:	<b>MWL</b>
Description:	<b>Water Level</b>
Distance (ft):	<b>.0</b>
Structural Grade:	<b>0</b>
O&M Grade:	<b>0</b>
Clock Start/From:	
Clock To:	
1st Value:	
2nd Value:	
Value Percent:	<b>5.000</b>
Continuous Index:	
Within 8" of Joint:	<b>NO</b>
Remarks:

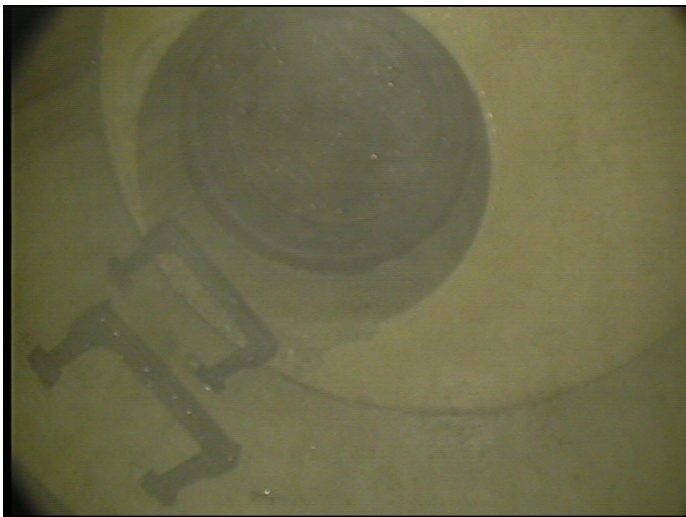
Code:	<b>AMH</b>
Description:	<b>Manhole</b>
Distance (ft):	<b>65.0</b>
Structural Grade:	<b>0</b>
O&M Grade:	<b>0</b>
Clock Start/From:	
Clock To:	
1st Value:	
2nd Value:	
Value Percent:	
Continuous Index:	
Within 8" of Joint:	<b>NO</b>
Remarks:	<b>M-507-92</b>
