## Profile/Photo Observation Report

Date:	<b>10/23/2021</b>	Weather:		Coding:	<b>PACP 6.0</b>
Pipe Length (ft):		Owner:	<b>Hobart, IN</b>	Pre Clean:	<b>Not Known</b>
P.O.#:	<b>986_1</b>	Surveyor:	<b>M. Pielacha</b>	PSR:	<b>P-507-093-094</b>
Customer:	<b>Hobart, IN</b>	Clean Date:		Shape:	<b>C</b>

Location Details:		Direction of Survey:	<b>Upstream</b>
US MH:	<b>M-507-94</b>	DS MH:	<b>M-507-93</b>
		Total Length Surveyed (ft):	<b>129.5</b>

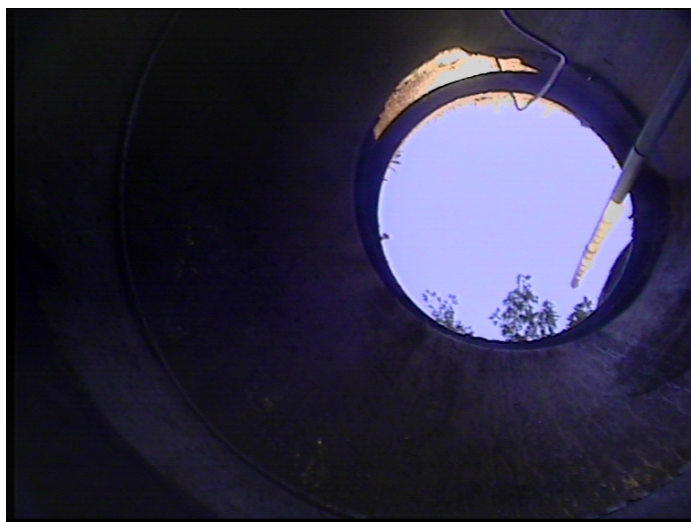
Code: **AMH**  
Description: **Manhole**

Distance (ft): **.0**  
Structural Grade: **0**  
O&M Grade: **0**  
Clock Start/From:  
Clock To:  
1st Value:  
2nd Value:  
Value Percent:  
Continuous Index:  
Within 8" of Joint: **NO**  
Remarks: **M-507-93**

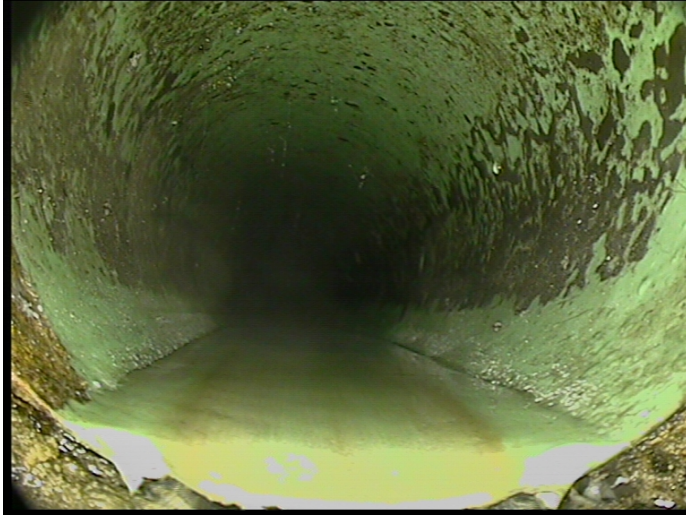
Code: **MWL**  
Description: **Water Level**

Distance (ft): **.0**  
Structural Grade: **0**  
O&M Grade: **0**  
Clock Start/From:  
Clock To:  
1st Value:  
2nd Value:  
Value Percent: **5.000**  
Continuous Index:  
Within 8" of Joint: **NO**  
Remarks:

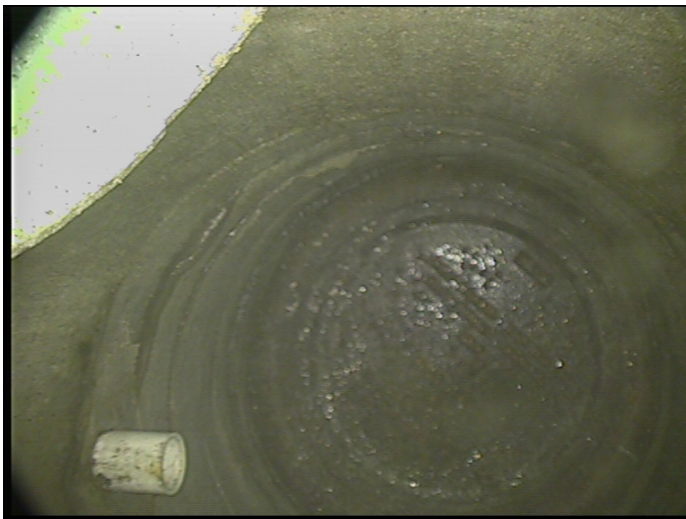
Code: **AMH**  
Description: **Manhole**

Distance (ft): **129.5**  
Structural Grade: **0**  
O&M Grade: **0**  
Clock Start/From:  
Clock To:  
1st Value:  
2nd Value:  
Value Percent:  
Continuous Index:  
Within 8" of Joint: **NO**  
Remarks: **M-507-94**
