Profile/Photo Observation Report

Date:	04/12/2018	Weather:		Coding:	PACP 6.0
Pipe Length (ft):	122.7	Owner:	NA	Pre Clean:	No Pre-Cleaning
P.O.#:		Surveyor:	Jen Costello	PSR:	P-506-038-LS027
Customer:		Clean Date:	01/01/1900	Shape:	C

Street:	W 10TH ST	Flow Control:	Not Controlled
City:	Hobart, IN	Year Renewed:	
Location:	Yard	Tape/Media #:	
Purpose:	Routine Assessment	Dia/Height:	8"
Use:	Sanitary	Material:	PVC
Drain Area:	NA	Lining:	
Category:	NA		
Comment:	Flow direction is marked wrong.

Location Details:		Direction of Survey:	Upstream
US MH:	M-507-096	DS MH:	M-506-038
		Total Length Surveyed (ft):	121.4

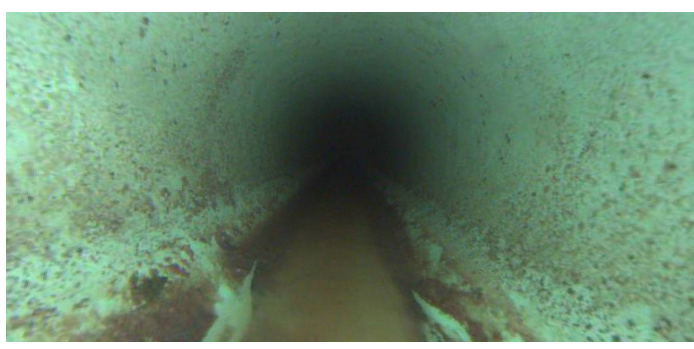
Code: **AMH**
Description: **Manhole**

Distance (ft): **.0**
Structural Grade: **0**
O&M Grade: **0**
Clock Start/From:
Clock To:
1st Value:
2nd Value:
Value Percent:
Continuous Index:
Within 8" of Joint: **NO**
Remarks: **M-506-038**

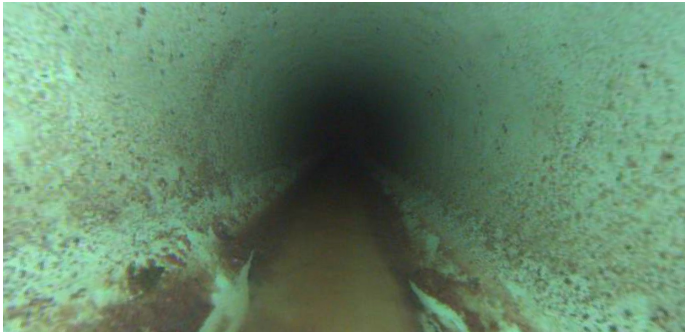
Code:	MWL
Description:	Water Level

Distance (ft):	.0
Structural Grade:	0
O&M Grade:	0
Clock Start/From:	
Clock To:	
1st Value:	
2nd Value:	
Value Percent:	5.000
Continuous Index:	
Within 8" of Joint:	NO
Remarks:
