Profile/Photo Observation Report

Date:	04/12/2018	Weather:		Coding:	PACP 6.0
Pipe Length (ft):	293.7	Owner:	NA	Pre Clean:	No Pre-Cleaning
P.O.#:		Surveyor:	Jen Costello	PSR:	P-507-095-096
Customer:		Clean Date:	01/01/1900	Shape:	C

Street:	METZ CT	Flow Control:	Not Controlled
City:	Hobart, IN	Year Renewed:	
Location:	Yard	Tape/Media #:	
Purpose:	Routine Assessment	Dia/Height:	8"
Use:	Sanitary	Material:	PVC
Drain Area:	NA	Lining:	
Category:	NA		
Comment:	Flow direction is marked wrong.		
Location Details:		Direction of Survey:	Upstream
US MH:	M-507-096	DS MH:	M-507-095
		Total Length Surveyed (ft):	286.4

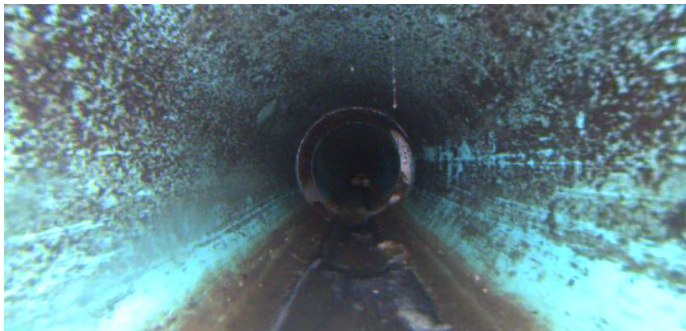
Code: **AMH**
Description: **Manhole**

Distance (ft): **.0**
Structural Grade: **0**
O&M Grade: **0**
Clock Start/From:
Clock To:
1st Value:
2nd Value:
Value Percent:
Continuous Index:
Within 8" of Joint: **NO**
Remarks: **M-507-095**

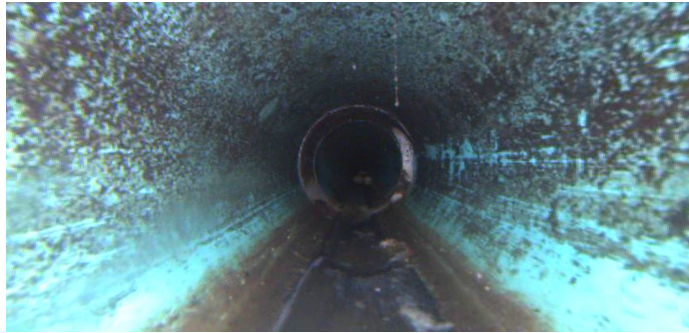
Code: **MWL**
Description: **Water Level**

Distance (ft): **.0**
Structural Grade: **0**
O&M Grade: **0**
Clock Start/From:
Clock To:
1st Value:
2nd Value:
Value Percent: **5.000**
Continuous Index:
Within 8" of Joint: **NO**
Remarks:

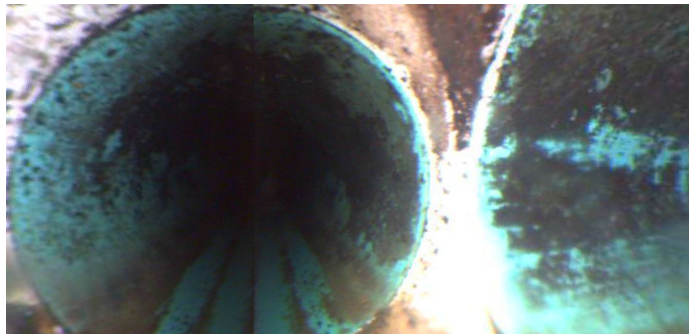
Code: **TF**
Description: **Tap Factory**

Distance (ft): **2.9**
Structural Grade: **0**
O&M Grade: **0**
Clock Start/From: **3**
Clock To:
1st Value: **4.000**
2nd Value:
Value Percent:
Continuous Index:
Within 8" of Joint:
Remarks:

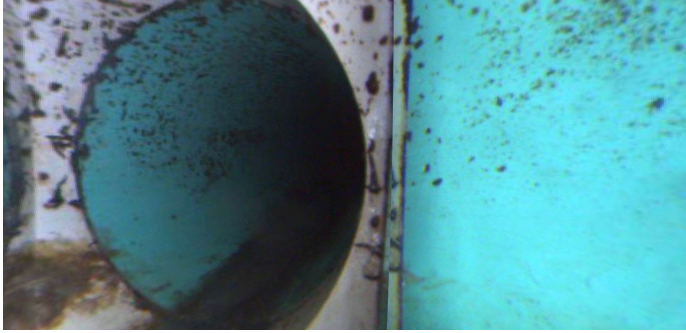
Code: **TF**
Description: **Tap Factory**

Distance (ft): **45.8**
Structural Grade: **0**
O&M Grade: **0**
Clock Start/From: **3**
Clock To:
1st Value: **4.000**
2nd Value:
Value Percent:
Continuous Index:
Within 8" of Joint:
Remarks:

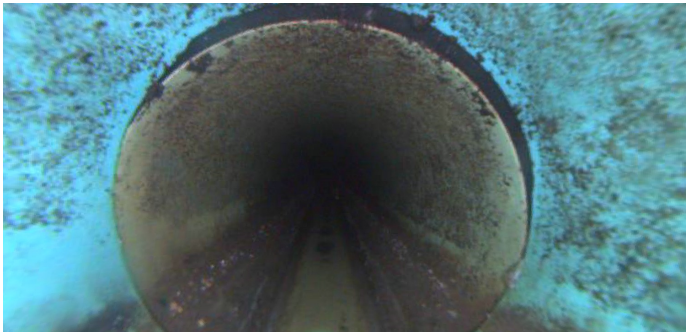
Code: **JOM**
Description: **Joint Offset Medium**

Distance (ft): **89.1**
Structural Grade: **1**
O&M Grade: **0**
Clock Start/From:
Clock To:
1st Value:
2nd Value:
Value Percent:
Continuous Index:
Within 8" of Joint: **NO**
Remarks:

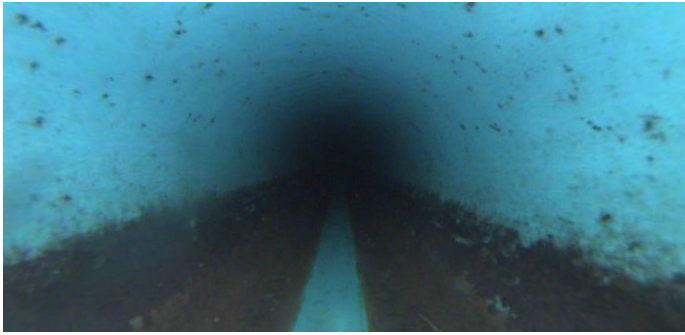
Code: **DAGS**
Description: **Deposits Attached Grease**

Distance (ft): **104.3**
Structural Grade: **0**
O&M Grade: **2**
Clock Start/From: **4**
Clock To: **8**
1st Value:
2nd Value:
Value Percent: **5.000**
Continuous Index: **S01**
Within 8" of Joint: **NO**
Remarks:

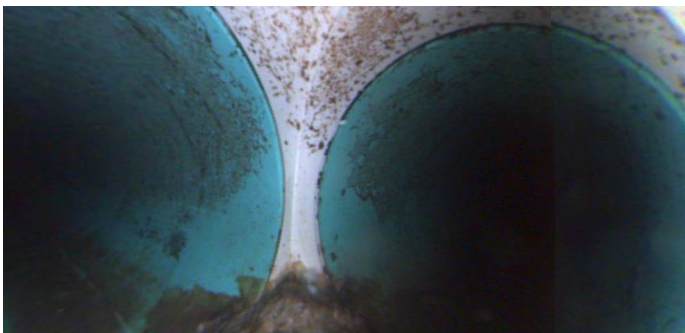
Code: **TFA**
Description: **Tap Factory Active**

Distance (ft): **223.0**
Structural Grade: **0**
O&M Grade: **0**
Clock Start/From: **3**
Clock To:
1st Value: **4.000**
2nd Value:
Value Percent:
Continuous Index:
Within 8" of Joint:
Remarks:

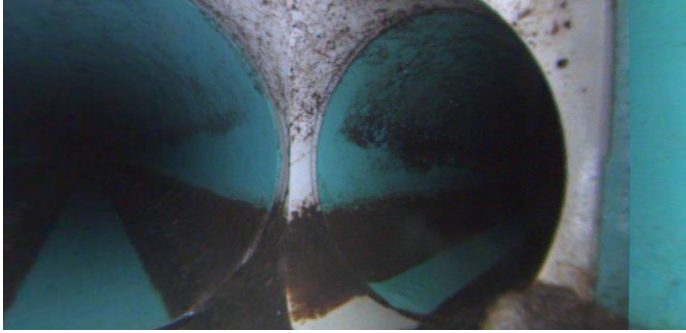
Code: **TF**
Description: **Tap Factory**

Distance (ft): **273.7**
Structural Grade: **0**
O&M Grade: **0**
Clock Start/From: **3**
Clock To:
1st Value: **4.000**
2nd Value:
Value Percent:
Continuous Index:
Within 8" of Joint:
Remarks:

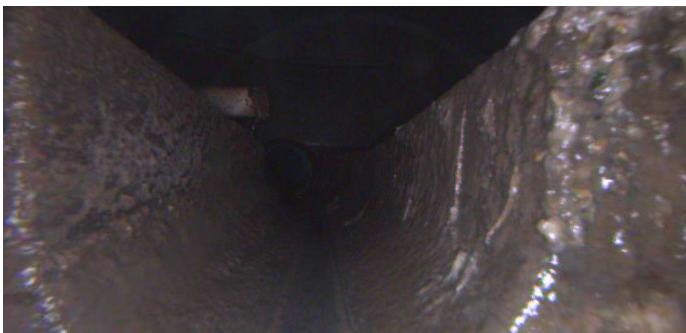
Code: **DAGS**
Description: **Deposits Attached Grease**

Distance (ft): **284.5**
Structural Grade: **0**
O&M Grade: **2**
Clock Start/From: **4**
Clock To: **8**
1st Value:
2nd Value:
Value Percent: **5.000**
Continuous Index: **F01**
Within 8" of Joint: **NO**
Remarks:

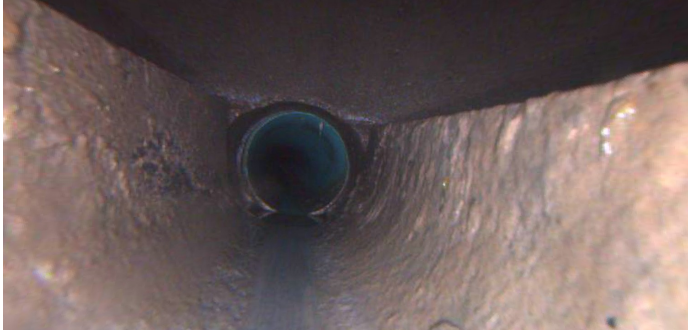
Code:	AMH
Description:	Manhole
Distance (ft):	286.4
Structural Grade:	0
O&M Grade:	0
Clock Start/From:	
Clock To:	
1st Value:	
2nd Value:	
Value Percent:	
Continuous Index:	
Within 8" of Joint:	NO
Remarks:	M-507-096
