## Profile/Photo Observation Report

Street:	<b>FOXCROFT STREET</b>	Flow Control:	<b>Not Controlled</b>
City:	<b>Hobart, IN</b>	Year Renewed:	
Location:	<b>Light Highway</b>	Tape/Media #:	
Purpose:	<b>Routine Assessment</b>	Dia/Height:	<b>8"</b>
Use:	<b>Sanitary</b>	Material:	<b>PVC</b>
Drain Area:	<b>NA</b>	Lining:	
Category:	<b>NA</b>		
Comment:	<b>Flow direction wrong</b>

Location Details:		Direction of Survey:	<b>Downstream</b>
US MH:	<b>M-507-099</b>	DS MH:	<b>M-507-098</b>
		Total Length Surveyed (ft):	<b>204.8</b>

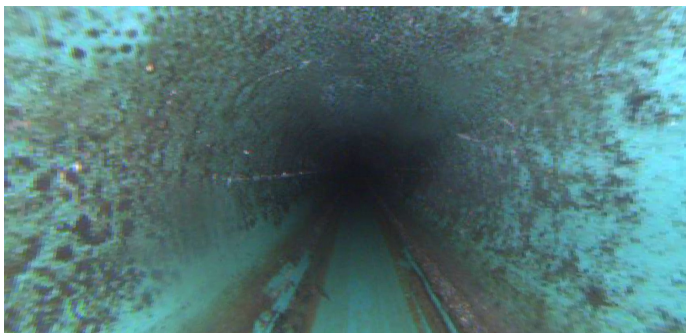
Code: **AMH**  
Description: **Manhole**

Distance (ft): **.0**  
Structural Grade: **0**  
O&M Grade: **0**  
Clock Start/From:  
Clock To:  
1st Value:  
2nd Value:  
Value Percent:  
Continuous Index:  
Within 8" of Joint: **NO**  
Remarks: **M-507-099**

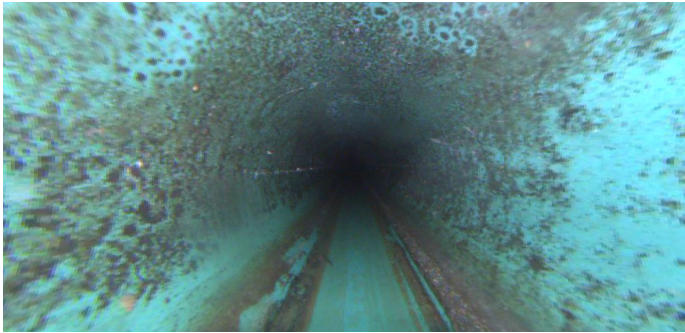
Code: **MWL**  
Description: **Water Level**

Distance (ft): **.0**  
Structural Grade: **0**  
O&M Grade: **0**  
Clock Start/From:  
Clock To:  
1st Value:  
2nd Value:  
Value Percent: **5.000**  
Continuous Index:  
Within 8" of Joint: **NO**  
Remarks:

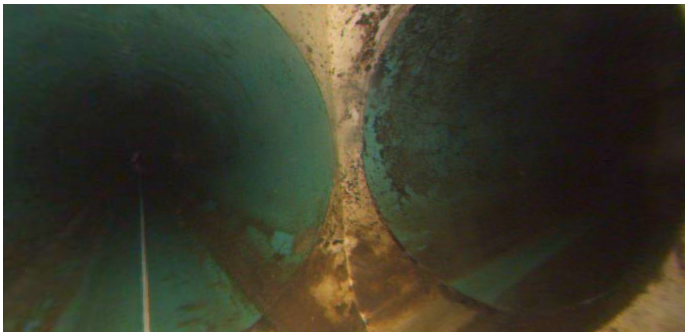
Code: **TFA**  
Description: **Tap Factory Active**

Distance (ft): **19.3**  
Structural Grade: **0**  
O&M Grade: **0**  
Clock Start/From: **9**  
Clock To:  
1st Value: **4.000**  
2nd Value:  
Value Percent:  
Continuous Index:  
Within 8" of Joint:  
Remarks:

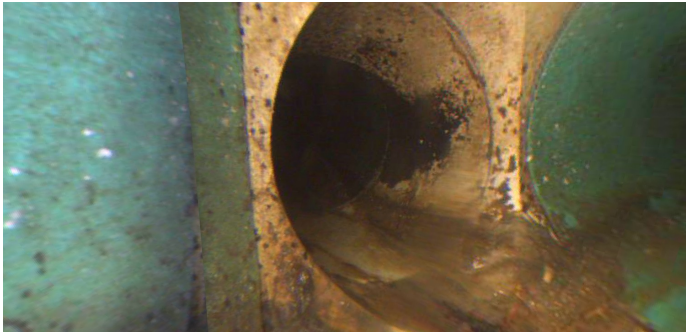
Code: **TFA**  
Description: **Tap Factory Active**

Distance (ft): **22.2**  
Structural Grade: **0**  
O&M Grade: **0**  
Clock Start/From: **3**  
Clock To:  
1st Value: **4.000**  
2nd Value:  
Value Percent:  
Continuous Index:  
Within 8" of Joint:  
Remarks:

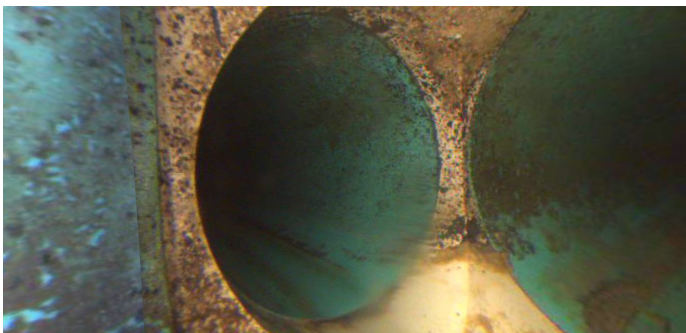
Code: **TF**  
Description: **Tap Factory**

Distance (ft): **133.9**  
Structural Grade: **0**  
O&M Grade: **0**  
Clock Start/From: **3**  
Clock To:  
1st Value: **4.000**  
2nd Value:  
Value Percent:  
Continuous Index:  
Within 8" of Joint:  
Remarks:

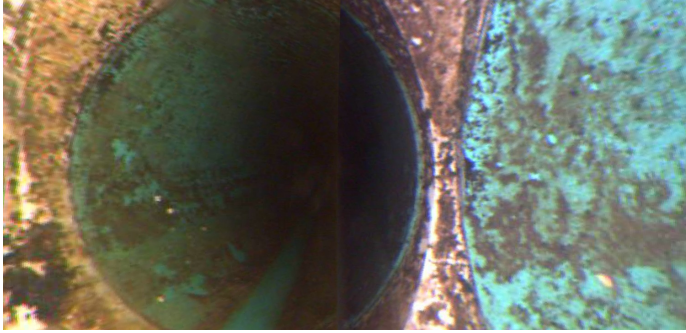
Code: **TF**  
Description: **Tap Factory**

Distance (ft): **135.4**  
Structural Grade: **0**  
O&M Grade: **0**  
Clock Start/From: **9**  
Clock To:  
1st Value: **4.000**  
2nd Value:  
Value Percent:  
Continuous Index:  
Within 8" of Joint:  
Remarks:

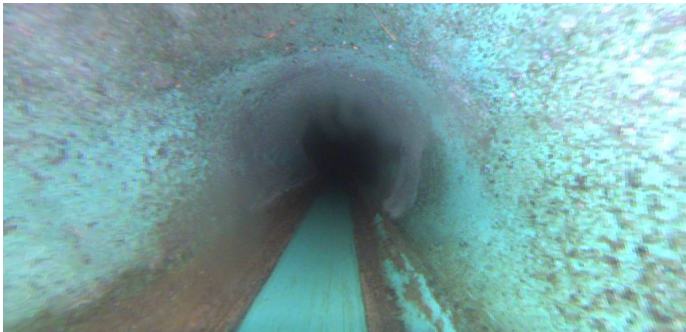
Code: **AMH**  
Description: **Manhole**

Distance (ft): **204.8**  
Structural Grade: **0**  
O&M Grade: **0**  
Clock Start/From:  
Clock To:  
1st Value:  
2nd Value:  
Value Percent:  
Continuous Index:  
Within 8" of Joint: **NO**  
Remarks: **M-507-098**
