Profile/Photo Observation Report

Date:	03/28/2018	Weather:		Coding:	PACP 6.0
Pipe Length (ft):	418.7	Owner:	NA	Pre Clean:	No Pre-Cleaning
P.O.#:		Surveyor:	Selasie Honu	PSR:	P-407-013-100
Customer:		Clean Date:	01/01/1900	Shape:	C

Street:	OFF S DECATUR ST	Flow Control:	Not Controlled
City:	Hobart, IN	Year Renewed:	
Location:	Light Highway	Tape/Media #:	
Purpose:	Routine Assessment	Dia/Height:	12"
Use:	Sanitary	Material:	PVC
Drain Area:	NA	Lining:	
Category:	NA		
Comment:	P_C at 141 ft nothing visible .Flow direction wrong		
Location Details:		Direction of Survey:	Upstream
US MH:	M-507-100	DS MH:	M-407-013
		Total Length Surveyed (ft):	142.1

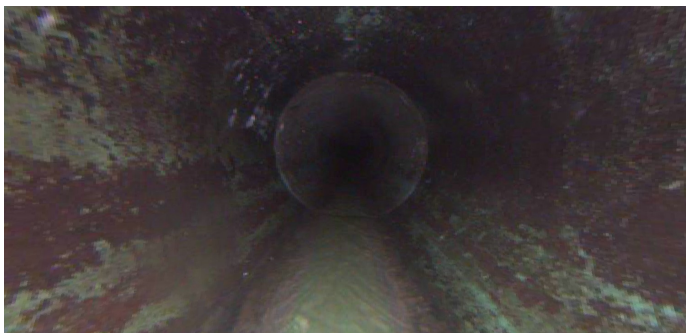
Code: **AMH**
Description: **Manhole**

Distance (ft): **.0**
Structural Grade: **0**
O&M Grade: **0**
Clock Start/From:
Clock To:
1st Value:
2nd Value:
Value Percent:
Continuous Index:
Within 8" of Joint: **NO**
Remarks: **M-407-013**

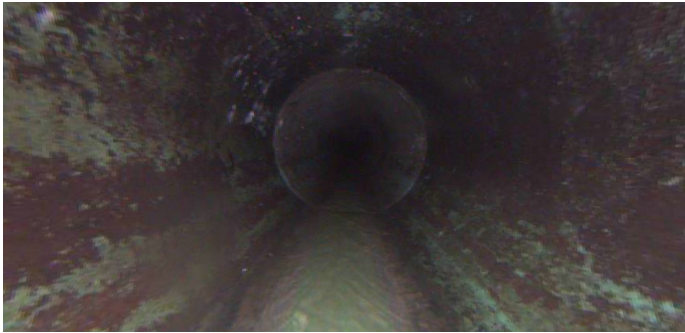
Code:	MWL
Description:	Water Level

Distance (ft):	.0
Structural Grade:	0
O&M Grade:	0
Clock Start/From:	
Clock To:	
1st Value:	
2nd Value:	
Value Percent:	5.000
Continuous Index:	
Within 8" of Joint:	NO
Remarks:

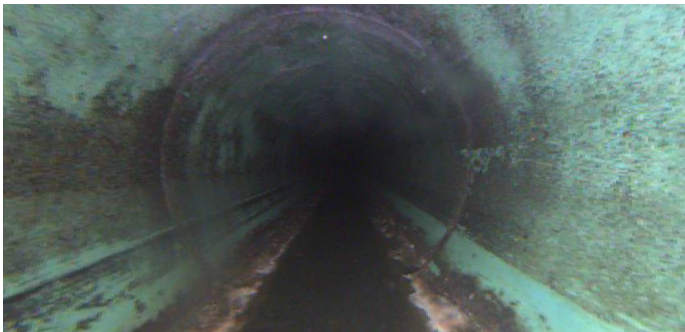
Code:	MSA
Description:	Abandoned Survey

Distance (ft):	142.1
Structural Grade:	0
O&M Grade:	0
Clock Start/From:	
Clock To:	
1st Value:	
2nd Value:	
Value Percent:	
Continuous Index:	
Within 8" of Joint:	NO
Remarks:	camera stopped
