## Profile/Photo Observation Report

Date:	<b>03/28/2018</b>	Weather:		Coding:	<b>PACP 6.0</b>
Pipe Length (ft):	<b>418.7</b>	Owner:	<b>NA</b>	Pre Clean:	<b>No Pre-Cleaning</b>
P.O.#:		Surveyor:	<b>JUSTIN GONZALES</b>	PSR:	<b>P-407-013-100</b>
Customer:		Clean Date:	<b>01/01/1900</b>	Shape:	<b>C</b>

Street:	<b>OFF S DECATUR ST</b>	Flow Control:	<b>Not Controlled</b>
City:	<b>Hobart, IN</b>	Year Renewed:	
Location:	<b>Light Highway</b>	Tape/Media #:	
Purpose:	<b>Routine Assessment</b>	Dia/Height:	<b>12"</b>
Use:	<b>Sanitary</b>	Material:	<b>PVC</b>
Drain Area:	<b>NA</b>	Lining:	
Category:	<b>NA</b>		
Comment:	<b>P_C at 390 ft nothing visible . Flow direction wrong</b>		
Location Details:		Direction of Survey:	<b>Downstream</b>
US MH:	<b>M-507-100</b>	DS MH:	<b>M-407-013</b>
		Total Length Surveyed (ft):	<b>391.4</b>

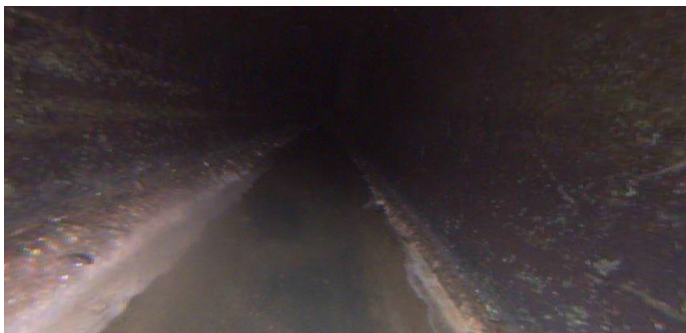
Code: **AMH**  
Description: **Manhole**

Distance (ft): **.0**  
Structural Grade: **0**  
O&M Grade: **0**  
Clock Start/From:  
Clock To:  
1st Value:  
2nd Value:  
Value Percent:  
Continuous Index:  
Within 8" of Joint: **NO**  
Remarks: **M-507-100**

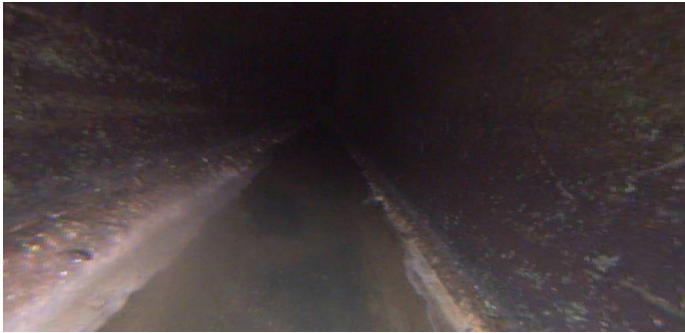
Code:	<b>MWL</b>
Description:	<b>Water Level</b>

Distance (ft):	<b>.0</b>
Structural Grade:	<b>0</b>
O&M Grade:	<b>0</b>
Clock Start/From:	
Clock To:	
1st Value:	
2nd Value:	
Value Percent:	<b>5.000</b>
Continuous Index:	
Within 8" of Joint:	<b>NO</b>
Remarks:

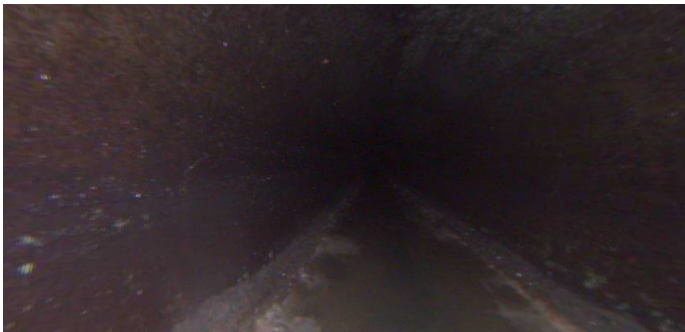
Code:	<b>DAZ</b>
Description:	<b>Deposits Attached Other</b>

Distance (ft):	<b>5.9</b>
Structural Grade:	<b>0</b>
O&M Grade:	<b>2</b>
Clock Start/From:	<b>7</b>
Clock To:	<b>5</b>
1st Value:	
2nd Value:	
Value Percent:	<b>5.000</b>
Continuous Index:	<b>S01</b>
Within 8" of Joint:	<b>YES</b>
Remarks:

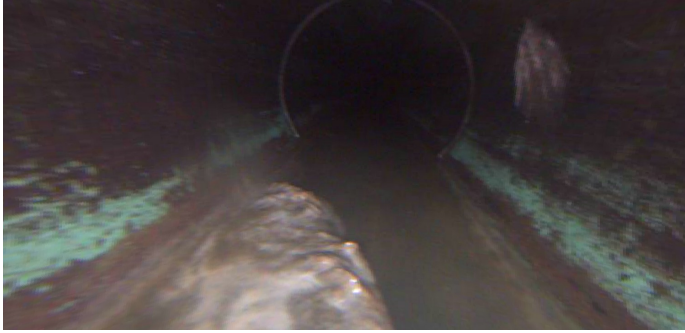
Code: **MGO**  
Description: **General Observation**

Distance (ft): **99.6**  
Structural Grade: **0**  
O&M Grade: **0**  
Clock Start/From:  
Clock To:  
1st Value:  
2nd Value:  
Value Percent:  
Continuous Index:  
Within 8" of Joint: **NO**  
Remarks: **TOILET TISSUE**

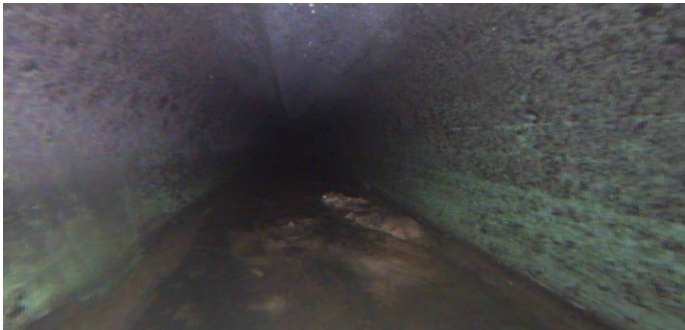
Code: **MGO**  
Description: **General Observation**

Distance (ft): **282.3**  
Structural Grade: **0**  
O&M Grade: **0**  
Clock Start/From:  
Clock To:  
1st Value:  
2nd Value:  
Value Percent:  
Continuous Index:  
Within 8" of Joint: **NO**  
Remarks: **TOILET TISSUE**

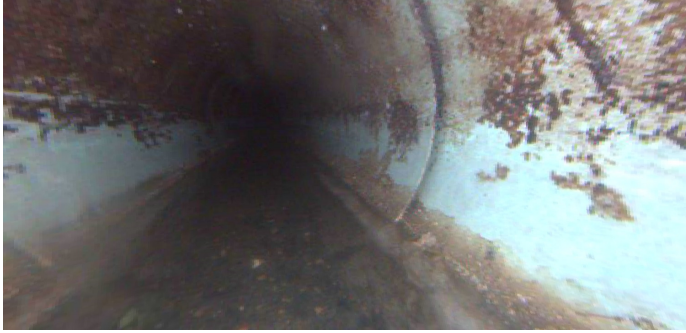
Code: **MSA**  
Description: **Abandoned Survey**

Distance (ft): **391.4**  
Structural Grade: **0**  
O&M Grade: **0**  
Clock Start/From:  
Clock To:  
1st Value:  
2nd Value:  
Value Percent:  
Continuous Index:  
Within 8" of Joint: **NO**  
Remarks: **ROBOT HAS STOPPED**

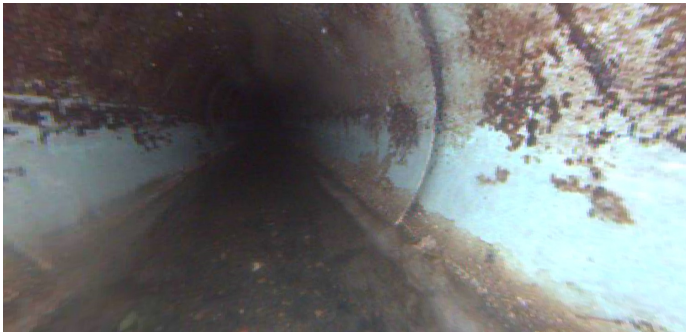
Code: **DAZ**  
Description: **Deposits Attached Other**

Distance (ft): **391.4**  
Structural Grade: **0**  
O&M Grade: **2**  
Clock Start/From: **7**  
Clock To: **5**  
1st Value:  
2nd Value:  
Value Percent: **5.000**  
Continuous Index: **F01**  
Within 8" of Joint: **YES**  
Remarks:
