Profile/Photo Observation Report

Street:	FOXCROFT STREET	Flow Control:	Not Controlled
City:	Hobart, IN	Year Renewed:	
Location:	Light Highway	Tape/Media #:	
Purpose:	Routine Assessment	Dia/Height:	12"
Use:	Sanitary	Material:	PVC
Drain Area:	NA	Lining:	
Category:	NA		
Comment:	P_C at 390 ft nothing visible . Flow direction wrong		
Location Details:		Direction of Survey:	Downstream
US MH:	M-507-100	DS MH:	M-407-013
		Total Length Surveyed (ft):	391.4

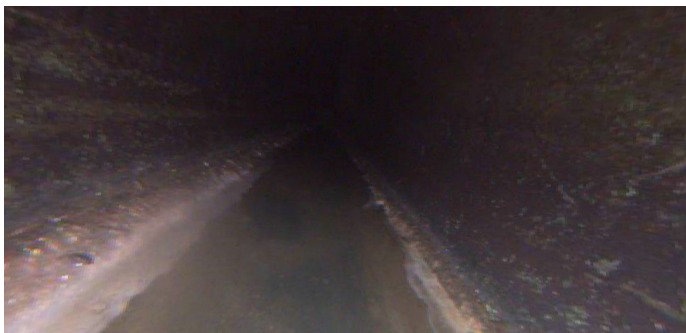
Code: **AMH**
Description: **Manhole**

Distance (ft): **.0**
Structural Grade: **0**
O&M Grade: **0**
Clock Start/From:
Clock To:
1st Value:
2nd Value:
Value Percent:
Continuous Index:
Within 8" of Joint: **NO**
Remarks: **M-507-100**

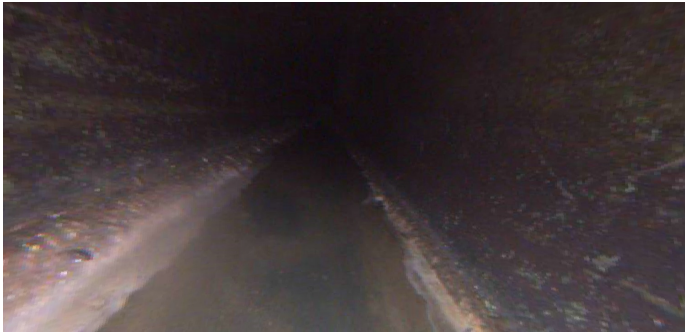
Code:	MWL
Description:	Water Level

Distance (ft):	.0
Structural Grade:	0
O&M Grade:	0
Clock Start/From:	
Clock To:	
1st Value:	
2nd Value:	
Value Percent:	5.000
Continuous Index:	
Within 8" of Joint:	NO
Remarks:

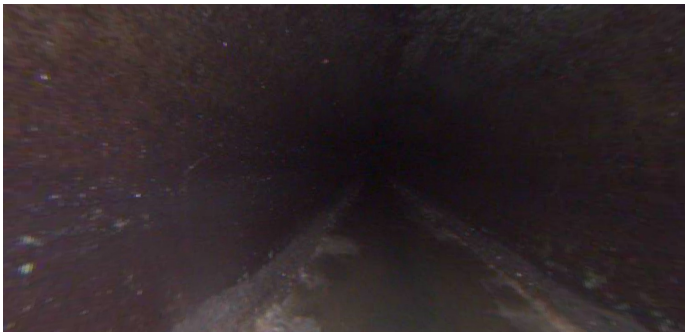
Code:	DAZ
Description:	Deposits Attached Other

Distance (ft):	5.9
Structural Grade:	0
O&M Grade:	2
Clock Start/From:	7
Clock To:	5
1st Value:	
2nd Value:	
Value Percent:	5.000
Continuous Index:	S01
Within 8" of Joint:	YES
Remarks:

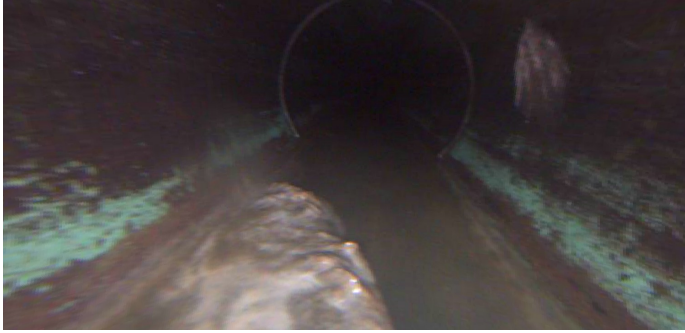
Code: **MGO**
Description: **General Observation**

Distance (ft): **99.6**
Structural Grade: **0**
O&M Grade: **0**
Clock Start/From:
Clock To:
1st Value:
2nd Value:
Value Percent:
Continuous Index:
Within 8" of Joint: **NO**
Remarks: **TOILET TISSUE**

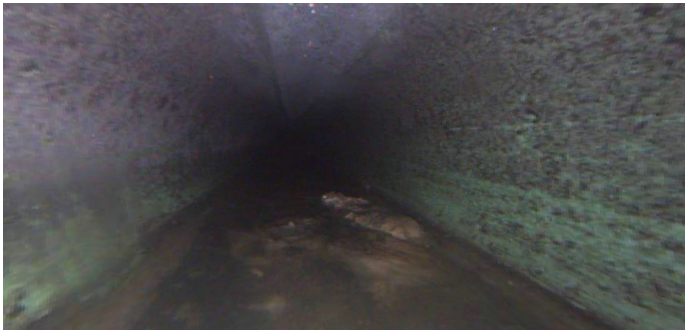
Code: **MGO**
Description: **General Observation**

Distance (ft): **282.3**
Structural Grade: **0**
O&M Grade: **0**
Clock Start/From:
Clock To:
1st Value:
2nd Value:
Value Percent:
Continuous Index:
Within 8" of Joint: **NO**
Remarks: **TOILET TISSUE**

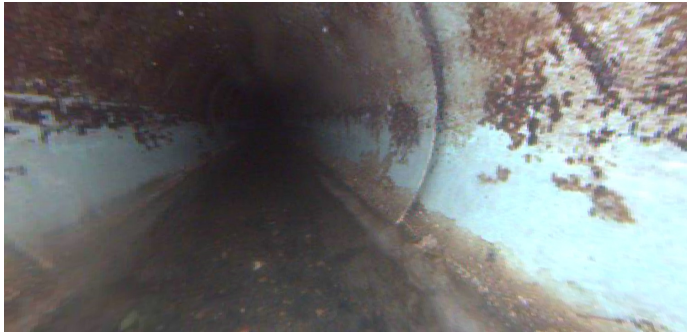
Code: **MSA**
Description: **Abandoned Survey**

Distance (ft): **391.4**
Structural Grade: **0**
O&M Grade: **0**
Clock Start/From:
Clock To:
1st Value:
2nd Value:
Value Percent:
Continuous Index:
Within 8" of Joint: **NO**
Remarks: **ROBOT HAS STOPPED**

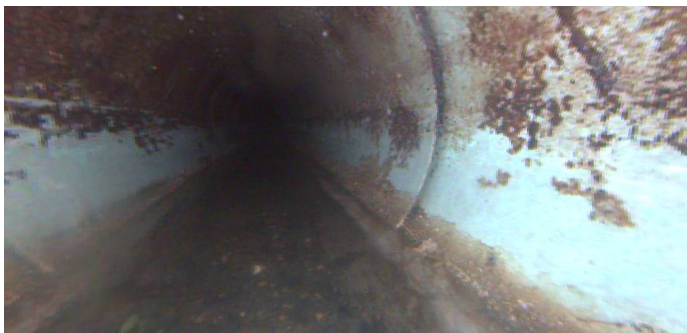
Code: **DAZ**
Description: **Deposits Attached Other**

Distance (ft): **391.4**
Structural Grade: **0**
O&M Grade: **2**
Clock Start/From: **7**
Clock To: **5**
1st Value:
2nd Value:
Value Percent: **5.000**
Continuous Index: **F01**
Within 8" of Joint: **YES**
Remarks:
