## Profile/Photo Observation Report

Date:	<b>03/28/2018</b>	Weather:		Coding:	<b>PACP 6.0</b>
Pipe Length (ft):	<b>279.3</b>	Owner:	<b>NA</b>	Pre Clean:	<b>No Pre-Cleaning</b>
P.O.#:		Surveyor:	<b>Selasie Honu</b>	PSR:	<b>P-507-099-100</b>
Customer:		Clean Date:	<b>01/01/1900</b>	Shape:	<b>C</b>

Street:	<b>OFF S DECATUR ST</b>	Flow Control:	<b>Not Controlled</b>
City:	<b>Hobart, IN</b>	Year Renewed:	
Location:	<b>Light Highway</b>	Tape/Media #:	
Purpose:	<b>Routine Assessment</b>	Dia/Height:	<b>8"</b>
Use:	<b>Sanitary</b>	Material:	<b>PVC</b>
Drain Area:	<b>NA</b>	Lining:	
Category:	<b>NA</b>		
Comment:	<b>R_M at 50 ft nothing visible . Flow direction wrong</b>		
Location Details:		Direction of Survey:	<b>Upstream</b>
US MH:	<b>M-507-100</b>	DS MH:	<b>M-507-099</b>
		Total Length Surveyed (ft):	<b>51.8</b>

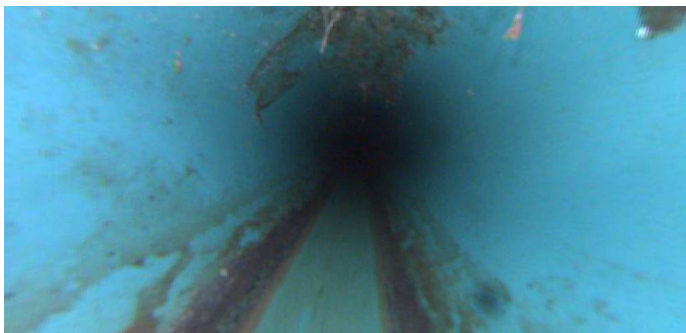
Code: **AMH**  
Description: **Manhole**

Distance (ft): **.0**  
Structural Grade: **0**  
O&M Grade: **0**  
Clock Start/From:  
Clock To:  
1st Value:  
2nd Value:  
Value Percent:  
Continuous Index:  
Within 8" of Joint: **NO**  
Remarks: **M-507-099**

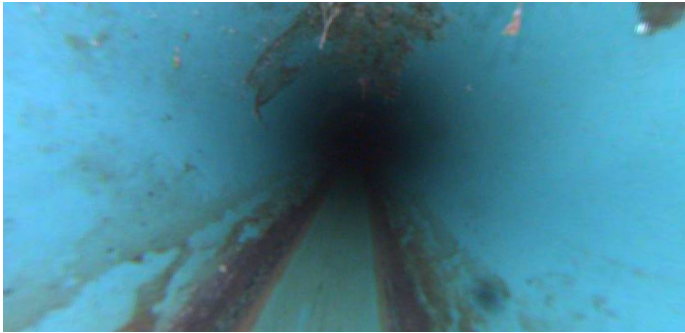
Code:	<b>MWL</b>
Description:	<b>Water Level</b>

Distance (ft):	<b>.0</b>
Structural Grade:	<b>0</b>
O&M Grade:	<b>0</b>
Clock Start/From:	
Clock To:	
1st Value:	
2nd Value:	
Value Percent:	<b>5.000</b>
Continuous Index:	
Within 8" of Joint:	<b>NO</b>
Remarks:

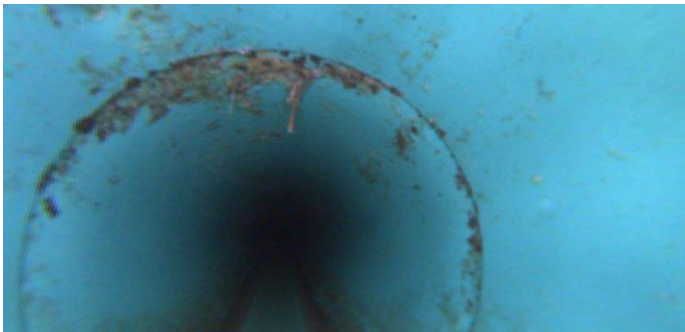
Code:	<b>RFJ</b>
Description:	<b>Roots Fine Joint</b>

Distance (ft):	<b>4.1</b>
Structural Grade:	<b>0</b>
O&M Grade:	<b>1</b>
Clock Start/From:	<b>12</b>
Clock To:	
1st Value:	
2nd Value:	
Value Percent:	
Continuous Index:	
Within 8" of Joint:	<b>YES</b>
Remarks:

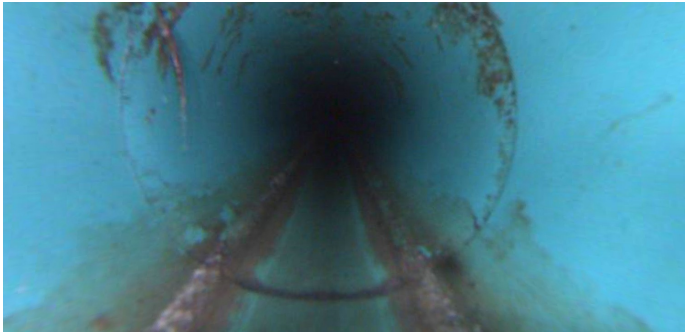
Code: **DAGS**  
Description: **Deposits Attached Grease**

Distance (ft): **16.9**  
Structural Grade: **0**  
O&M Grade: **2**  
Clock Start/From: **7**  
Clock To: **5**  
1st Value:  
2nd Value:  
Value Percent: **5.000**  
Continuous Index: **S01**  
Within 8" of Joint: **NO**  
Remarks:

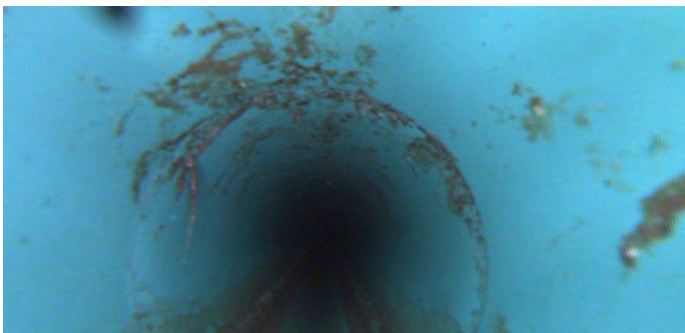
Code: **RFJ**  
Description: **Roots Fine Joint**

Distance (ft): **16.9**  
Structural Grade: **0**  
O&M Grade: **1**  
Clock Start/From: **10**  
Clock To:  
1st Value:  
2nd Value:  
Value Percent:  
Continuous Index:  
Within 8" of Joint: **YES**  
Remarks:

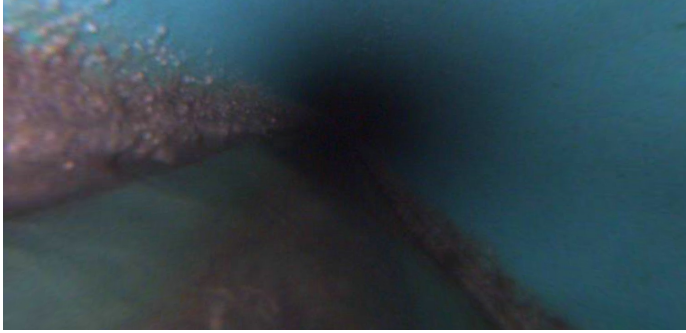
Code: **DAGS**  
Description: **Deposits Attached Grease**

Distance (ft): **51.8**  
Structural Grade: **0**  
O&M Grade: **2**  
Clock Start/From: **7**  
Clock To: **5**  
1st Value:  
2nd Value:  
Value Percent: **5.000**  
Continuous Index: **F01**  
Within 8" of Joint: **NO**  
Remarks:

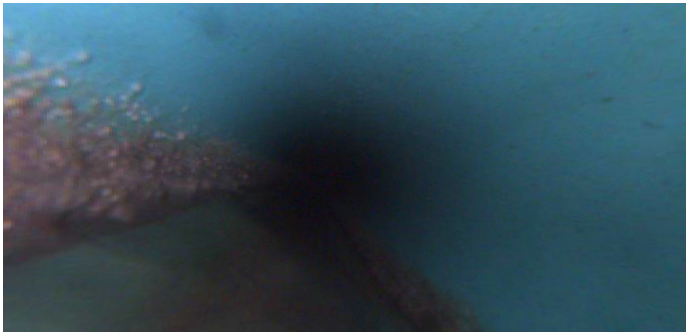
Code: **MSA**  
Description: **Abandoned Survey**

Distance (ft): **51.8**  
Structural Grade: **0**  
O&M Grade: **0**  
Clock Start/From:  
Clock To:  
1st Value:  
2nd Value:  
Value Percent:  
Continuous Index:  
Within 8" of Joint: **NO**  
Remarks: **CAMERA STOPPED**
