## Profile/Photo Observation Report

Date:	<b>03/28/2018</b>	Weather:		Coding:	<b>PACP 6.0</b>
Pipe Length (ft):	<b>279.3</b>	Owner:	<b>NA</b>	Pre Clean:	<b>No Pre-Cleaning</b>
P.O.#:		Surveyor:	<b>Selasie Honu</b>	PSR:	<b>P-507-099-100</b>
Customer:		Clean Date:	<b>01/01/1900</b>	Shape:	<b>C</b>

Street:	<b>FOXCROFT STREET</b>	Flow Control:	<b>Not Controlled</b>
City:	<b>Hobart, IN</b>	Year Renewed:	
Location:	<b>Light Highway</b>	Tape/Media #:	
Purpose:	<b>Routine Assessment</b>	Dia/Height:	<b>8"</b>
Use:	<b>Sanitary</b>	Material:	<b>PVC</b>
Drain Area:	<b>NA</b>	Lining:	
Category:	<b>NA</b>		
Comment:	<b>R_M at 50 ft nothing visible . Flow direction wrong</b>		
Location Details:		Direction of Survey:	<b>Upstream</b>
US MH:	<b>M-507-100</b>	DS MH:	<b>M-507-099</b>
		Total Length Surveyed (ft):	<b>51.8</b>

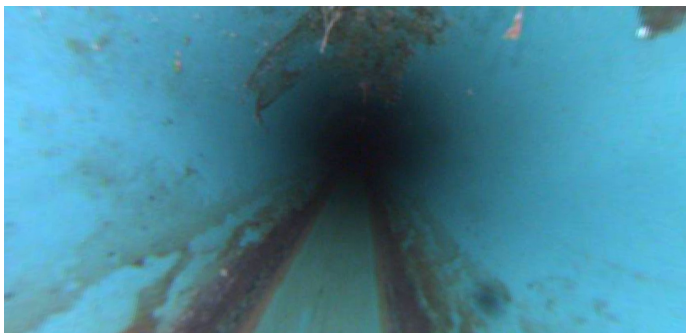
Code: **AMH**  
Description: **Manhole**

Distance (ft): **.0**  
Structural Grade: **0**  
O&M Grade: **0**  
Clock Start/From:  
Clock To:  
1st Value:  
2nd Value:  
Value Percent:  
Continuous Index:  
Within 8" of Joint: **NO**  
Remarks: **M-507-099**

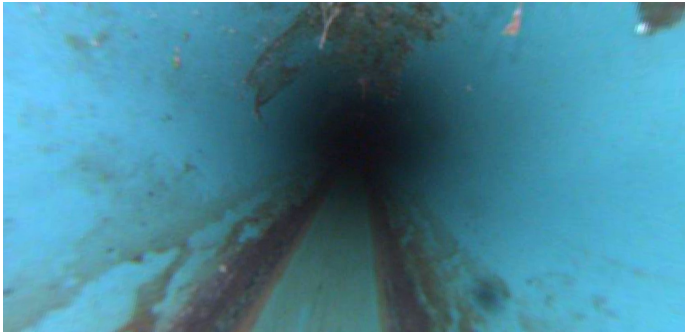
Code:	<b>MWL</b>
Description:	<b>Water Level</b>

Distance (ft):	<b>.0</b>
Structural Grade:	<b>0</b>
O&M Grade:	<b>0</b>
Clock Start/From:	
Clock To:	
1st Value:	
2nd Value:	
Value Percent:	<b>5.000</b>
Continuous Index:	
Within 8" of Joint:	<b>NO</b>
Remarks:

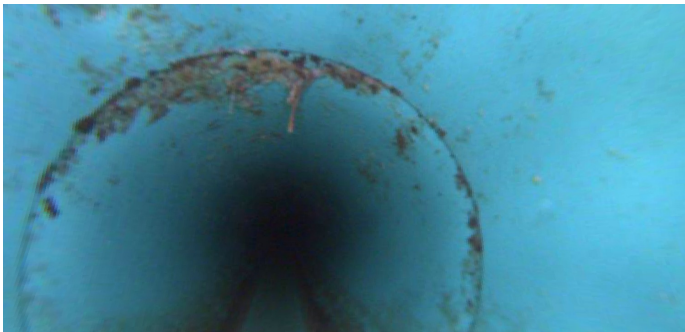
Code:	<b>RFJ</b>
Description:	<b>Roots Fine Joint</b>

Distance (ft):	<b>4.1</b>
Structural Grade:	<b>0</b>
O&M Grade:	<b>1</b>
Clock Start/From:	<b>12</b>
Clock To:	
1st Value:	
2nd Value:	
Value Percent:	
Continuous Index:	
Within 8" of Joint:	<b>YES</b>
Remarks:

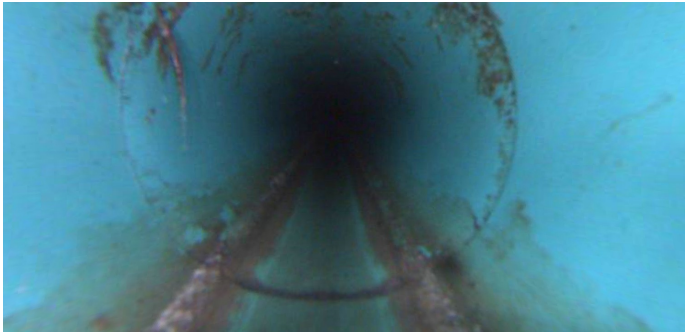
Code: **DAGS**  
Description: **Deposits Attached Grease**

Distance (ft): **16.9**  
Structural Grade: **0**  
O&M Grade: **2**  
Clock Start/From: **7**  
Clock To: **5**  
1st Value:  
2nd Value:  
Value Percent: **5.000**  
Continuous Index: **S01**  
Within 8" of Joint: **NO**  
Remarks:

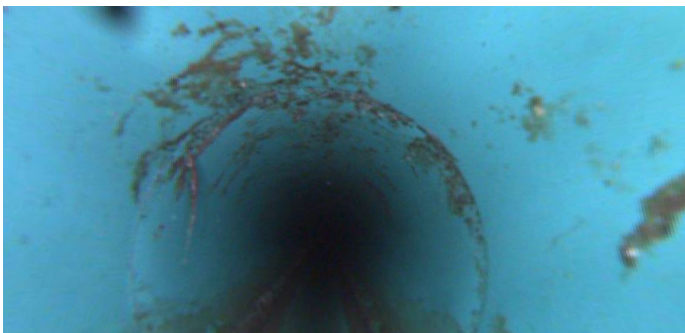
Code: **RFJ**  
Description: **Roots Fine Joint**

Distance (ft): **16.9**  
Structural Grade: **0**  
O&M Grade: **1**  
Clock Start/From: **10**  
Clock To:  
1st Value:  
2nd Value:  
Value Percent:  
Continuous Index:  
Within 8" of Joint: **YES**  
Remarks:

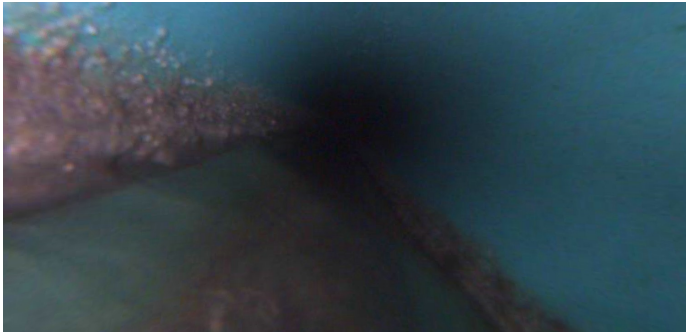
Code: **DAGS**  
Description: **Deposits Attached Grease**

Distance (ft): **51.8**  
Structural Grade: **0**  
O&M Grade: **2**  
Clock Start/From: **7**  
Clock To: **5**  
1st Value:  
2nd Value:  
Value Percent: **5.000**  
Continuous Index: **F01**  
Within 8" of Joint: **NO**  
Remarks:

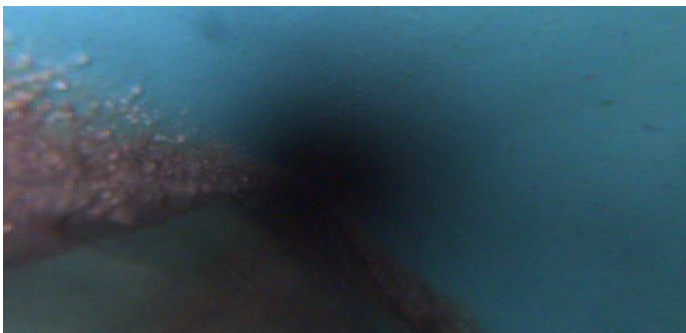
Code: **MSA**  
Description: **Abandoned Survey**

Distance (ft): **51.8**  
Structural Grade: **0**  
O&M Grade: **0**  
Clock Start/From:  
Clock To:  
1st Value:  
2nd Value:  
Value Percent:  
Continuous Index:  
Within 8" of Joint: **NO**  
Remarks: **CAMERA STOPPED**
