Profile/Photo Observation Report

Date:	04/11/2018	Weather:		Coding:	PACP 6.0
Pipe Length (ft):	209.6	Owner:	NA	Pre Clean:	Not Known
P.O.#:		Surveyor:	Jen Costello	PSR:	P-603-001-049
Customer:		Clean Date:	01/01/1900	Shape:	C

Street:	W 40TH PL	Flow Control:	Not Controlled
City:	Hobart, IN	Year Renewed:	
Location:	Other	Tape/Media #:	
Purpose:	Not Known	Dia/Height:	10"
Use:	Sanitary	Material:	VCP
Drain Area:	NA	Lining:	
Category:	NA		
Comment:

Location Details:		Direction of Survey:	Downstream
US MH:	M-603-001	DS MH:	M-604-049
		Total Length Surveyed (ft):	118.4

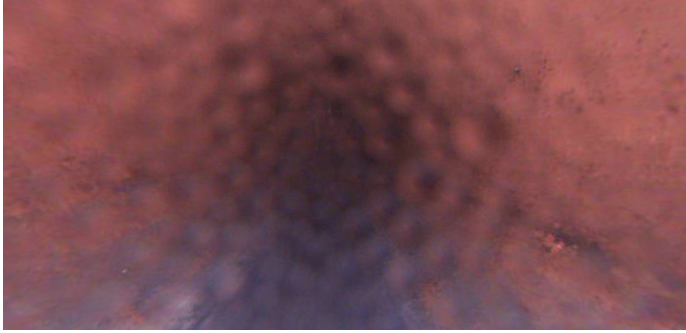
Code: **AMH**
Description: **Manhole**

Distance (ft): **.0**
Structural Grade: **0**
O&M Grade: **0**
Clock Start/From:
Clock To:
1st Value:
2nd Value:
Value Percent:
Continuous Index:
Within 8" of Joint: **NO**
Remarks: **M-603-001**

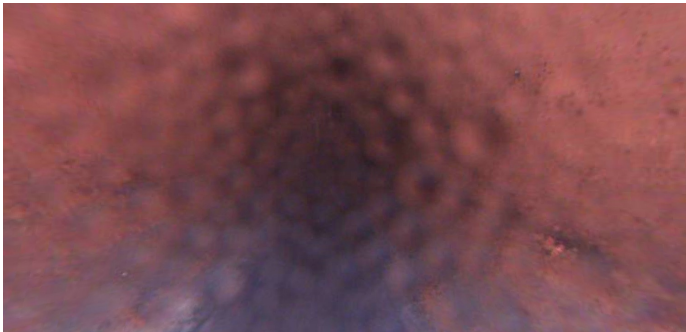
Code: **MWL**
Description: **Water Level**

Distance (ft): **.0**
Structural Grade: **0**
O&M Grade: **0**
Clock Start/From:
Clock To:
1st Value:
2nd Value:
Value Percent: **5.000**
Continuous Index:
Within 8" of Joint: **NO**
Remarks:

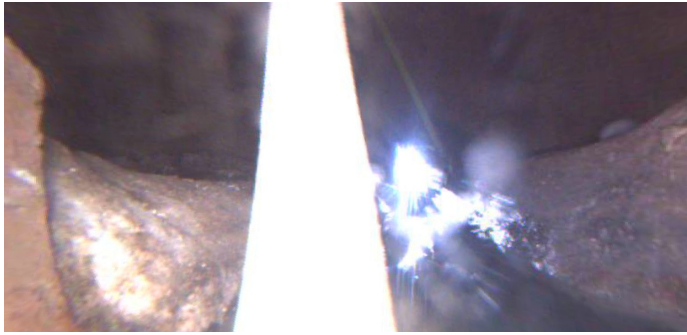
Code:	MGO
Description:	General Observation
Distance (ft):	.0
Structural Grade:	0
O&M Grade:	0
Clock Start/From:	
Clock To:	
1st Value:	
2nd Value:	
Value Percent:	
Continuous Index:	
Within 8" of Joint:	NO
Remarks:	rear camera

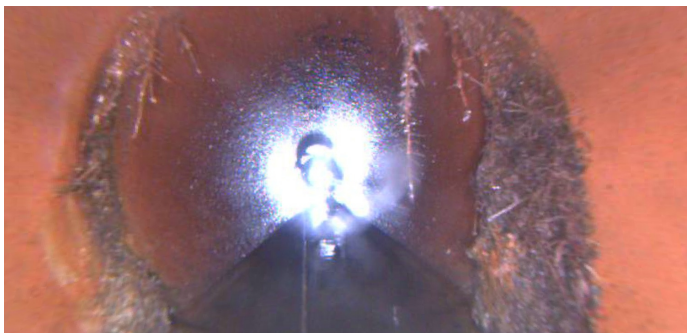
Code:	RMJ
Description:	Roots Medium Joint
Distance (ft):	5.0
Structural Grade:	0
O&M Grade:	3
Clock Start/From:	8
Clock To:	4
1st Value:	
2nd Value:	
Value Percent:	10.000
Continuous Index:	
Within 8" of Joint:	YES
Remarks:

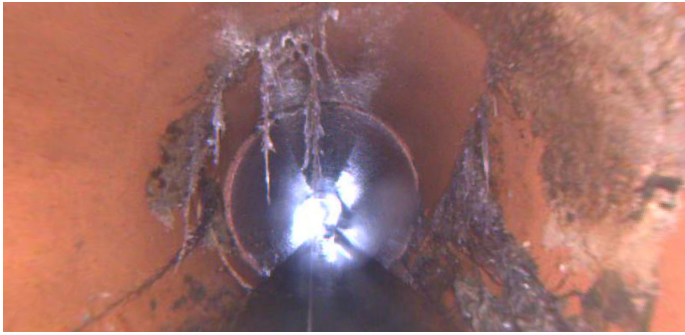
Code: **FM**
Description: **Fracture Multiple**

Distance (ft): **10.6**
Structural Grade: **4**
O&M Grade: **0**
Clock Start/From: **8**
Clock To: **4**
1st Value:
2nd Value:
Value Percent:
Continuous Index:
Within 8" of Joint: **YES**
Remarks:

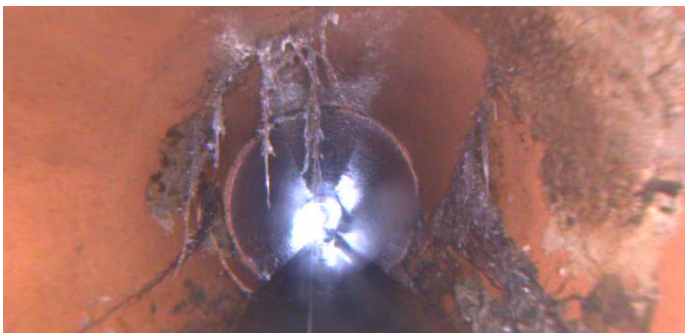
Code: **RMB**
Description: **Roots Medium Barrel**

Distance (ft): **10.6**
Structural Grade: **0**
O&M Grade: **4**
Clock Start/From: **8**
Clock To: **4**
1st Value:
2nd Value:
Value Percent: **5.000**
Continuous Index:
Within 8" of Joint: **NO**
Remarks:

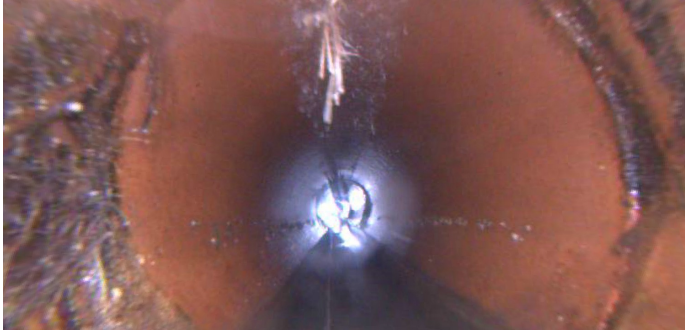
Code: **RMJ**
Description: **Roots Medium Joint**

Distance (ft): **14.6**
Structural Grade: **0**
O&M Grade: **3**
Clock Start/From: **8**
Clock To: **4**
1st Value:
2nd Value:
Value Percent: **10.000**
Continuous Index:
Within 8" of Joint: **YES**
Remarks:

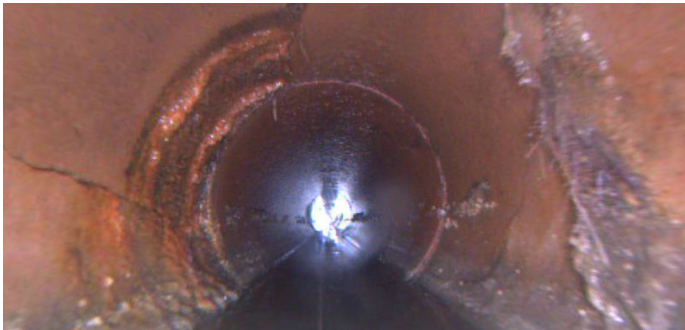
Code: **IW**
Description: **Infil Weeper**

Distance (ft): **20.2**
Structural Grade: **0**
O&M Grade: **2**
Clock Start/From: **12**
Clock To: **4**
1st Value:
2nd Value:
Value Percent:
Continuous Index:
Within 8" of Joint: **YES**
Remarks:

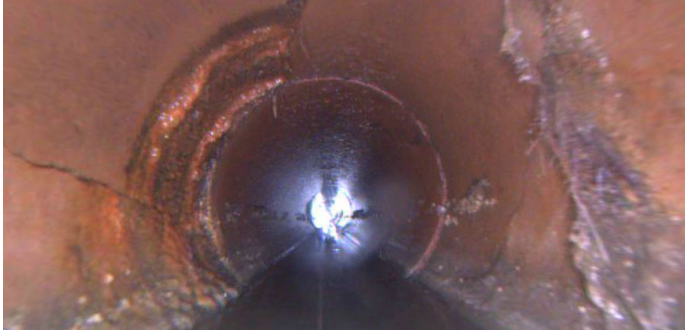
Code: **FM**
Description: **Fracture Multiple**

Distance (ft): **20.2**
Structural Grade: **4**
O&M Grade: **0**
Clock Start/From: **8**
Clock To: **4**
1st Value:
2nd Value:
Value Percent:
Continuous Index:
Within 8" of Joint:
Remarks:

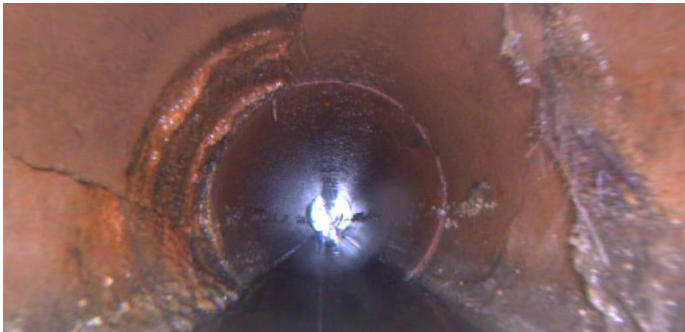
Code: **RFB**
Description: **Roots Fine Barrel**

Distance (ft): **20.2**
Structural Grade: **0**
O&M Grade: **2**
Clock Start/From: **8**
Clock To: **4**
1st Value:
2nd Value:
Value Percent:
Continuous Index:
Within 8" of Joint: **NO**
Remarks:

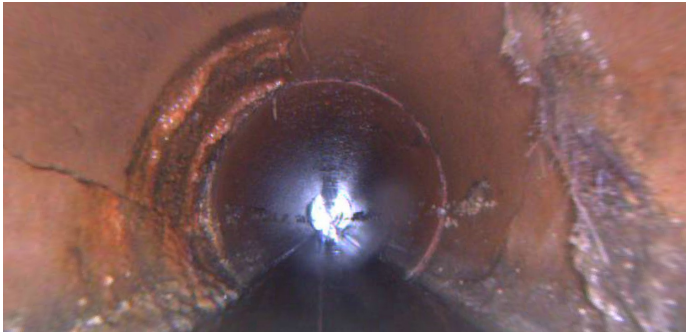
Code: ID
Description: Infil Dripper

Distance (ft): 20.2
Structural Grade: 0
O&M Grade: 3
Clock Start/From: 12
Clock To:
1st Value:
2nd Value:
Value Percent:
Continuous Index:
Within 8" of Joint: YES
Remarks:

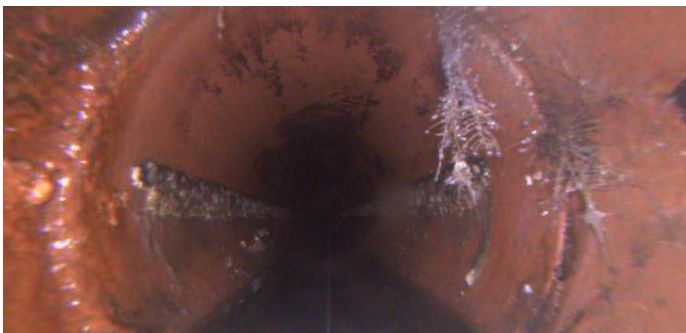
Code: IS
Description: Infil Stain

Distance (ft): 34.4
Structural Grade: 0
O&M Grade: 0
Clock Start/From: 12
Clock To: 4
1st Value:
2nd Value:
Value Percent:
Continuous Index:
Within 8" of Joint: YES
Remarks:

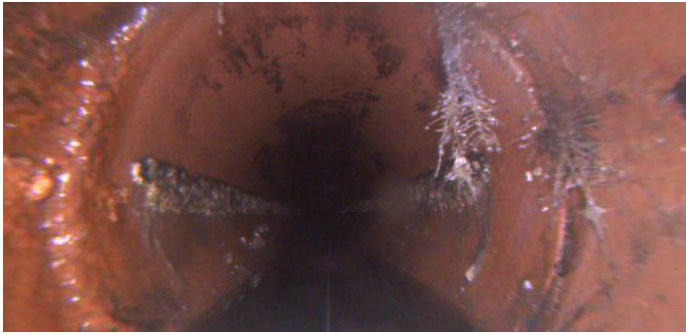
Code: **RFJ**
Description: **Roots Fine Joint**

Distance (ft): **34.4**
Structural Grade: **0**
O&M Grade: **1**
Clock Start/From: **8**
Clock To: **4**
1st Value:
2nd Value:
Value Percent:
Continuous Index: **S01**
Within 8" of Joint: **YES**
Remarks:

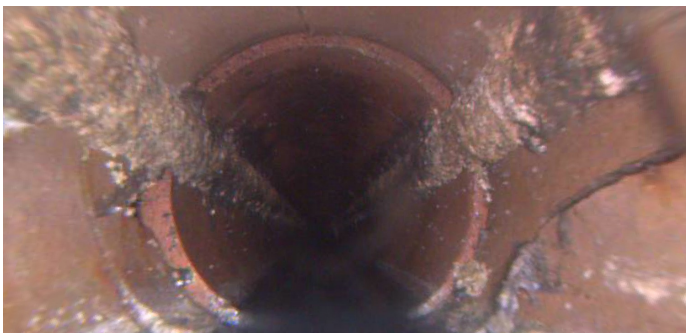
Code: **RFB**
Description: **Roots Fine Barrel**

Distance (ft): **69.1**
Structural Grade: **0**
O&M Grade: **2**
Clock Start/From: **8**
Clock To: **4**
1st Value:
2nd Value:
Value Percent:
Continuous Index:
Within 8" of Joint: **NO**
Remarks:

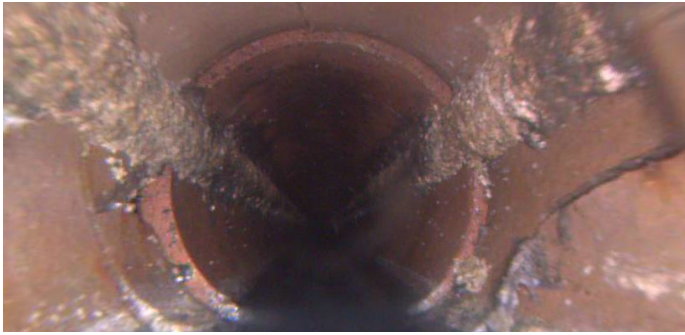
Code: **FM**
Description: **Fracture Multiple**

Distance (ft): **69.1**
Structural Grade: **4**
O&M Grade: **0**
Clock Start/From: **8**
Clock To: **4**
1st Value:
2nd Value:
Value Percent:
Continuous Index:
Within 8" of Joint: **YES**
Remarks:

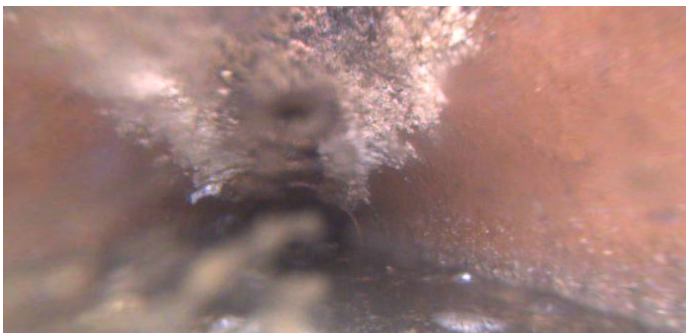
Code: **MCU**
Description: **Camera Underwater**

Distance (ft): **89.8**
Structural Grade: **0**
O&M Grade: **4**
Clock Start/From:
Clock To:
1st Value:
2nd Value:
Value Percent:
Continuous Index: **F02**
Within 8" of Joint: **NO**
Remarks:

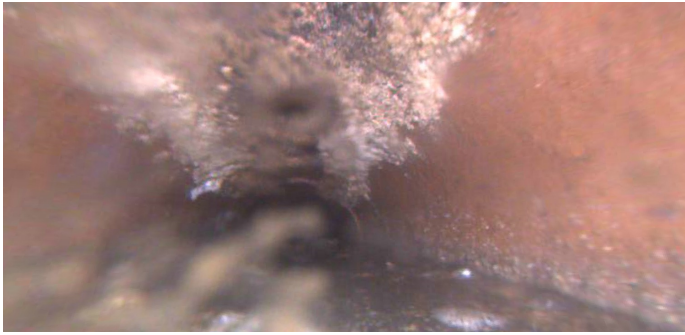
Code: **RFJ**
Description: **Roots Fine Joint**

Distance (ft): **89.8**
Structural Grade: **0**
O&M Grade: **1**
Clock Start/From: **8**
Clock To: **4**
1st Value:
2nd Value:
Value Percent:
Continuous Index: **S03**
Within 8" of Joint: **YES**
Remarks:

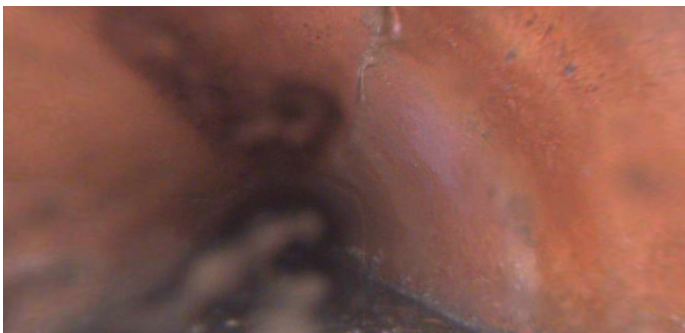
Code: **RFB**
Description: **Roots Fine Barrel**

Distance (ft): **92.8**
Structural Grade: **0**
O&M Grade: **2**
Clock Start/From: **12**
Clock To:
1st Value:
2nd Value:
Value Percent:
Continuous Index:
Within 8" of Joint: **NO**
Remarks:

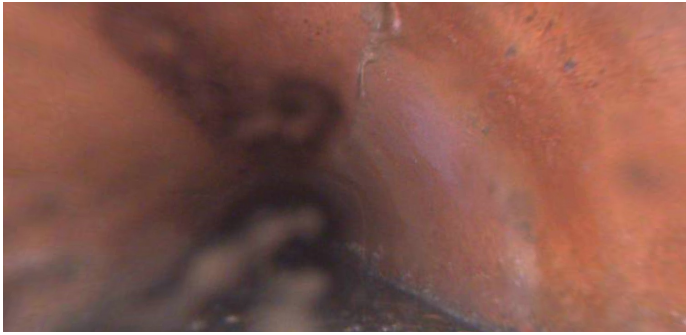
Code: **FL**
Description: **Fracture Longitudinal**

Distance (ft): **92.8**
Structural Grade: **3**
O&M Grade: **0**
Clock Start/From: **12**
Clock To:
1st Value:
2nd Value:
Value Percent:
Continuous Index:
Within 8" of Joint:
Remarks:

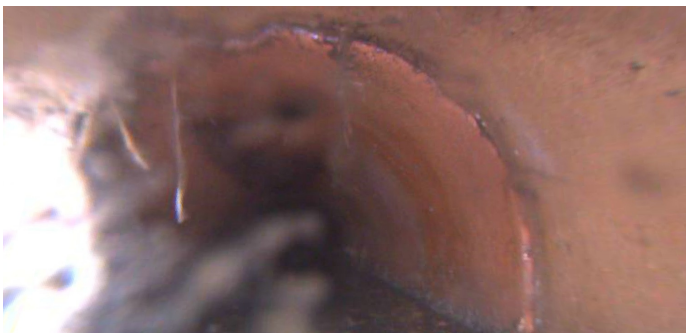
Code: **RMJ**
Description: **Roots Medium Joint**

Distance (ft): **93.3**
Structural Grade: **0**
O&M Grade: **3**
Clock Start/From: **12**
Clock To: **4**
1st Value:
2nd Value:
Value Percent: **10.000**
Continuous Index:
Within 8" of Joint: **YES**
Remarks:

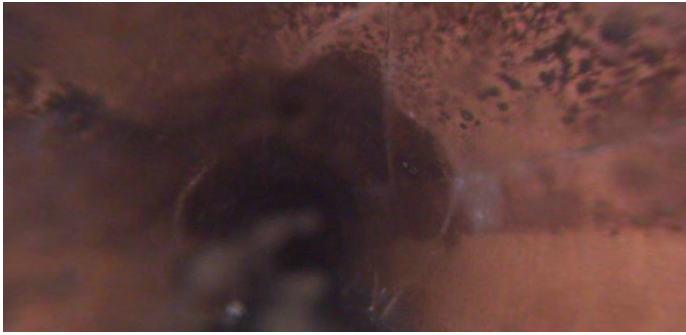
Code: **FM**
Description: **Fracture Multiple**

Distance (ft): **100.9**
Structural Grade: **4**
O&M Grade: **0**
Clock Start/From: **8**
Clock To: **4**
1st Value:
2nd Value:
Value Percent:
Continuous Index: **S04**
Within 8" of Joint: **YES**
Remarks:

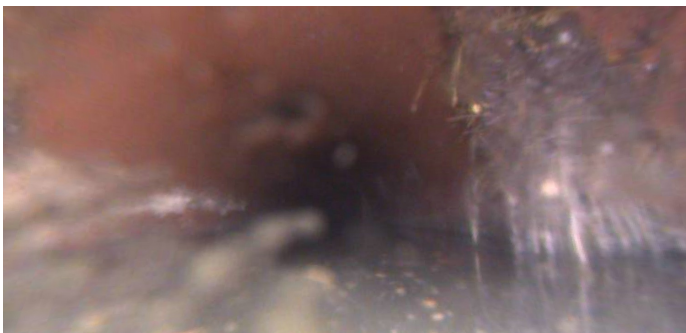
Code: **FM**
Description: **Fracture Multiple**

Distance (ft): **116.7**
Structural Grade: **4**
O&M Grade: **0**
Clock Start/From: **8**
Clock To: **4**
1st Value:
2nd Value:
Value Percent:
Continuous Index: **F04**
Within 8" of Joint: **YES**
Remarks:

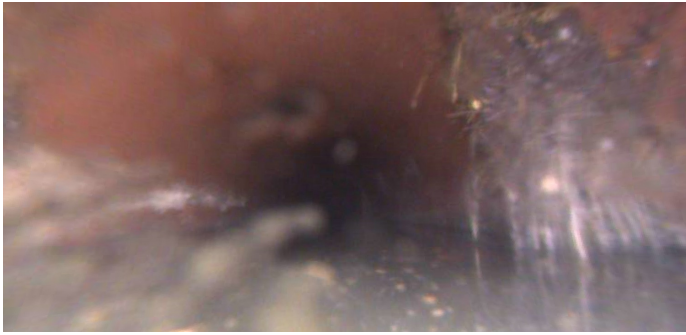
Code: **RFJ**
Description: **Roots Fine Joint**

Distance (ft): **116.7**
Structural Grade: **0**
O&M Grade: **1**
Clock Start/From: **8**
Clock To: **4**
1st Value:
2nd Value:
Value Percent:
Continuous Index: **F03**
Within 8" of Joint: **YES**
Remarks:

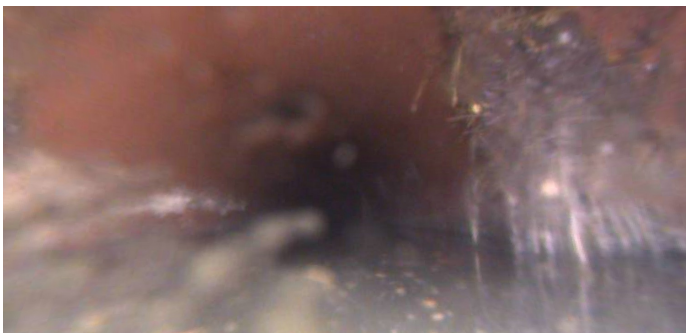
Code: **RMJ**
Description: **Roots Medium Joint**

Distance (ft): **116.7**
Structural Grade: **0**
O&M Grade: **3**
Clock Start/From: **8**
Clock To: **12**
1st Value:
2nd Value:
Value Percent: **10.000**
Continuous Index:
Within 8" of Joint: **YES**
Remarks:

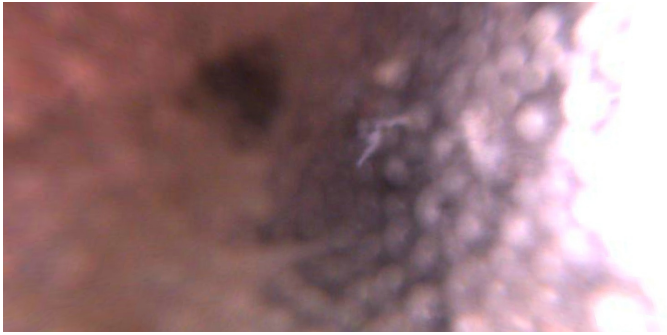
Code: **RMB**
Description: **Roots Medium Barrel**

Distance (ft): **117.3**
Structural Grade: **0**
O&M Grade: **4**
Clock Start/From: **12**
Clock To: **6**
1st Value:
2nd Value:
Value Percent: **40.000**
Continuous Index:
Within 8" of Joint: **NO**
Remarks:

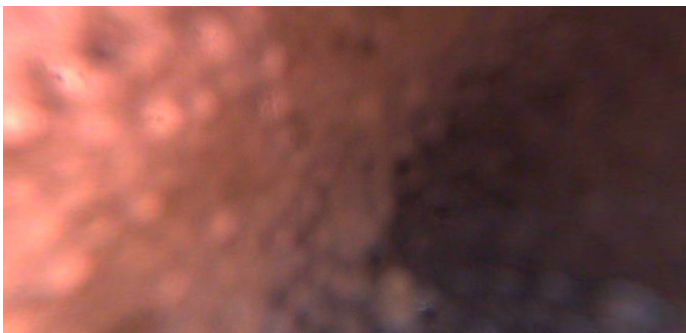
Code: **MSA**
Description: **Abandoned Survey**

Distance (ft): **118.4**
Structural Grade: **0**
O&M Grade: **0**
Clock Start/From:
Clock To:
1st Value:
2nd Value:
Value Percent:
Continuous Index:
Within 8" of Joint: **NO**
Remarks: **roots**
