## Profile/Photo Observation Report

| Street: | <b>W 40th ave</b> | Flow Control: | <b>Not Controlled</b> |
| City: | <b>Hobart, IN</b> | Year Renewed: | |

| US MH: | <b>M-603-001</b> | DS MH: | <b>M-604-049</b> |

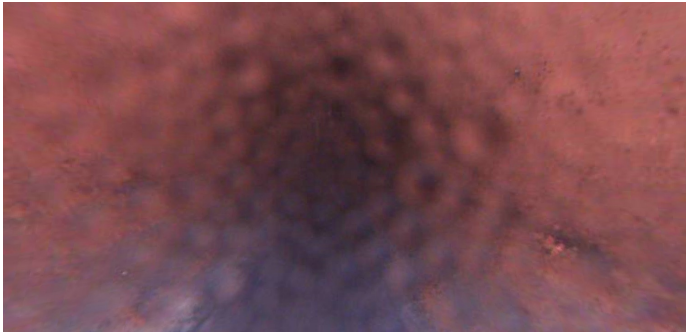
Code: **AMH**  
Description: **Manhole**

Distance (ft): **.0**  
Structural Grade: **0**  
O&M Grade: **0**  
Clock Start/From:  
Clock To:  
1st Value:  
2nd Value:  
Value Percent:  
Continuous Index:  
Within 8" of Joint: **NO**  
Remarks: **M-603-001**

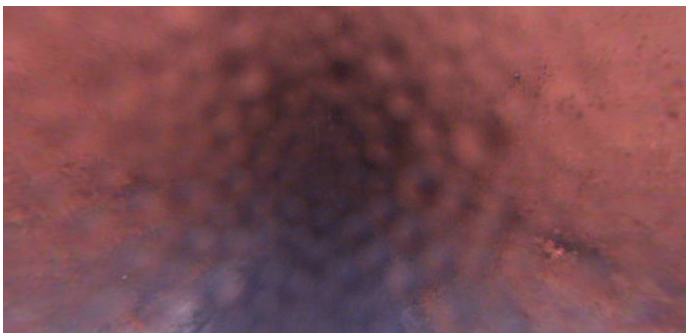
Code: **MWL**  
Description: **Water Level**

Distance (ft): **.0**  
Structural Grade: **0**  
O&M Grade: **0**  
Clock Start/From:  
Clock To:  
1st Value:  
2nd Value:  
Value Percent: **5.000**  
Continuous Index:  
Within 8" of Joint: **NO**  
Remarks:

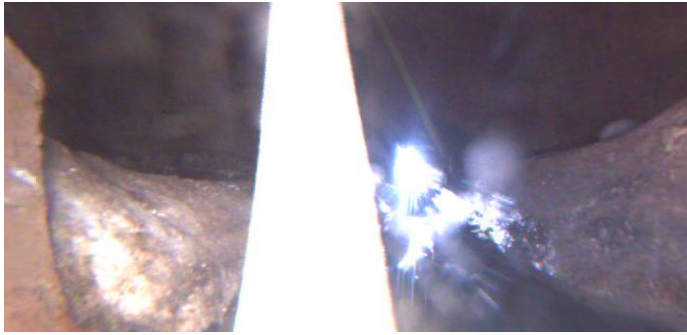
| Code: | <b>MGO</b> |
| Description: | <b>General Observation</b> |
| Remarks: | <b>rear camera</b> |

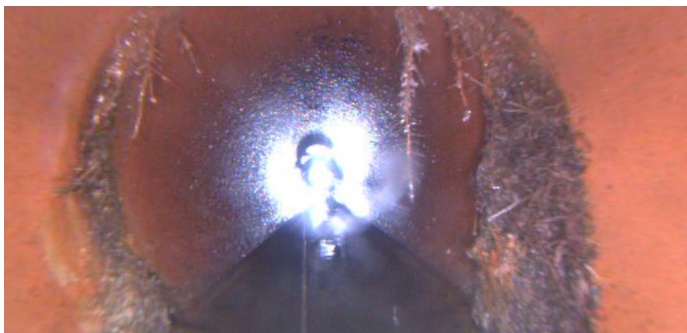
| Code: | <b>RMJ</b> |
| Description: | <b>Roots Medium Joint</b> |
| Distance (ft): | <b>5.0</b> |
| O&M Grade: | <b>3</b> |
| Value Percent: | <b>10.000</b> |

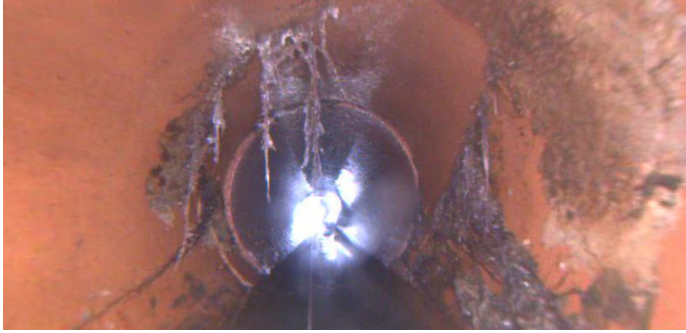
Code: **FM**  
Description: **Fracture Multiple**

Distance (ft): **10.6**  
Structural Grade: **4**  
O&M Grade: **0**  
Clock Start/From: **8**  
Clock To: **4**  
1st Value:  
2nd Value:  
Value Percent:  
Continuous Index:  
Within 8" of Joint: **YES**  
Remarks:

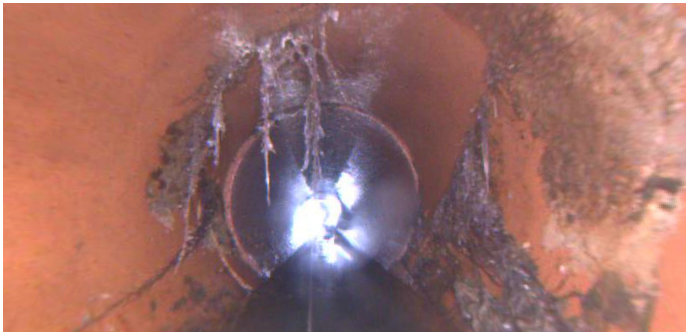
Code: **RMB**  
Description: **Roots Medium Barrel**

Distance (ft): **10.6**  
Structural Grade: **0**  
O&M Grade: **4**  
Clock Start/From: **8**  
Clock To: **4**  
1st Value:  
2nd Value:  
Value Percent: **5.000**  
Continuous Index:  
Within 8" of Joint: **NO**  
Remarks:

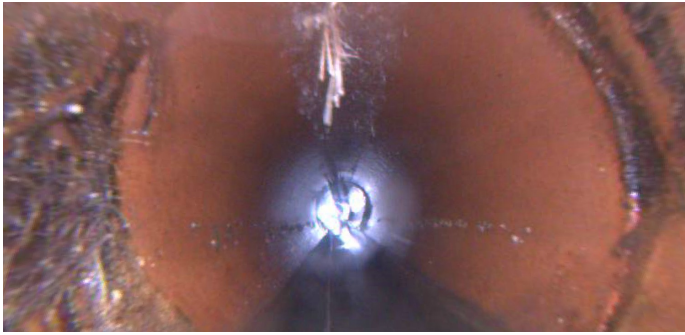
Code: **RMJ**  
Description: **Roots Medium Joint**

Distance (ft): **14.6**  
Structural Grade: **0**  
O&M Grade: **3**  
Clock Start/From: **8**  
Clock To: **4**  
1st Value:  
2nd Value:  
Value Percent: **10.000**  
Continuous Index:  
Within 8" of Joint: **YES**  
Remarks:

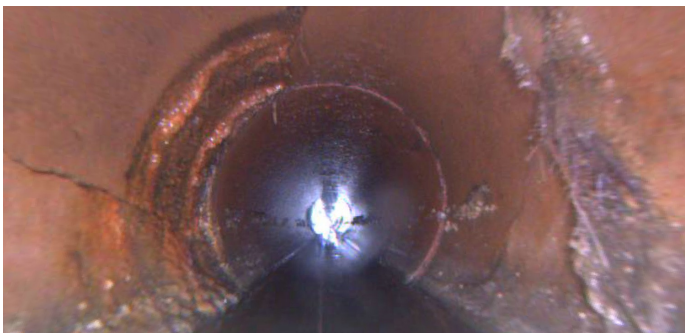
Code: **IW**  
Description: **Infil Weeper**

Distance (ft): **20.2**  
Structural Grade: **0**  
O&M Grade: **2**  
Clock Start/From: **12**  
Clock To: **4**  
1st Value:  
2nd Value:  
Value Percent:  
Continuous Index:  
Within 8" of Joint: **YES**  
Remarks:

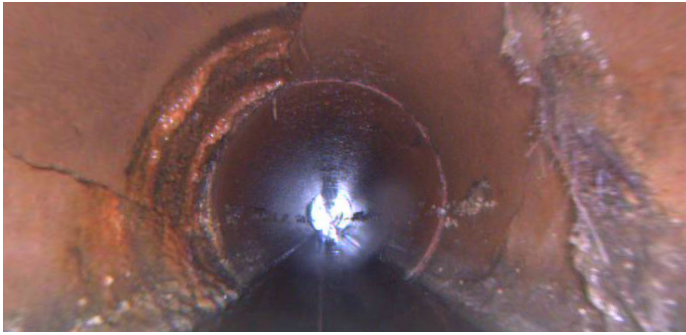
Code: **FM**  
Description: **Fracture Multiple**

Distance (ft): **20.2**  
Structural Grade: **4**  
O&M Grade: **0**  
Clock Start/From: **8**  
Clock To: **4**  
1st Value:  
2nd Value:  
Value Percent:  
Continuous Index:  
Within 8" of Joint:  
Remarks:

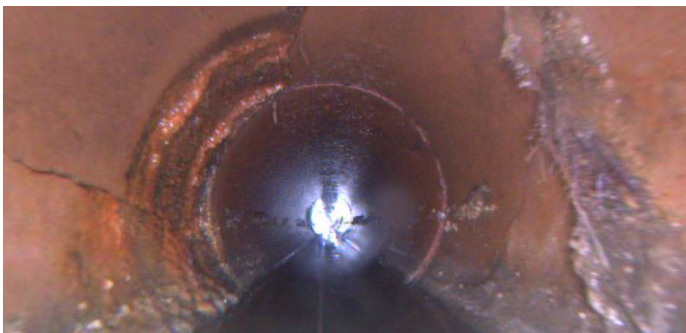
Code: **RFB**  
Description: **Roots Fine Barrel**

Distance (ft): **20.2**  
Structural Grade: **0**  
O&M Grade: **2**  
Clock Start/From: **8**  
Clock To: **4**  
1st Value:  
2nd Value:  
Value Percent:  
Continuous Index:  
Within 8" of Joint: **NO**  
Remarks:

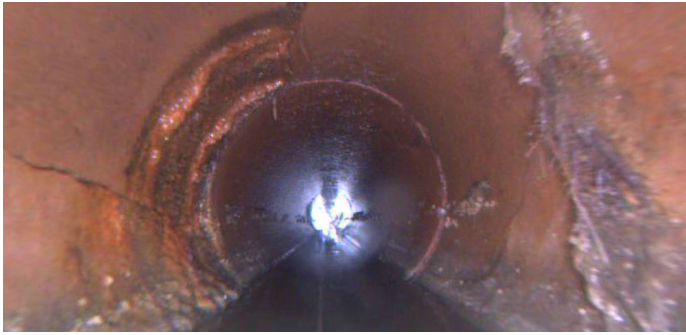
Code: ID  
Description: Infil Dripper

Distance (ft): 20.2  
Structural Grade: 0  
O&M Grade: 3  
Clock Start/From: 12  
Clock To:  
1st Value:  
2nd Value:  
Value Percent:  
Continuous Index:  
Within 8" of Joint: YES  
Remarks:

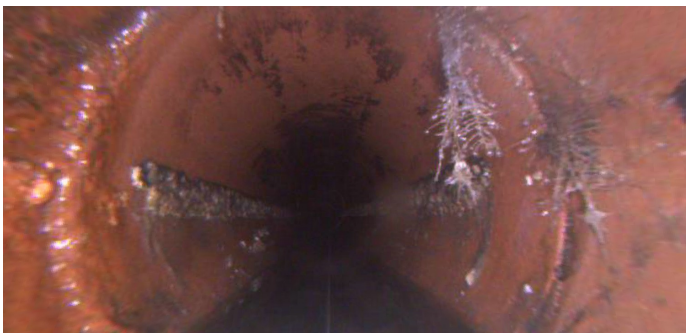
Code: IS  
Description: Infil Stain

Distance (ft): 34.4  
Structural Grade: 0  
O&M Grade: 0  
Clock Start/From: 12  
Clock To: 4  
1st Value:  
2nd Value:  
Value Percent:  
Continuous Index:  
Within 8" of Joint: YES  
Remarks:

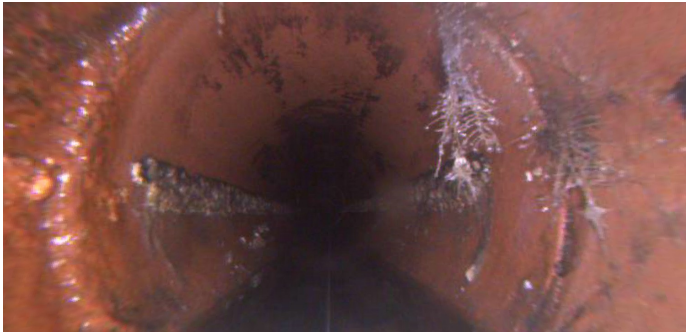
Code: **RFJ**  
Description: **Roots Fine Joint**

Distance (ft): **34.4**  
Structural Grade: **0**  
O&M Grade: **1**  
Clock Start/From: **8**  
Clock To: **4**  
1st Value:  
2nd Value:  
Value Percent:  
Continuous Index: **S01**  
Within 8" of Joint: **YES**  
Remarks:

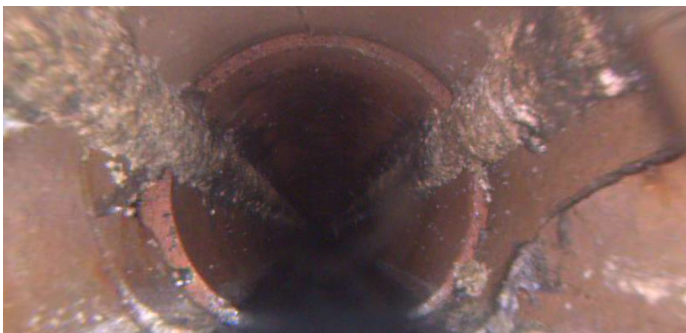
Code: **RFB**  
Description: **Roots Fine Barrel**

Distance (ft): **69.1**  
Structural Grade: **0**  
O&M Grade: **2**  
Clock Start/From: **8**  
Clock To: **4**  
1st Value:  
2nd Value:  
Value Percent:  
Continuous Index:  
Within 8" of Joint: **NO**  
Remarks:

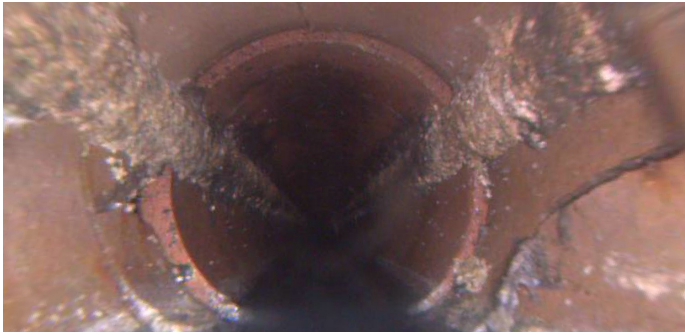
Code: **FM**  
Description: **Fracture Multiple**

Distance (ft): **69.1**  
Structural Grade: **4**  
O&M Grade: **0**  
Clock Start/From: **8**  
Clock To: **4**  
1st Value:  
2nd Value:  
Value Percent:  
Continuous Index:  
Within 8" of Joint: **YES**  
Remarks:

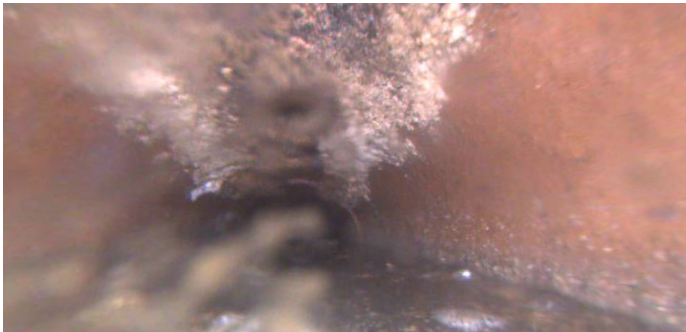
Code: **MCU**  
Description: **Camera Underwater**

Distance (ft): **89.8**  
Structural Grade: **0**  
O&M Grade: **4**  
Clock Start/From:  
Clock To:  
1st Value:  
2nd Value:  
Value Percent:  
Continuous Index: **F02**  
Within 8" of Joint: **NO**  
Remarks:

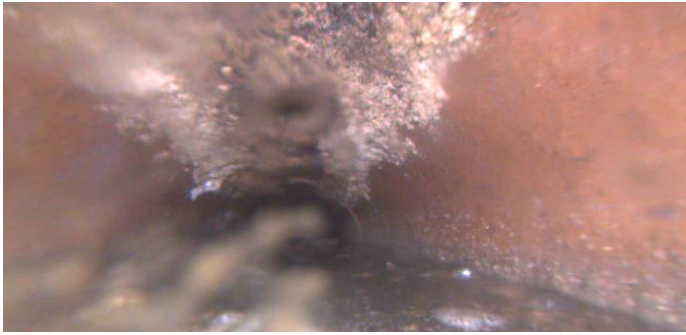
Code: **RFJ**  
Description: **Roots Fine Joint**

Distance (ft): **89.8**  
Structural Grade: **0**  
O&M Grade: **1**  
Clock Start/From: **8**  
Clock To: **4**  
1st Value:  
2nd Value:  
Value Percent:  
Continuous Index: **S03**  
Within 8" of Joint: **YES**  
Remarks:

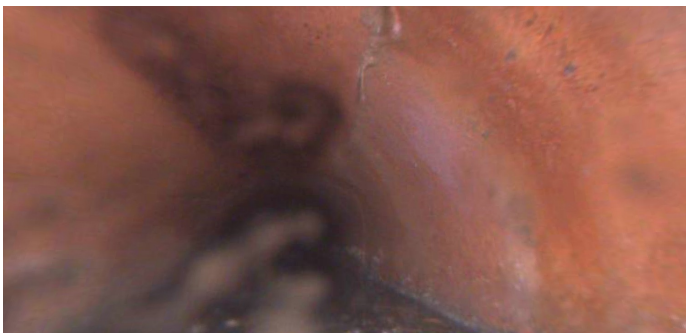
Code: **RFB**  
Description: **Roots Fine Barrel**

Distance (ft): **92.8**  
Structural Grade: **0**  
O&M Grade: **2**  
Clock Start/From: **12**  
Clock To:  
1st Value:  
2nd Value:  
Value Percent:  
Continuous Index:  
Within 8" of Joint: **NO**  
Remarks:

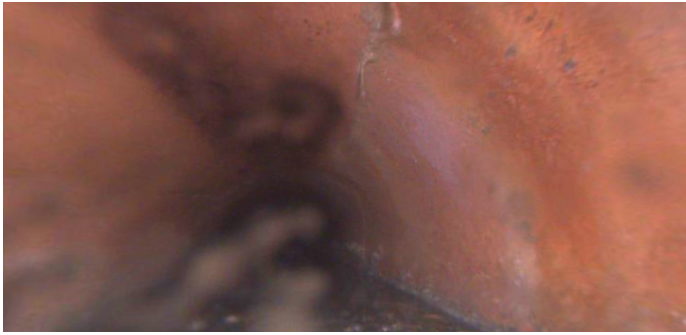
Code: **FL**  
Description: **Fracture Longitudinal**

Distance (ft): **92.8**  
Structural Grade: **3**  
O&M Grade: **0**  
Clock Start/From: **12**  
Clock To:  
1st Value:  
2nd Value:  
Value Percent:  
Continuous Index:  
Within 8" of Joint:  
Remarks:

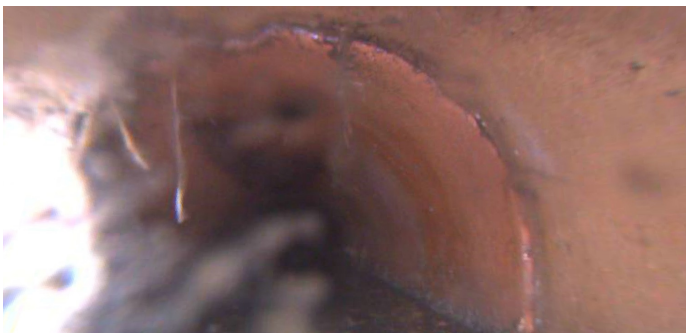
Code: **RMJ**  
Description: **Roots Medium Joint**

Distance (ft): **93.3**  
Structural Grade: **0**  
O&M Grade: **3**  
Clock Start/From: **12**  
Clock To: **4**  
1st Value:  
2nd Value:  
Value Percent: **10.000**  
Continuous Index:  
Within 8" of Joint: **YES**  
Remarks:

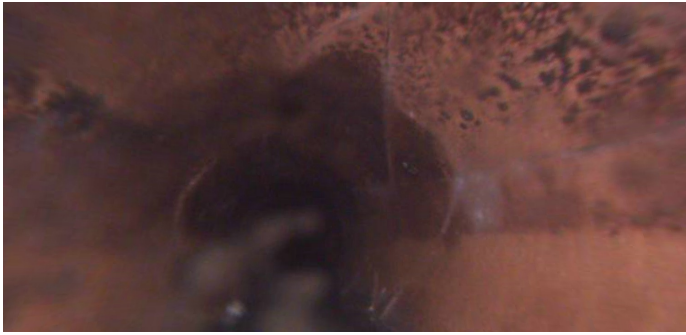
Code: **FM**  
Description: **Fracture Multiple**

Distance (ft): **100.9**  
Structural Grade: **4**  
O&M Grade: **0**  
Clock Start/From: **8**  
Clock To: **4**  
1st Value:  
2nd Value:  
Value Percent:  
Continuous Index: **S04**  
Within 8" of Joint: **YES**  
Remarks:

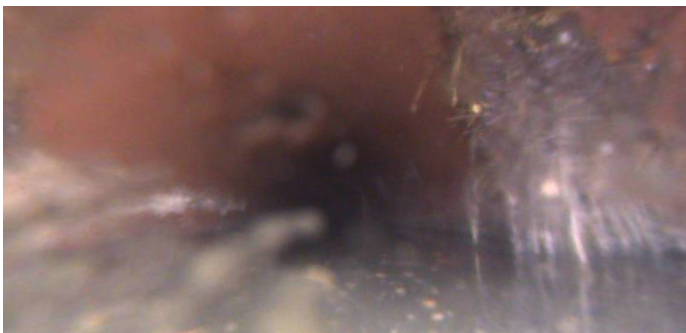
Code: **FM**  
Description: **Fracture Multiple**

Distance (ft): **116.7**  
Structural Grade: **4**  
O&M Grade: **0**  
Clock Start/From: **8**  
Clock To: **4**  
1st Value:  
2nd Value:  
Value Percent:  
Continuous Index: **F04**  
Within 8" of Joint: **YES**  
Remarks:

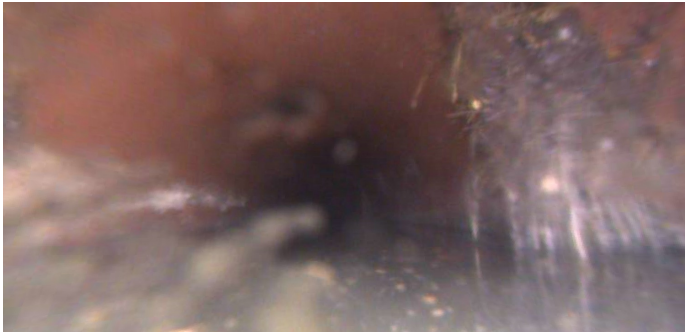
Code: **RFJ**  
Description: **Roots Fine Joint**

Distance (ft): **116.7**  
Structural Grade: **0**  
O&M Grade: **1**  
Clock Start/From: **8**  
Clock To: **4**  
1st Value:  
2nd Value:  
Value Percent:  
Continuous Index: **F03**  
Within 8" of Joint: **YES**  
Remarks:

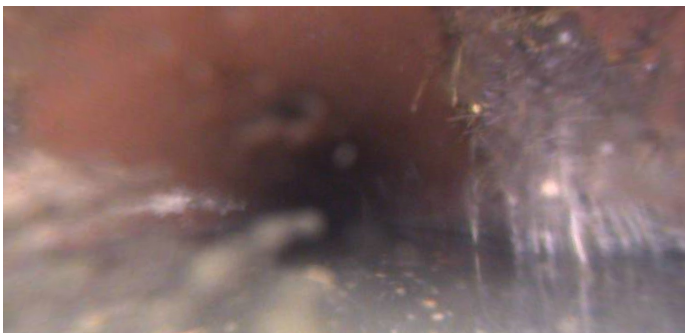
Code: **RMJ**  
Description: **Roots Medium Joint**

Distance (ft): **116.7**  
Structural Grade: **0**  
O&M Grade: **3**  
Clock Start/From: **8**  
Clock To: **12**  
1st Value:  
2nd Value:  
Value Percent: **10.000**  
Continuous Index:  
Within 8" of Joint: **YES**  
Remarks:

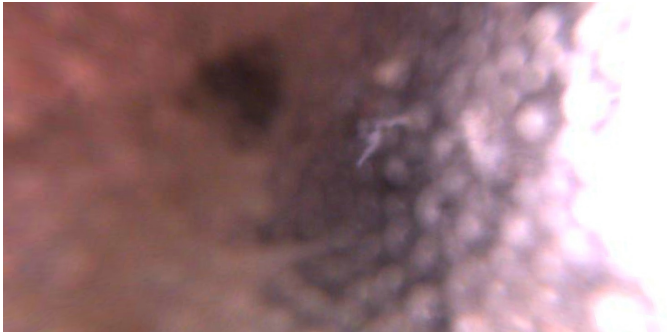
Code: **RMB**  
Description: **Roots Medium Barrel**

Distance (ft): **117.3**  
Structural Grade: **0**  
O&M Grade: **4**  
Clock Start/From: **12**  
Clock To: **6**  
1st Value:  
2nd Value:  
Value Percent: **40.000**  
Continuous Index:  
Within 8" of Joint: **NO**  
Remarks:

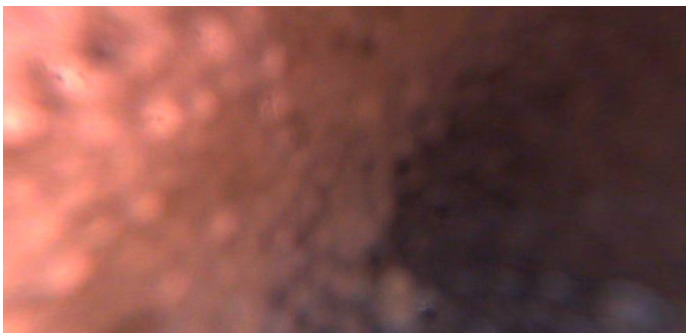
Code: **MSA**  
Description: **Abandoned Survey**

Distance (ft): **118.4**  
Structural Grade: **0**  
O&M Grade: **0**  
Clock Start/From:  
Clock To:  
1st Value:  
2nd Value:  
Value Percent:  
Continuous Index:  
Within 8" of Joint: **NO**  
Remarks: **roots**
