Profile/Photo Observation Report

Date:	03/27/2024	Weather:		Coding:	PACP 7.0
Pipe Length (ft):	234.0	Owner:	City of Hobart	Pre Clean:	Heavy Cleaning
P.O.#:		Surveyor:	S. Bucklin	PSR:	P-603-002-001
Customer:	City of Hobart	Clean Date:	03/25/2024	Shape:	C

Street:	W 39TH PL	Flow Control:	De-watered Using Jetter
City:	Hobart, IN	Year Renewed:	
Location:	Easement/Right of Way	Tape/Media #:	
Purpose:	Sewer System Evaluation Survey (SS)	Dia/Height:	10"
Use:	Sanitary Sewage Pipe	Material:	VCP
Drain Area:		Lining:	None
Category:	NA		
Comment:			
Location Details:		Direction of Survey:	Downstream
US MH:	M-603-002	DS MH:	M-603-001
		Total Length Surveyed (ft):	233.1

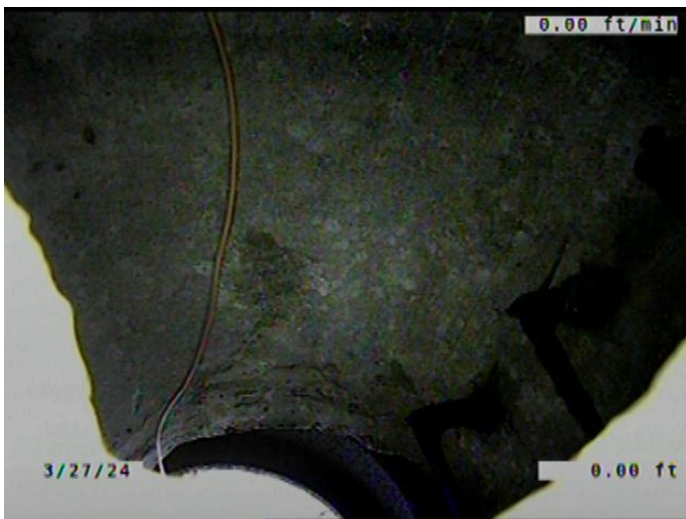
Code: **AMH**
Description: **Manhole**

Distance (ft): **.0**
Structural Grade: **0**
O&M Grade: **0**
Clock Start/From:
Clock To:
1st Value:
2nd Value:
Value Percent:
Continuous Index:
Within 8" of Joint: **NO**
Remarks: **M-603-002**

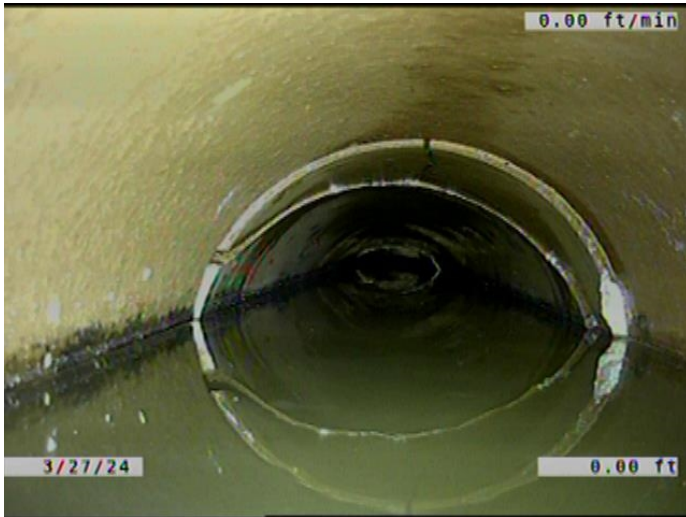
Code: **MWL**
Description: **Miscellaneous Water Level**

Distance (ft): **.0**
Structural Grade: **0**
O&M Grade: **0**
Clock Start/From:
Clock To:
1st Value:
2nd Value:
Value Percent: **65.000**
Continuous Index:
Within 8" of Joint: **NO**
Remarks:

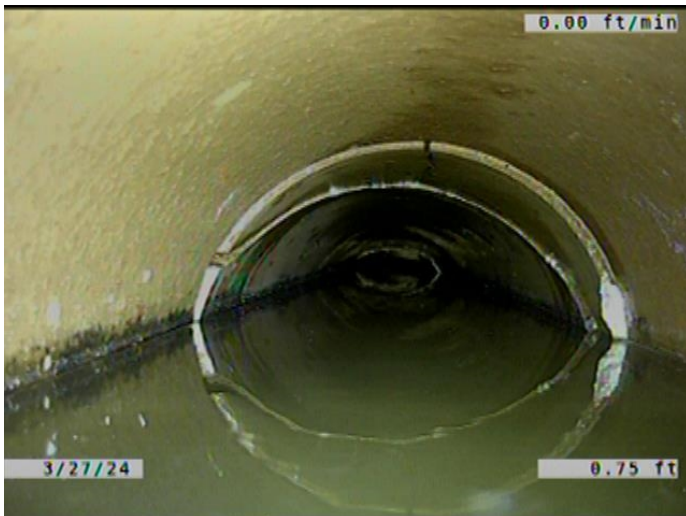
Code: **MGO**
Description: **Miscellaneous General Observation**

Distance (ft): **.7**
Structural Grade: **0**
O&M Grade: **0**
Clock Start/From:
Clock To:
1st Value:
2nd Value:
Value Percent:
Continuous Index:
Within 8" of Joint: **NO**
Remarks: **CHANNEL SITS LOWER THE THE PIPE.
HAD TO START IN THE PIPE.**

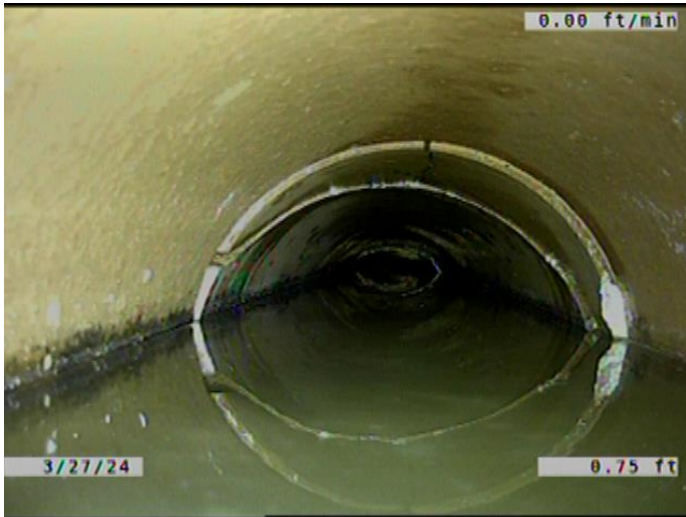
Code: **MWLS**
 Description: **Miscellaneous Water Level Sag**

Distance (ft): **.7**
 Structural Grade: **4**
 O&M Grade: **0**
 Clock Start/From:
 Clock To:
 1st Value:
 2nd Value:
 Value Percent: **70.000**
 Continuous Index: **S01**
 Within 8" of Joint: **NO**
 Remarks:

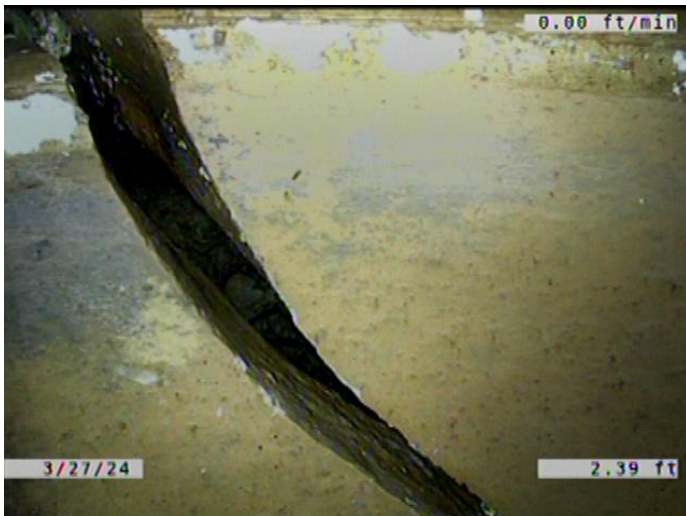
Code: **BSV**
 Description: **Broken Soil Visible**

Distance (ft): **2.4**
 Structural Grade: **5**
 O&M Grade: **0**
 Clock Start/From: **10**
 Clock To: **4**
 1st Value:
 2nd Value:
 Value Percent:
 Continuous Index:
 Within 8" of Joint: **YES**
 Remarks:

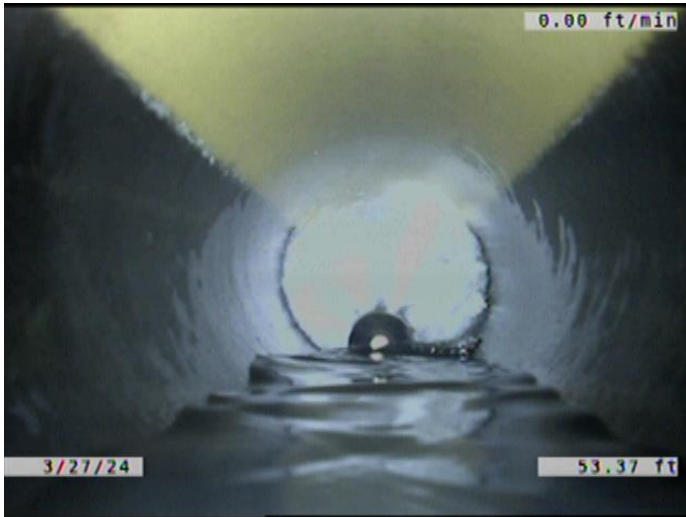
Code:	MGO
Description:	Miscellaneous General Observation
Distance (ft):	53.4
Structural Grade:	0
O&M Grade:	0
Clock Start/From:	
Clock To:	
1st Value:	
2nd Value:	
Value Percent:	
Continuous Index:	
Within 8" of Joint:	NO
Remarks:	COMPUTER ISSUES. HAD TO START ANOTHER VIDEO.

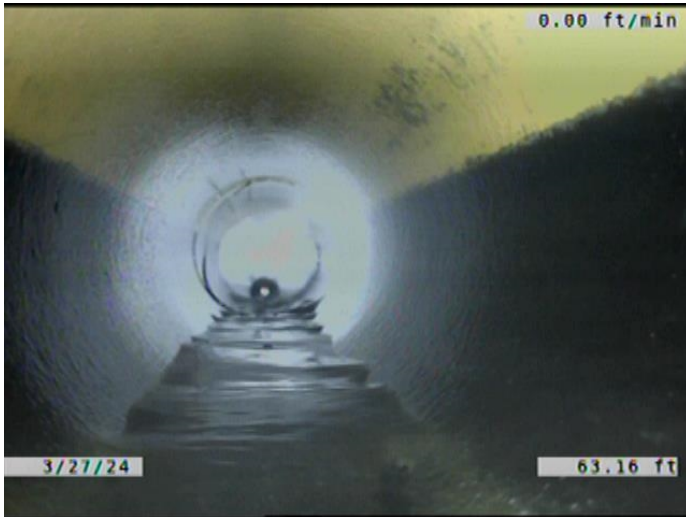
Code: **LL**
Description: **Line Left**

Distance (ft): **63.2**
Structural Grade: **0**
O&M Grade: **1**
Clock Start/From:
Clock To:
1st Value:
2nd Value:
Value Percent: **10.000**
Continuous Index:
Within 8" of Joint: **NO**
Remarks:

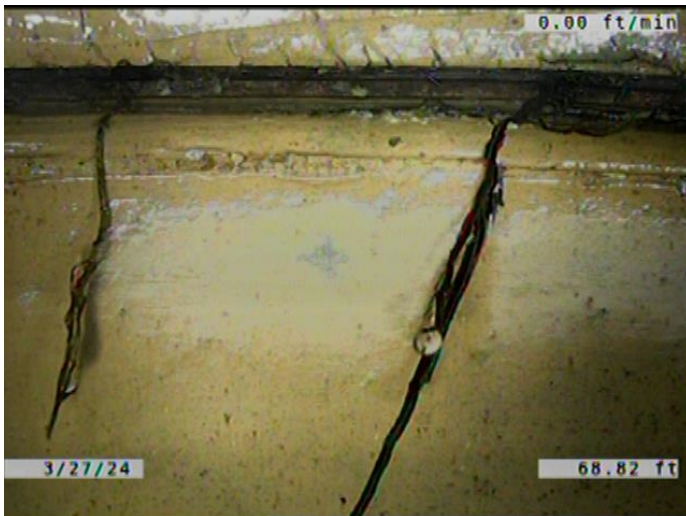
Code: **RFB**
Description: **Roots Fine Barrel**

Distance (ft): **68.8**
Structural Grade: **0**
O&M Grade: **2**
Clock Start/From: **11**
Clock To: **12**
1st Value:
2nd Value:
Value Percent:
Continuous Index:
Within 8" of Joint: **NO**
Remarks:

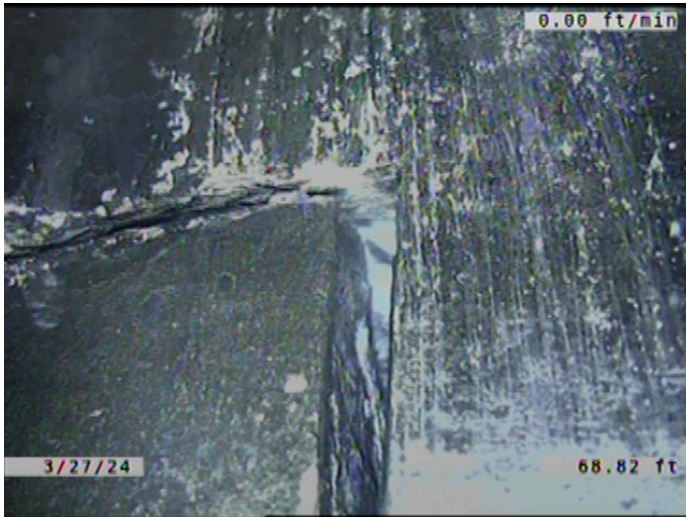
Code: **B**
Description: **Broken**

Distance (ft): **68.8**
Structural Grade: **4**
O&M Grade: **0**
Clock Start/From: **5**
Clock To: **12**
1st Value:
2nd Value:
Value Percent:
Continuous Index:
Within 8" of Joint: **YES**
Remarks:

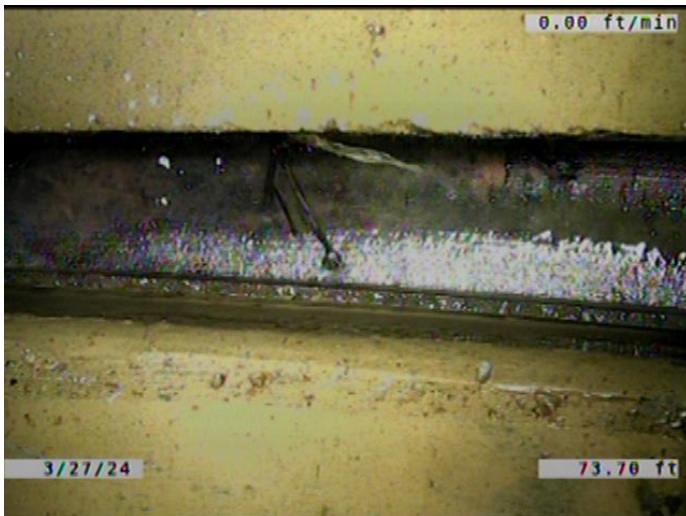
Code: **RFJ**
Description: **Roots Fine Joint**

Distance (ft): **73.7**
Structural Grade: **0**
O&M Grade: **1**
Clock Start/From: **2**
Clock To:
1st Value:
2nd Value:
Value Percent:
Continuous Index:
Within 8" of Joint: **YES**
Remarks:

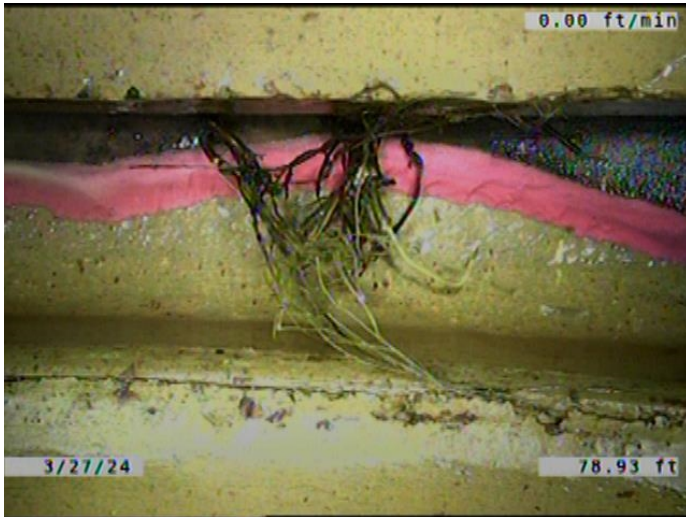
Code: **RFJ**
 Description: **Roots Fine Joint**

Distance (ft): **78.9**
 Structural Grade: **0**
 O&M Grade: **1**
 Clock Start/From: **2**
 Clock To:
 1st Value:
 2nd Value:
 Value Percent:
 Continuous Index:
 Within 8" of Joint: **YES**
 Remarks:

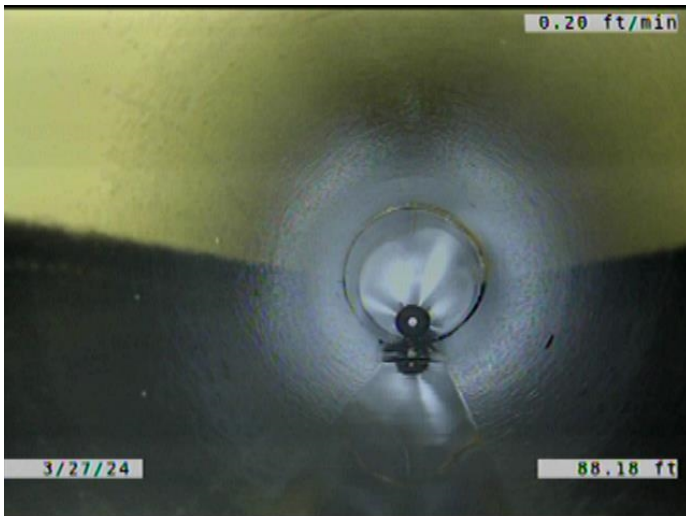
Code: **LR**
 Description: **Line Right**

Distance (ft): **88.2**
 Structural Grade: **0**
 O&M Grade: **1**
 Clock Start/From:
 Clock To:
 1st Value:
 2nd Value:
 Value Percent: **5.000**
 Continuous Index:
 Within 8" of Joint: **NO**
 Remarks:

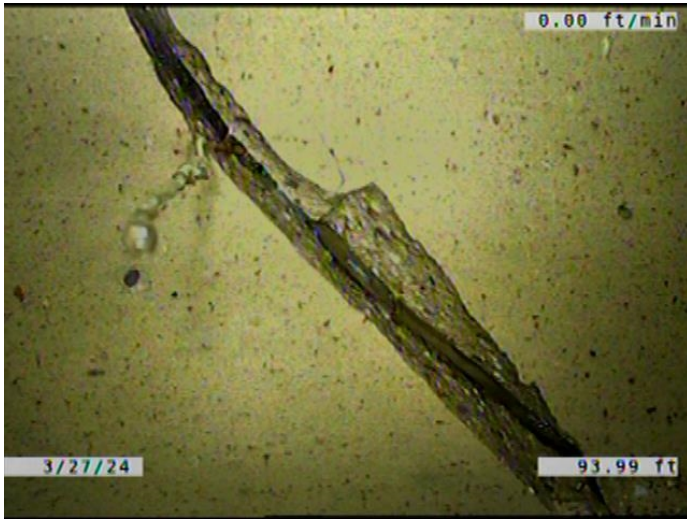
Code: **RFB**
Description: **Roots Fine Barrel**

Distance (ft): **94.0**
Structural Grade: **0**
O&M Grade: **2**
Clock Start/From: **12**
Clock To: **2**
1st Value:
2nd Value:
Value Percent:
Continuous Index:
Within 8" of Joint: **NO**
Remarks:

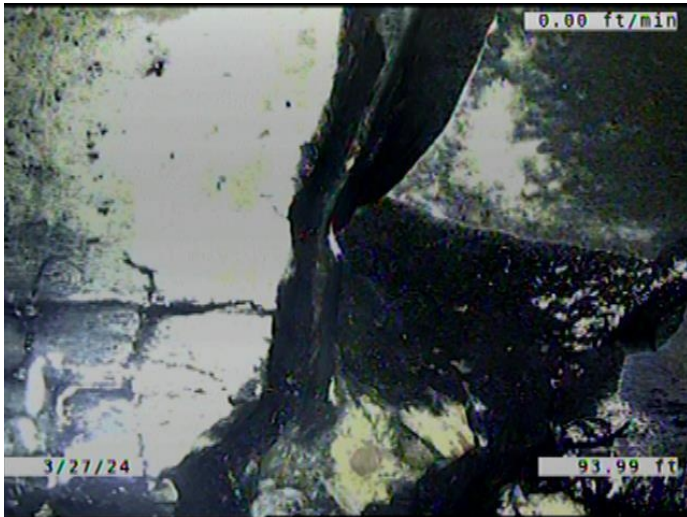
Code: **B**
Description: **Broken**

Distance (ft): **94.0**
Structural Grade: **4**
O&M Grade: **0**
Clock Start/From: **11**
Clock To: **7**
1st Value:
2nd Value:
Value Percent:
Continuous Index:
Within 8" of Joint: **NO**
Remarks:

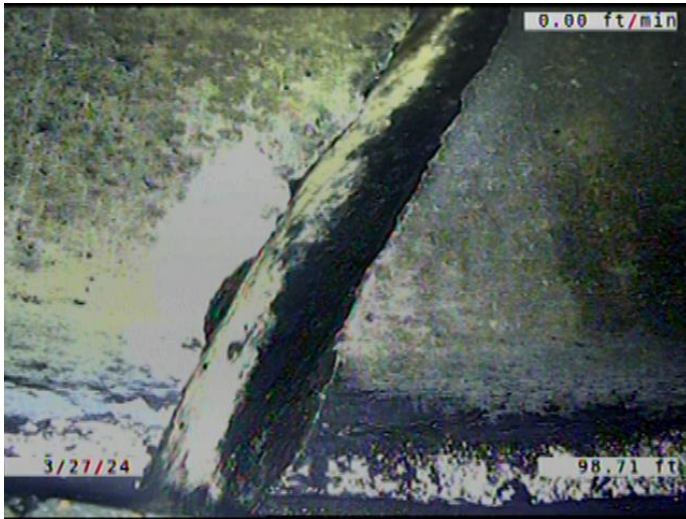
Code: **B**
Description: **Broken**

Distance (ft): **98.7**
Structural Grade: **4**
O&M Grade: **0**
Clock Start/From: **2**
Clock To: **5**
1st Value:
2nd Value:
Value Percent:
Continuous Index:
Within 8" of Joint: **YES**
Remarks:

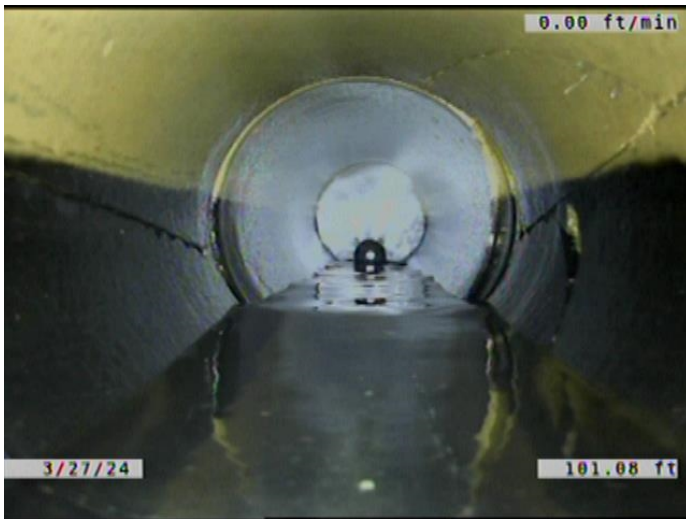
Code: **B**
Description: **Broken**

Distance (ft): **101.1**
Structural Grade: **4**
O&M Grade: **0**
Clock Start/From: **12**
Clock To: **12**
1st Value:
2nd Value:
Value Percent:
Continuous Index:
Within 8" of Joint: **YES**
Remarks:

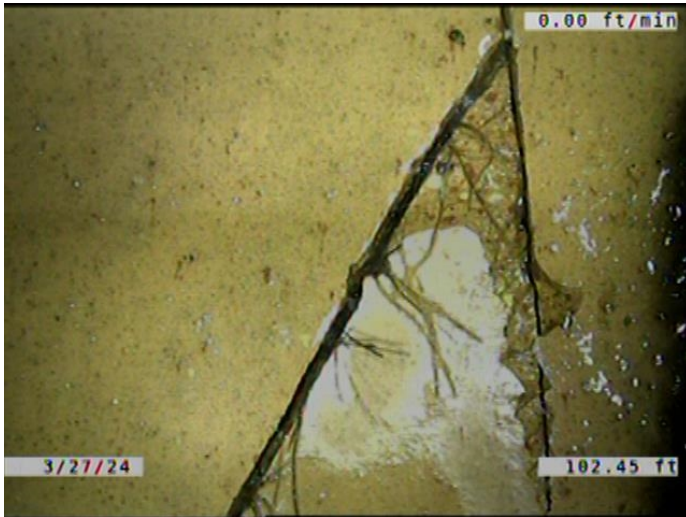
Code: **RFB**
 Description: **Roots Fine Barrel**

Distance (ft): **102.4**
 Structural Grade: **0**
 O&M Grade: **2**
 Clock Start/From: **1**
 Clock To: **3**
 1st Value:
 2nd Value:
 Value Percent:
 Continuous Index:
 Within 8" of Joint: **NO**
 Remarks:

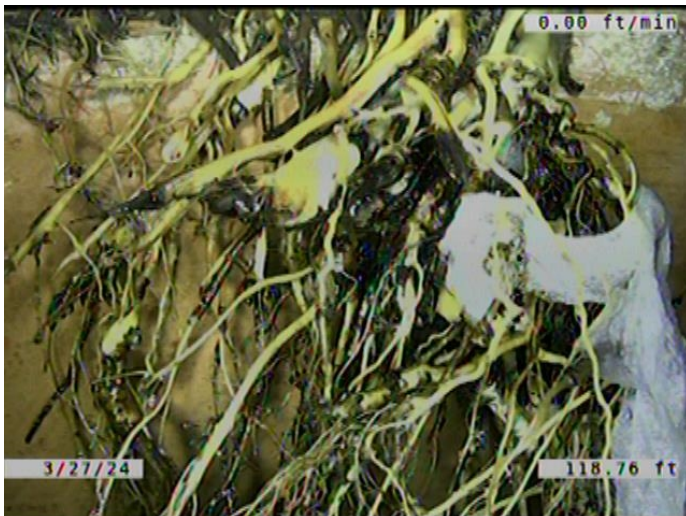
Code: **RMJ**
 Description: **Roots Medium Joint**

Distance (ft): **118.8**
 Structural Grade: **0**
 O&M Grade: **3**
 Clock Start/From: **9**
 Clock To: **12**
 1st Value:
 2nd Value:
 Value Percent: **5.000**
 Continuous Index:
 Within 8" of Joint: **YES**
 Remarks:

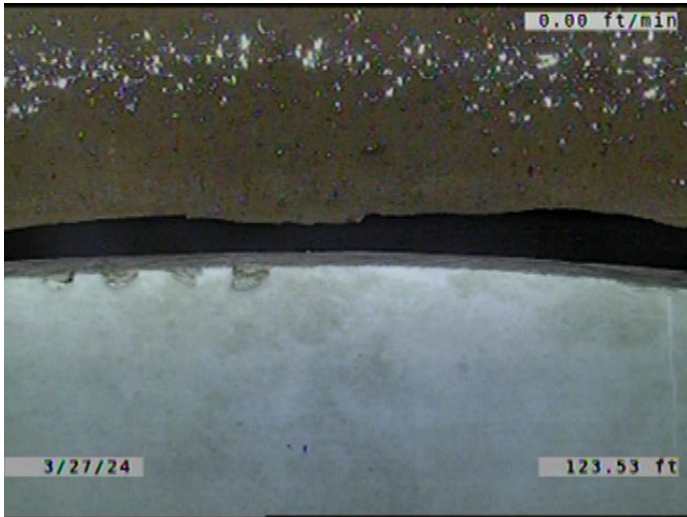
Code: **RPR**
Description: **Point Repair Replacement**

Distance (ft): **123.5**
Structural Grade: **0**
O&M Grade: **0**
Clock Start/From:
Clock To:
1st Value:
2nd Value:
Value Percent:
Continuous Index: **S02**
Within 8" of Joint: **YES**
Remarks: **REPLACED WITH PVC.**

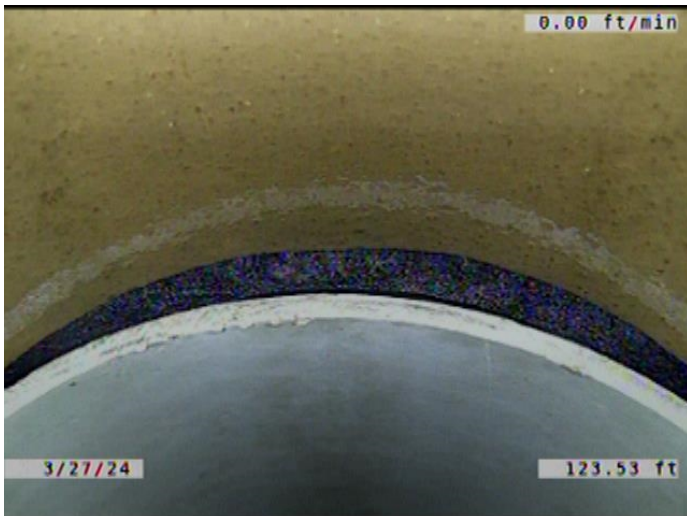
Code: **JOMD**
Description: **Joint Offset Medium Defective**

Distance (ft): **123.5**
Structural Grade: **3**
O&M Grade: **0**
Clock Start/From:
Clock To:
1st Value:
2nd Value:
Value Percent:
Continuous Index:
Within 8" of Joint: **NO**
Remarks:

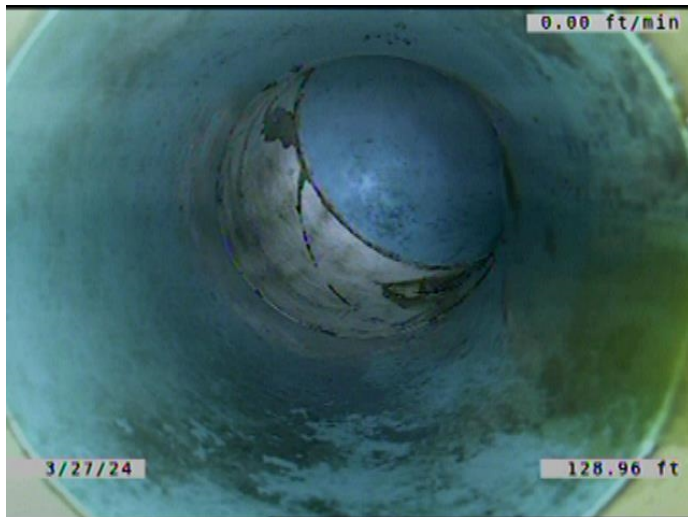
Code:	TFA
Description:	Tap Factory Activity
Distance (ft):	129.0
Structural Grade:	0
O&M Grade:	0
Clock Start/From:	2
Clock To:	
1st Value:	6.000
2nd Value:	
Value Percent:	
Continuous Index:	
Within 8" of Joint:	YES
Remarks:

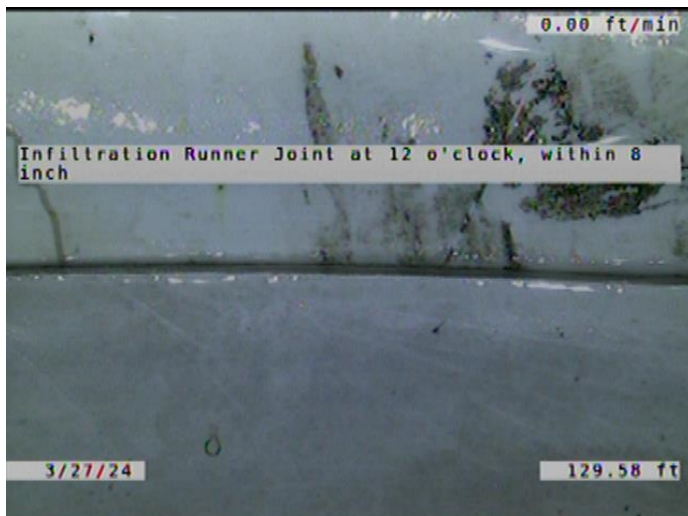
Code:	IRJ
Description:	Infiltration Runner Joint
Distance (ft):	129.6
Structural Grade:	0
O&M Grade:	4
Clock Start/From:	12
Clock To:	
1st Value:	
2nd Value:	
Value Percent:	
Continuous Index:	
Within 8" of Joint:	YES
Remarks:

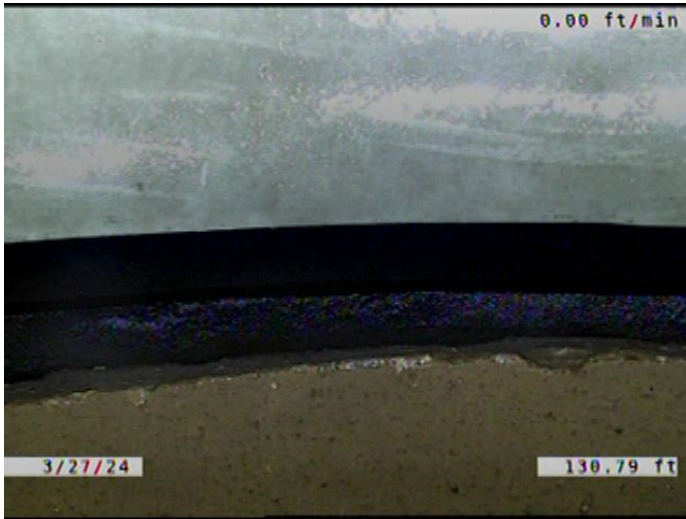
Code: **RPR**
Description: **Point Repair Replacement**

Distance (ft): **130.8**
Structural Grade: **0**
O&M Grade: **0**
Clock Start/From:
Clock To:
1st Value:
2nd Value:
Value Percent:
Continuous Index: **F02**
Within 8" of Joint: **YES**
Remarks: **REPLACED WITH PVC.**

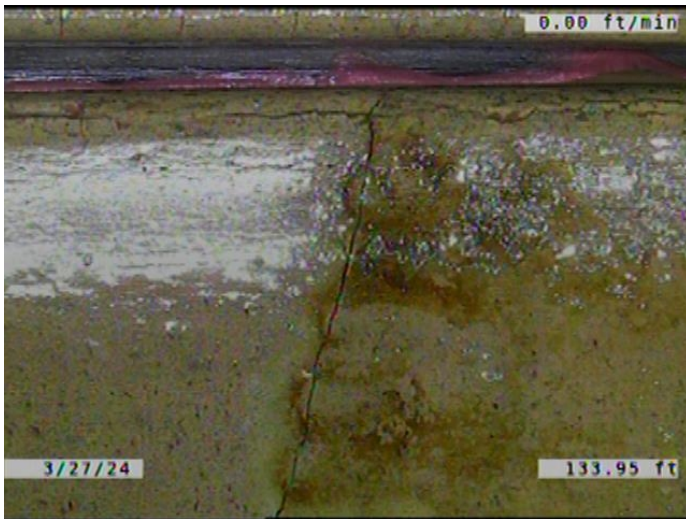
Code: **IDB**
Description: **Infiltration Dripper Barrel**

Distance (ft): **133.9**
Structural Grade: **0**
O&M Grade: **3**
Clock Start/From: **12**
Clock To: **1**
1st Value:
2nd Value:
Value Percent:
Continuous Index:
Within 8" of Joint: **YES**
Remarks:

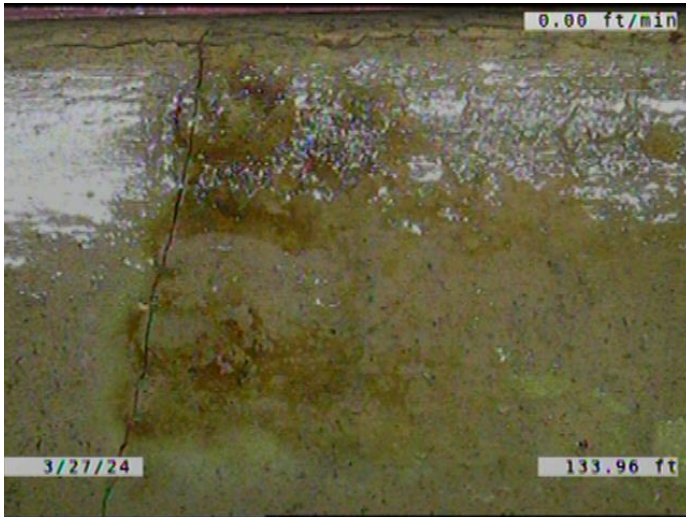
Code: **ISB**
Description: **Infiltration Stain Barrel**

Distance (ft): **134.0**
Structural Grade: **0**
O&M Grade: **1**
Clock Start/From: **12**
Clock To: **3**
1st Value:
2nd Value:
Value Percent:
Continuous Index:
Within 8" of Joint: **YES**
Remarks:

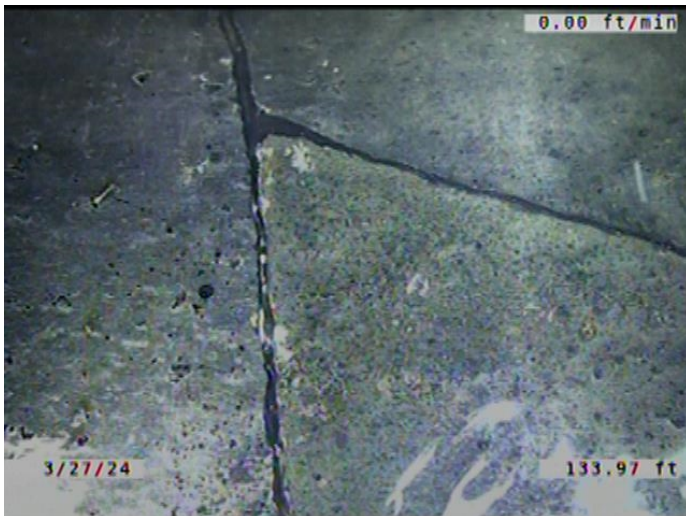
Code: **B**
Description: **Broken**

Distance (ft): **134.0**
Structural Grade: **4**
O&M Grade: **0**
Clock Start/From: **4**
Clock To: **1**
1st Value:
2nd Value:
Value Percent:
Continuous Index:
Within 8" of Joint: **YES**
Remarks:

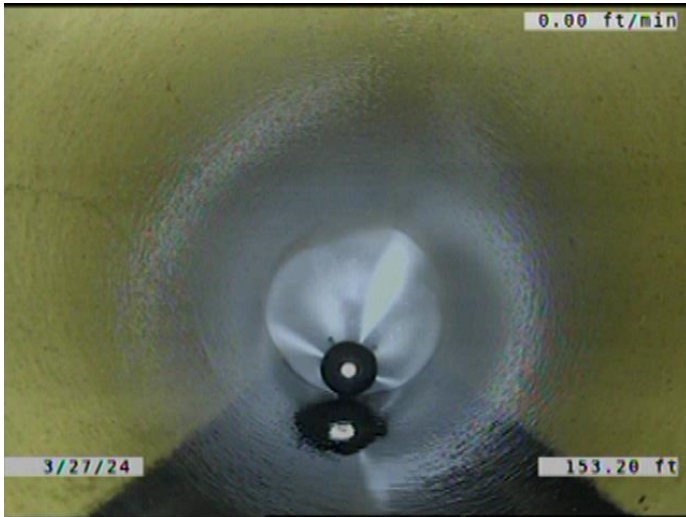
Code: **MWLS**
Description: **Miscellaneous Water Level Sag**

Distance (ft): **153.2**
Structural Grade: **4**
O&M Grade: **0**
Clock Start/From:
Clock To:
1st Value:
2nd Value:
Value Percent: **70.000**
Continuous Index: **F01**
Within 8" of Joint: **NO**
Remarks:

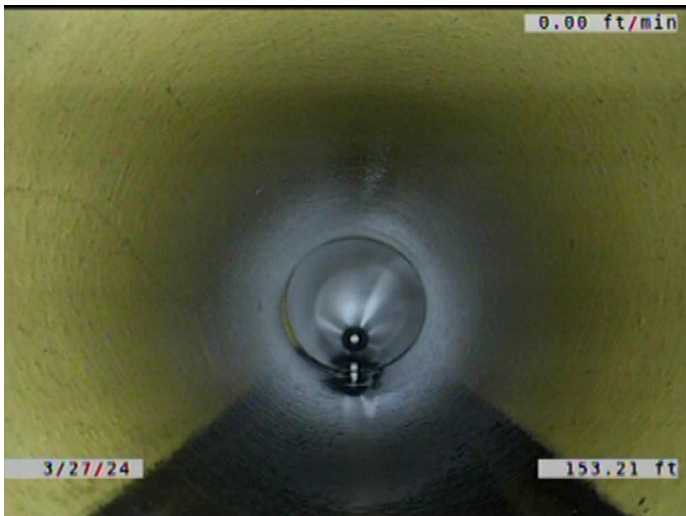
Code: **MWL**
Description: **Miscellaneous Water Level**

Distance (ft): **153.2**
Structural Grade: **0**
O&M Grade: **0**
Clock Start/From:
Clock To:
1st Value:
2nd Value:
Value Percent: **15.000**
Continuous Index:
Within 8" of Joint: **NO**
Remarks:

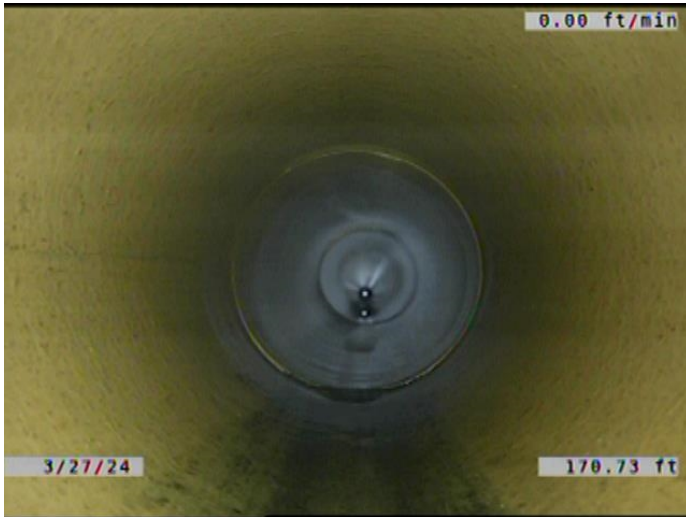
Code: **MWL**
Description: **Miscellaneous Water Level**

Distance (ft): **170.7**
Structural Grade: **0**
O&M Grade: **0**
Clock Start/From:
Clock To:
1st Value:
2nd Value:
Value Percent: **5.000**
Continuous Index:
Within 8" of Joint: **NO**
Remarks:

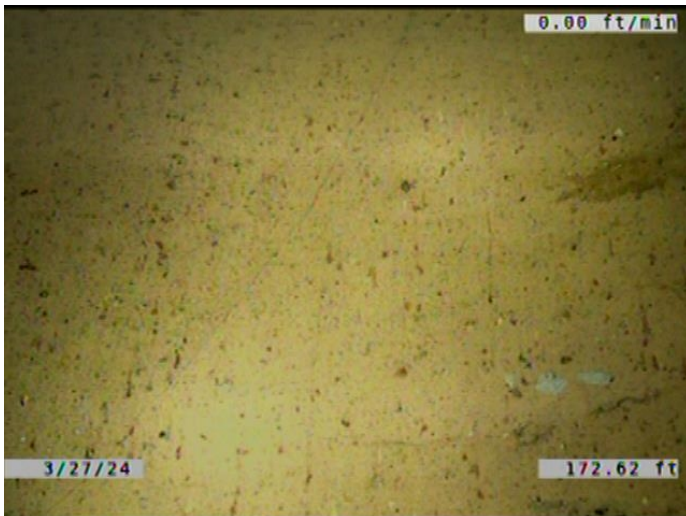
Code: **CM**
Description: **Crack Multiple**

Distance (ft): **172.6**
Structural Grade: **3**
O&M Grade: **0**
Clock Start/From: **7**
Clock To: **11**
1st Value:
2nd Value:
Value Percent:
Continuous Index:
Within 8" of Joint: **YES**
Remarks:

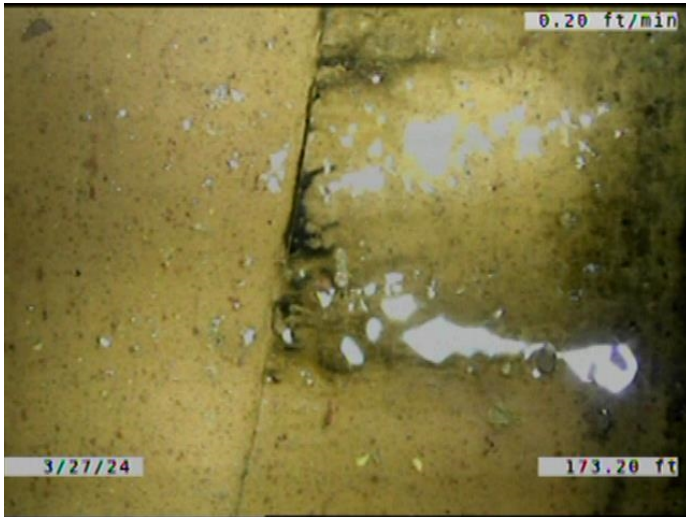
Code: **IRB**
Description: **Infiltration Runner Barrel**

Distance (ft): **173.2**
Structural Grade: **0**
O&M Grade: **4**
Clock Start/From: **8**
Clock To:
1st Value:
2nd Value:
Value Percent:
Continuous Index:
Within 8" of Joint: **YES**
Remarks:

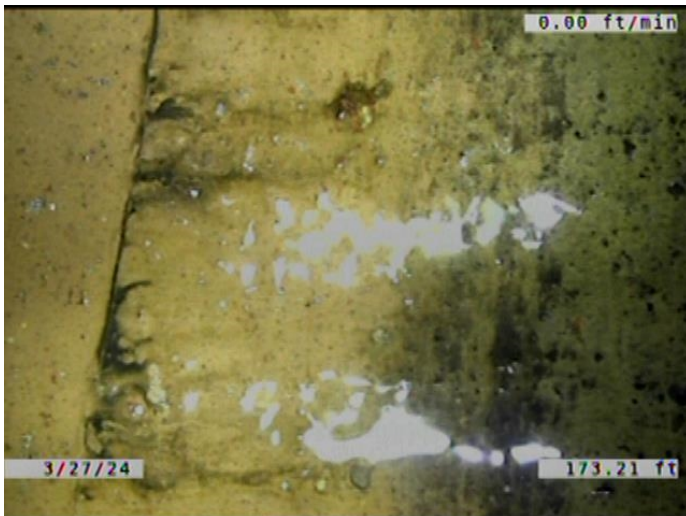
Code: **ISB**
Description: **Infiltration Stain Barrel**

Distance (ft): **173.2**
Structural Grade: **0**
O&M Grade: **1**
Clock Start/From: **6**
Clock To: **8**
1st Value:
2nd Value:
Value Percent:
Continuous Index:
Within 8" of Joint: **YES**
Remarks:

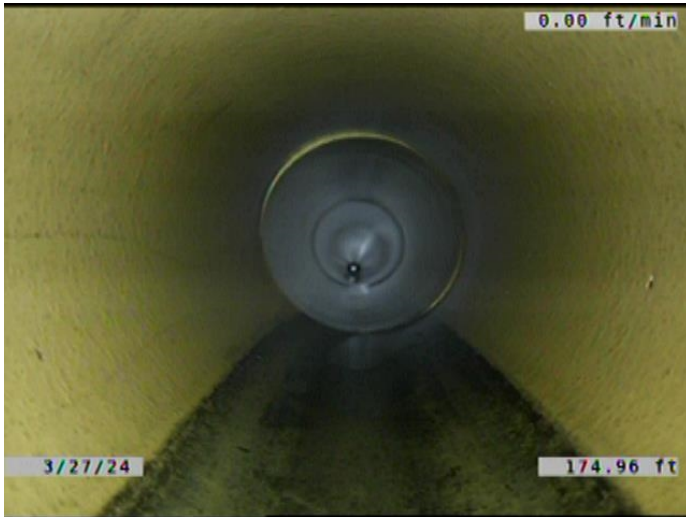
Code: **MWLS**
Description: **Miscellaneous Water Level Sag**

Distance (ft): **175.0**
Structural Grade: **3**
O&M Grade: **0**
Clock Start/From:
Clock To:
1st Value:
2nd Value:
Value Percent: **45.000**
Continuous Index: **S03**
Within 8" of Joint: **NO**
Remarks:

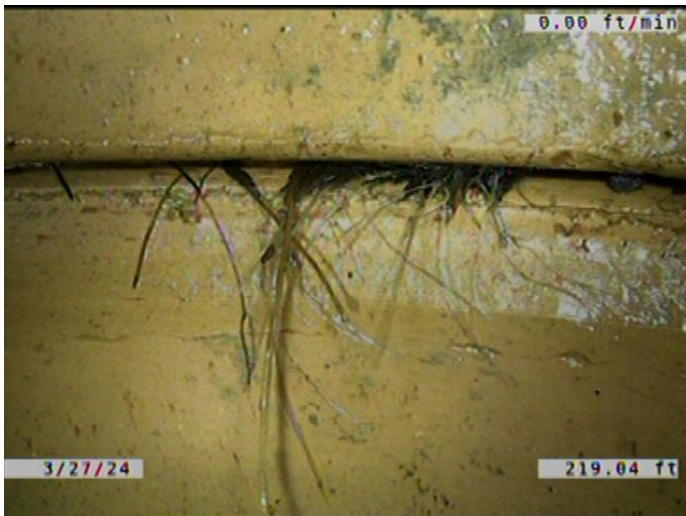
Code: **RFJ**
Description: **Roots Fine Joint**

Distance (ft): **219.0**
Structural Grade: **0**
O&M Grade: **1**
Clock Start/From: **1**
Clock To: **3**
1st Value:
2nd Value:
Value Percent:
Continuous Index:
Within 8" of Joint: **YES**
Remarks:

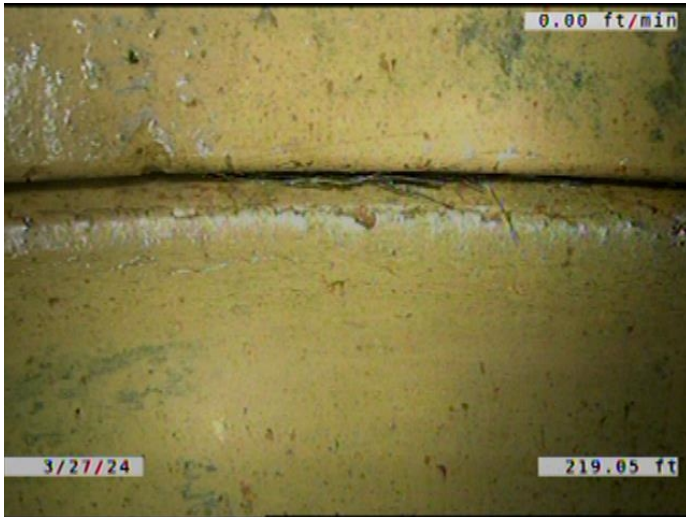
Code: **RFJ**
 Description: **Roots Fine Joint**

Distance (ft): **219.0**
 Structural Grade: **0**
 O&M Grade: **1**
 Clock Start/From: **9**
 Clock To: **10**
 1st Value:
 2nd Value:
 Value Percent:
 Continuous Index:
 Within 8" of Joint: **YES**
 Remarks:

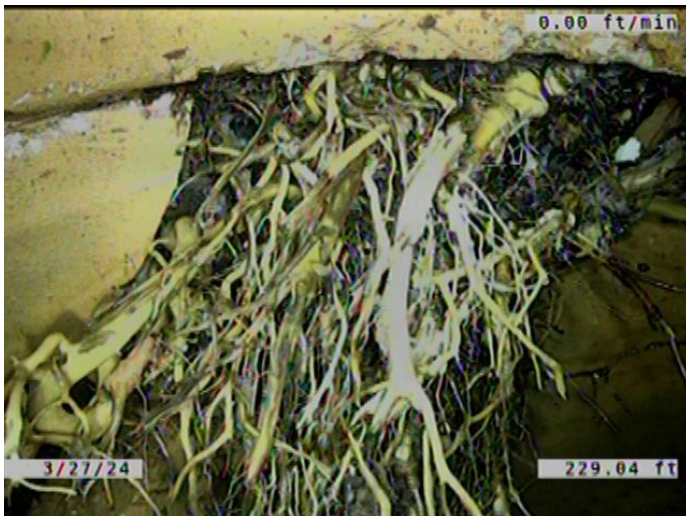
Code: **RMB**
 Description: **Roots Medium Barrel**

Distance (ft): **229.0**
 Structural Grade: **0**
 O&M Grade: **4**
 Clock Start/From: **9**
 Clock To: **3**
 1st Value:
 2nd Value:
 Value Percent: **5.000**
 Continuous Index:
 Within 8" of Joint: **NO**
 Remarks:

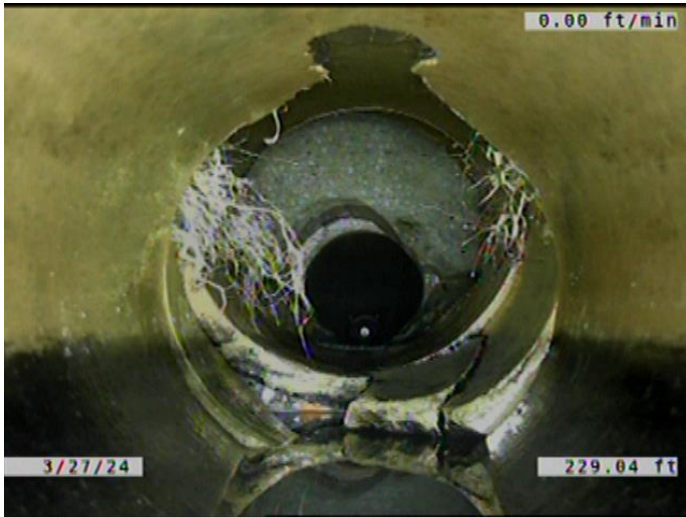
Code: **DR**
Description: **Deformed Rigid**

Distance (ft): **229.0**
Structural Grade: **5**
O&M Grade: **0**
Clock Start/From:
Clock To:
1st Value:
2nd Value:
Value Percent: **10.000**
Continuous Index:
Within 8" of Joint: **NO**
Remarks:

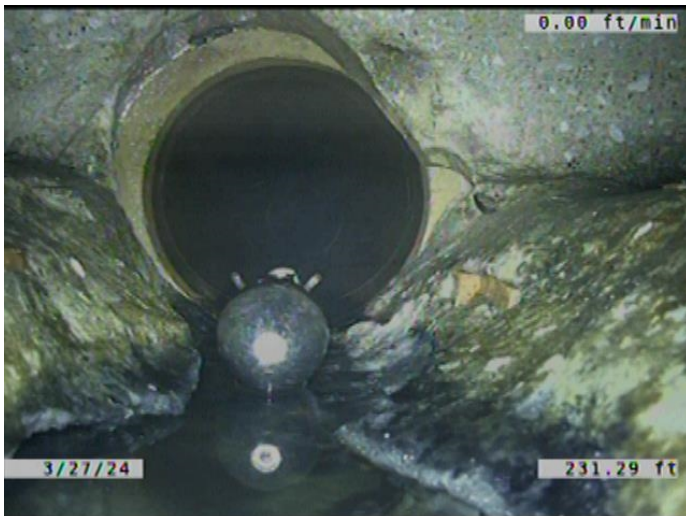
Code: **MWLS**
Description: **Miscellaneous Water Level Sag**

Distance (ft): **231.3**
Structural Grade: **3**
O&M Grade: **0**
Clock Start/From:
Clock To:
1st Value:
2nd Value:
Value Percent: **45.000**
Continuous Index: **F03**
Within 8" of Joint: **NO**
Remarks:

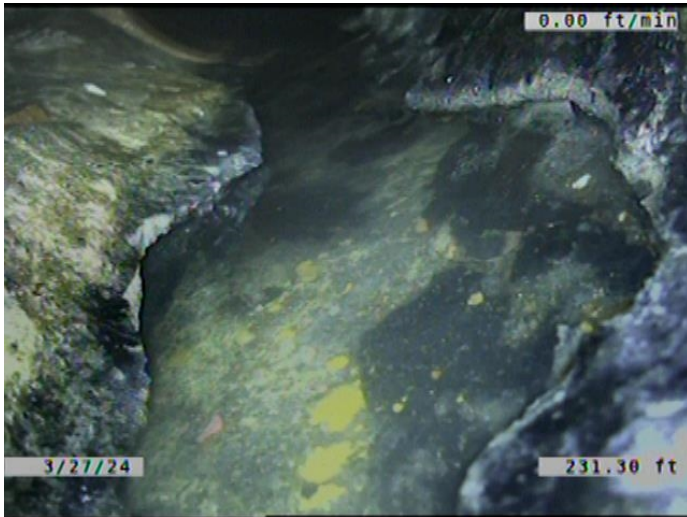
Code:	MGO
Description:	Miscellaneous General Observation
Distance (ft):	231.3
Structural Grade:	0
O&M Grade:	0
Clock Start/From:	
Clock To:	
1st Value:	
2nd Value:	
Value Percent:	
Continuous Index:	
Within 8" of Joint:	NO
Remarks:	CHANNEL MISSING IN THE MANHOLE.

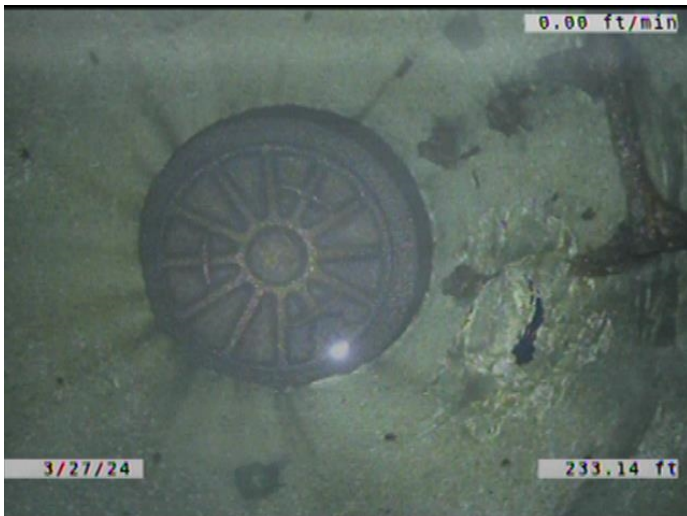
Code:	AMH
Description:	Manhole
Distance (ft):	233.1
Structural Grade:	0
O&M Grade:	0
Clock Start/From:	
Clock To:	
1st Value:	
2nd Value:	
Value Percent:	
Continuous Index:	
Within 8" of Joint:	NO
Remarks:	M-603-001
