## Profile/Photo Observation Report

Street:	<b>OFF W 39TH PL</b>	Flow Control:	<b>Not Controlled</b>
City:	<b>Hobart, IN</b>	Year Renewed:	
Location:	<b>Other</b>	Tape/Media #:	
Purpose:	<b>Not Known</b>	Dia/Height:	<b>10"</b>
Use:	<b>Sanitary</b>	Material:	<b>VCP</b>
Drain Area:	<b>NA</b>	Lining:	
Category:	<b>NA</b>		
Comment:

Location Details:		Direction of Survey:	<b>Downstream</b>
US MH:	<b>M-603-002</b>	DS MH:	<b>M-603-003</b>
		Total Length Surveyed (ft):	<b>2.3</b>

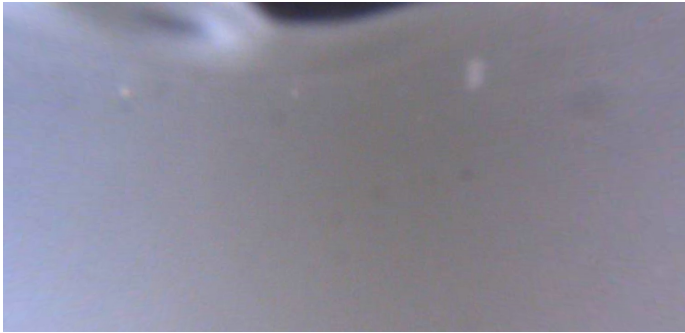
Code:	<b>MWL</b>
Description:	<b>Water Level</b>

Distance (ft):	<b>.0</b>
Structural Grade:	<b>0</b>
O&M Grade:	<b>0</b>
Clock Start/From:	
Clock To:	
1st Value:	
2nd Value:	
Value Percent:	<b>70.000</b>
Continuous Index:	
Within 8" of Joint:	<b>NO</b>
Remarks:

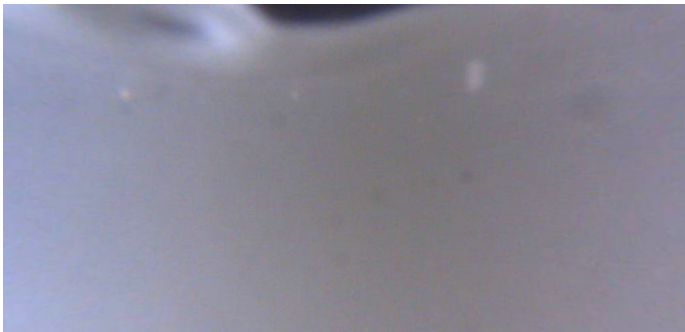
Code:	<b>MCU</b>
Description:	<b>Camera Underwater</b>

Distance (ft):	<b>.0</b>
Structural Grade:	<b>0</b>
O&M Grade:	<b>4</b>
Clock Start/From:	
Clock To:	
1st Value:	
2nd Value:	
Value Percent:	
Continuous Index:	
Within 8" of Joint:	<b>NO</b>
Remarks:

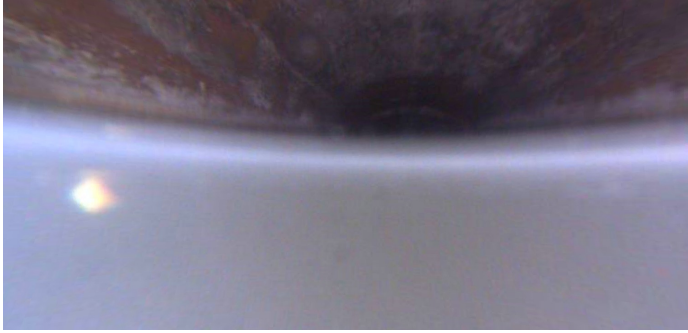
Code:	<b>MSA</b>
Description:	<b>Abandoned Survey</b>
Distance (ft):	<b>2.3</b>
Structural Grade:	<b>0</b>
O&M Grade:	<b>0</b>
Clock Start/From:	
Clock To:	
1st Value:	
2nd Value:	
Value Percent:	
Continuous Index:	
Within 8" of Joint:	<b>NO</b>
Remarks:	<b>mcu</b>
