Profile/Photo Observation Report

Date:	04/11/2018	Weather:		Coding:	PACP 6.0
Pipe Length (ft):	246.6	Owner:	NA	Pre Clean:	Not Known
P.O.#:		Surveyor:	Jen Costello	PSR:	P-603-003-002
Customer:		Clean Date:	01/01/1900	Shape:	C

Street:	W 40th ave	Flow Control:	Not Controlled
City:	Hobart, IN	Year Renewed:	
Location:	Other	Tape/Media #:	
Purpose:	Not Known	Dia/Height:	10"
Use:	Sanitary	Material:	VCP
Drain Area:	NA	Lining:	
Category:	NA		
Comment:

Location Details:		Direction of Survey:	Downstream
US MH:	M-603-002	DS MH:	M-603-003
		Total Length Surveyed (ft):	2.3

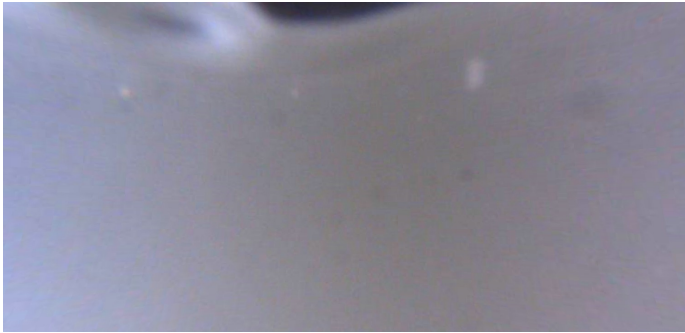
Code:	MWL
Description:	Water Level

Distance (ft):	.0
Structural Grade:	0
O&M Grade:	0
Clock Start/From:	
Clock To:	
1st Value:	
2nd Value:	
Value Percent:	70.000
Continuous Index:	
Within 8" of Joint:	NO
Remarks:

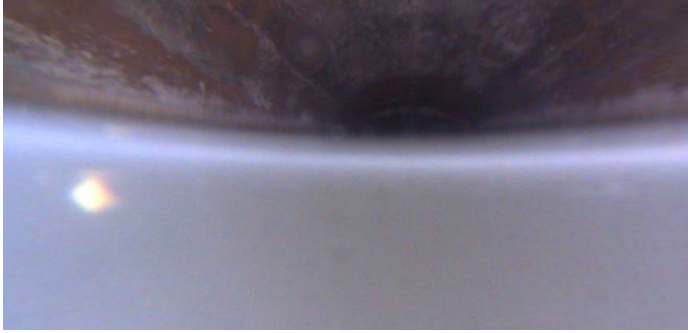
Code:	MSA
Description:	Abandoned Survey
Distance (ft):	2.3
Structural Grade:	0
O&M Grade:	0
Clock Start/From:	
Clock To:	
1st Value:	
2nd Value:	
Value Percent:	
Continuous Index:	
Within 8" of Joint:	NO
Remarks:	mcu
