## Profile/Photo Observation Report

Street:	<b>OFF W 39TH PL</b>	Flow Control:	<b>Not Controlled</b>
City:	<b>Hobart, IN</b>	Year Renewed:	
Location:	<b>Other</b>	Tape/Media #:	
Purpose:	<b>Not Known</b>	Dia/Height:	<b>10"</b>
Use:	<b>Sanitary</b>	Material:	<b>VCP</b>
Drain Area:	<b>NA</b>	Lining:	
Category:	<b>NA</b>		
Comment:

Location Details:		Direction of Survey:	<b>Upstream</b>
US MH:	<b>M-603-002</b>	DS MH:	<b>M-603-003</b>
		Total Length Surveyed (ft):	<b>5.5</b>

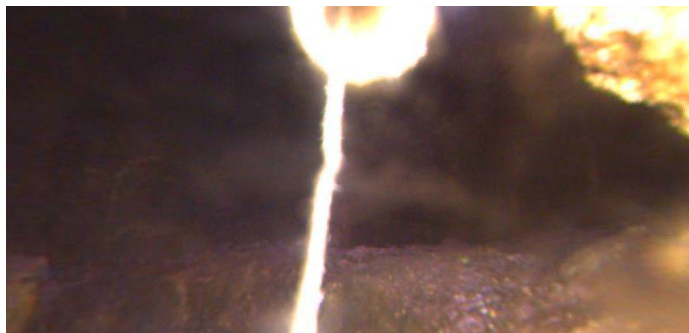
Code: **AMH**  
 Description: **Manhole**  
 Distance (ft): **.0**  
 Structural Grade: **0**  
 O&M Grade: **0**  
 Clock Start/From:  
 Clock To:  
 1st Value:  
 2nd Value:  
 Value Percent:  
 Continuous Index:  
 Within 8" of Joint: **NO**  
 Remarks: **M-603-002**

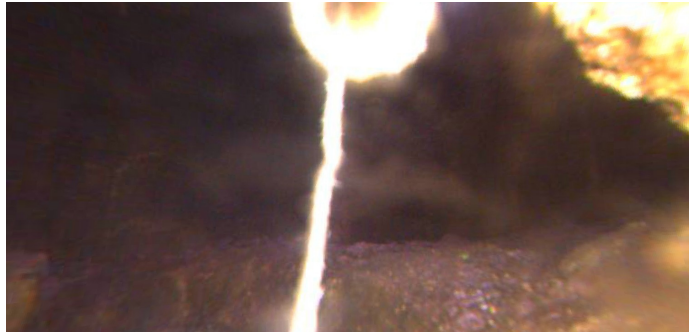
Code: **MWL**  
Description: **Water Level**

Distance (ft): **.0**  
Structural Grade: **0**  
O&M Grade: **0**  
Clock Start/From:  
Clock To:  
1st Value:  
2nd Value:  
Value Percent: **5.000**  
Continuous Index:  
Within 8" of Joint: **NO**  
Remarks:

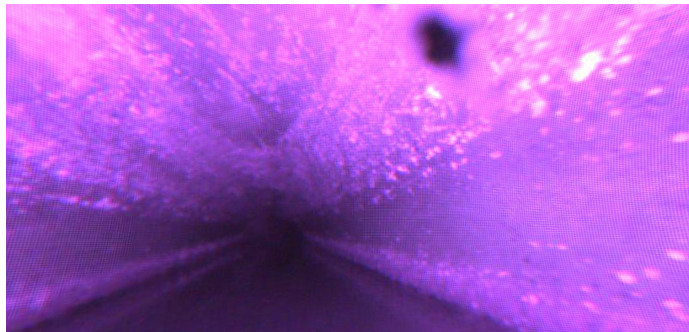
Code: **MSA**  
Description: **Abandoned Survey**

Distance (ft): **5.5**  
Structural Grade: **0**  
O&M Grade: **0**  
Clock Start/From:  
Clock To:  
1st Value:  
2nd Value:  
Value Percent:  
Continuous Index:  
Within 8" of Joint: **NO**  
Remarks: **debris**
