## Profile/Photo Observation Report

Street:	<b>OFF W 39TH PL</b>	Flow Control:	<b>Not Controlled</b>
City:	<b>Hobart, IN</b>	Year Renewed:	
Location:	<b>Other</b>	Tape/Media #:	
Purpose:	<b>Not Known</b>	Dia/Height:	<b>8"</b>
Use:	<b>Sanitary</b>	Material:	<b>VCP</b>
Drain Area:	<b>NA</b>	Lining:	
Category:	<b>NA</b>		
Comment:

Location Details:		Direction of Survey:	<b>Downstream</b>
US MH:	<b>M-603-003</b>	DS MH:	<b>M-603-026</b>
		Total Length Surveyed (ft):	<b>18.6</b>

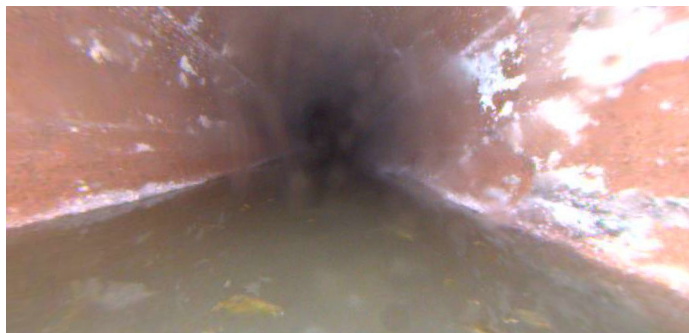
Code: **AMH**  
 Description: **Manhole**  
 Distance (ft): **.0**  
 Structural Grade: **0**  
 O&M Grade: **0**  
 Clock Start/From:  
 Clock To:  
 1st Value:  
 2nd Value:  
 Value Percent:  
 Continuous Index:  
 Within 8" of Joint: **NO**  
 Remarks: **M-603-003**

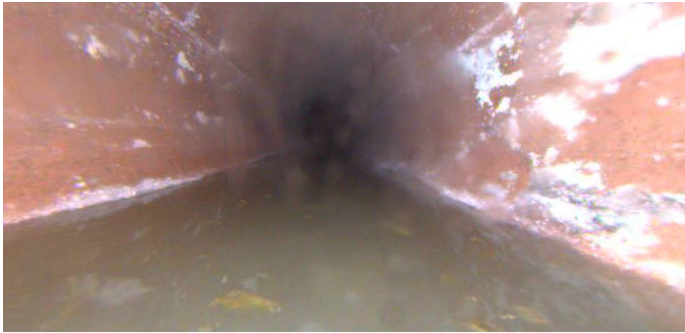
Code:	<b>MWL</b>
Description:	<b>Water Level</b>

Distance (ft):	<b>.0</b>
Structural Grade:	<b>0</b>
O&M Grade:	<b>0</b>
Clock Start/From:	
Clock To:	
1st Value:	
2nd Value:	
Value Percent:	<b>30.000</b>
Continuous Index:	
Within 8" of Joint:	<b>NO</b>
Remarks:

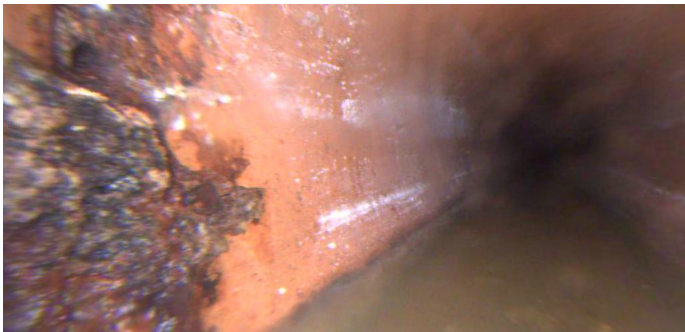
Code:	<b>DAE</b>
Description:	<b>Deposits Attached Encrustation</b>

Distance (ft):	<b>3.8</b>
Structural Grade:	<b>0</b>
O&M Grade:	<b>2</b>
Clock Start/From:	<b>8</b>
Clock To:	<b>10</b>
1st Value:	
2nd Value:	
Value Percent:	<b>5.000</b>
Continuous Index:	
Within 8" of Joint:	<b>YES</b>
Remarks:

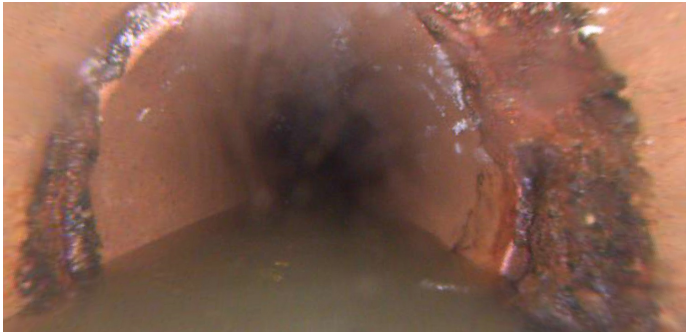
Code: **DAE**  
Description: **Deposits Attached Encrustation**

Distance (ft): **7.8**  
Structural Grade: **0**  
O&M Grade: **2**  
Clock Start/From: **8**  
Clock To: **4**  
1st Value:  
2nd Value:  
Value Percent: **5.000**  
Continuous Index:  
Within 8" of Joint: **YES**  
Remarks:

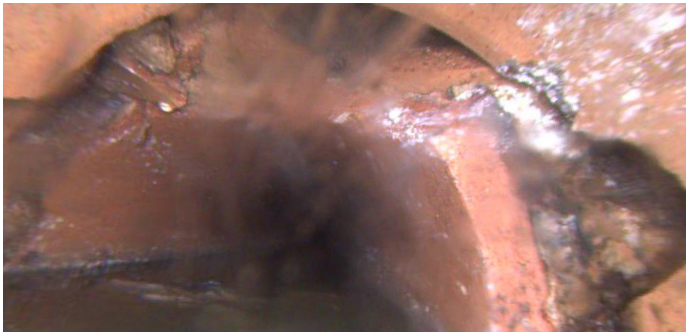
Code: **HVV**  
Description: **Hole Void Visible**

Distance (ft): **17.7**  
Structural Grade: **5**  
O&M Grade: **0**  
Clock Start/From: **8**  
Clock To: **4**  
1st Value:  
2nd Value:  
Value Percent:  
Continuous Index:  
Within 8" of Joint: **YES**  
Remarks:

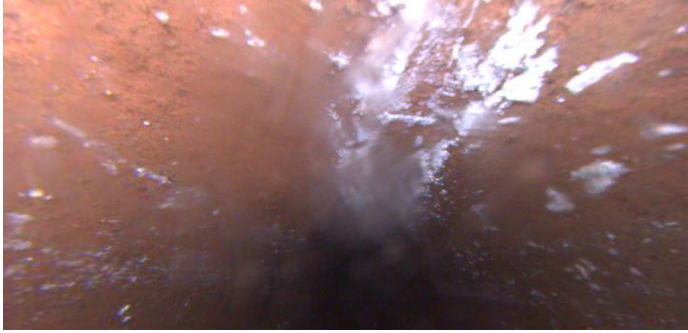
Code:	<b>MSA</b>
Description:	<b>Abandoned Survey</b>
Distance (ft):	<b>18.6</b>
Structural Grade:	<b>0</b>
O&M Grade:	<b>0</b>
Clock Start/From:	
Clock To:	
1st Value:	
2nd Value:	
Value Percent:	
Continuous Index:	
Within 8" of Joint:	<b>NO</b>
Remarks:	<b>debris under water</b>
