## Profile/Photo Observation Report

Street:	<b>W 40th ave</b>	Flow Control:	<b>Not Controlled</b>
City:	<b>Hobart, IN</b>	Year Renewed:	
Location:	<b>Other</b>	Tape/Media #:	
Purpose:	<b>Not Known</b>	Dia/Height:	<b>8"</b>
Use:	<b>Sanitary</b>	Material:	<b>VCP</b>
Drain Area:	<b>NA</b>	Lining:	
Category:	<b>NA</b>		
Comment:

Location Details:		Direction of Survey:	<b>Downstream</b>
US MH:	<b>M-603-003</b>	DS MH:	<b>M-603-026</b>
		Total Length Surveyed (ft):	<b>18.6</b>

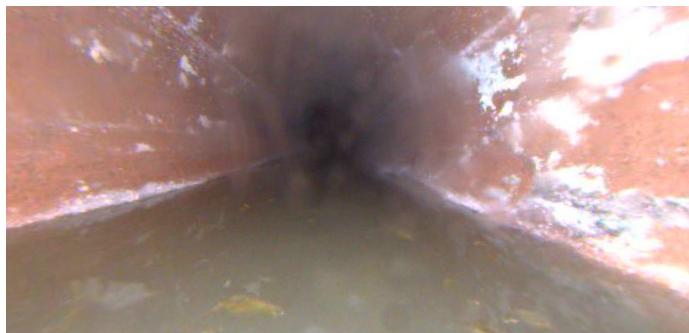
Code: **AMH**  
 Description: **Manhole**

Distance (ft): **.0**  
 Structural Grade: **0**  
 O&M Grade: **0**  
 Clock Start/From:  
 Clock To:  
 1st Value:  
 2nd Value:  
 Value Percent:  
 Continuous Index:  
 Within 8" of Joint: **NO**  
 Remarks: **M-603-003**

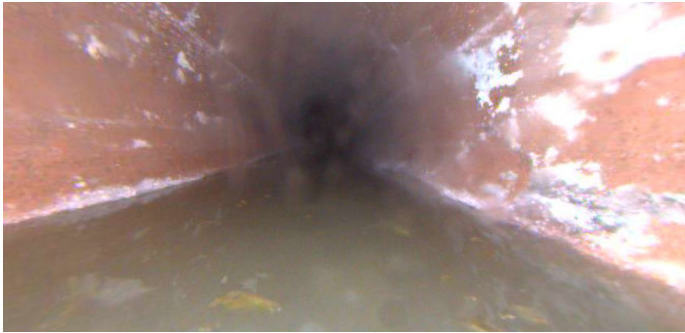
Code:	<b>MWL</b>
Description:	<b>Water Level</b>

Distance (ft):	<b>.0</b>
Structural Grade:	<b>0</b>
O&M Grade:	<b>0</b>
Clock Start/From:	
Clock To:	
1st Value:	
2nd Value:	
Value Percent:	<b>30.000</b>
Continuous Index:	
Within 8" of Joint:	<b>NO</b>
Remarks:

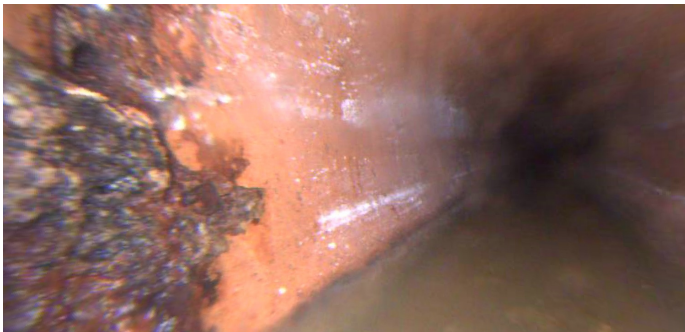
Code:	<b>DAE</b>
Description:	<b>Deposits Attached Encrustation</b>

Distance (ft):	<b>3.8</b>
Structural Grade:	<b>0</b>
O&M Grade:	<b>2</b>
Clock Start/From:	<b>8</b>
Clock To:	<b>10</b>
1st Value:	
2nd Value:	
Value Percent:	<b>5.000</b>
Continuous Index:	
Within 8" of Joint:	<b>YES</b>
Remarks:

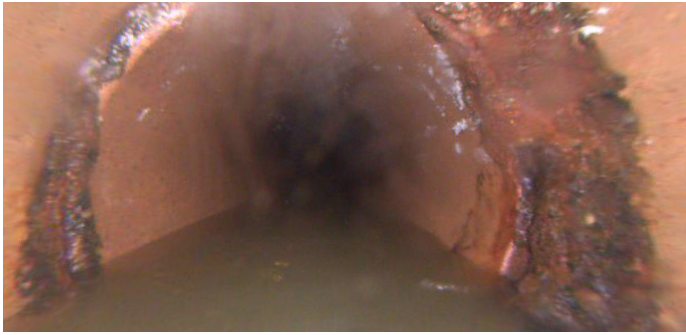
Code: **DAE**  
Description: **Deposits Attached Encrustation**

Distance (ft): **7.8**  
Structural Grade: **0**  
O&M Grade: **2**  
Clock Start/From: **8**  
Clock To: **4**  
1st Value:  
2nd Value:  
Value Percent: **5.000**  
Continuous Index:  
Within 8" of Joint: **YES**  
Remarks:

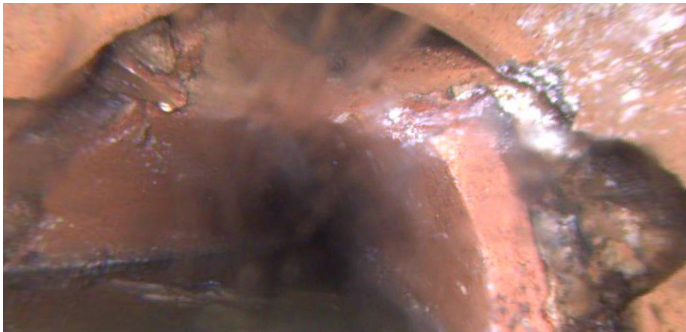
Code: **HVV**  
Description: **Hole Void Visible**

Distance (ft): **17.7**  
Structural Grade: **5**  
O&M Grade: **0**  
Clock Start/From: **8**  
Clock To: **4**  
1st Value:  
2nd Value:  
Value Percent:  
Continuous Index:  
Within 8" of Joint: **YES**  
Remarks:

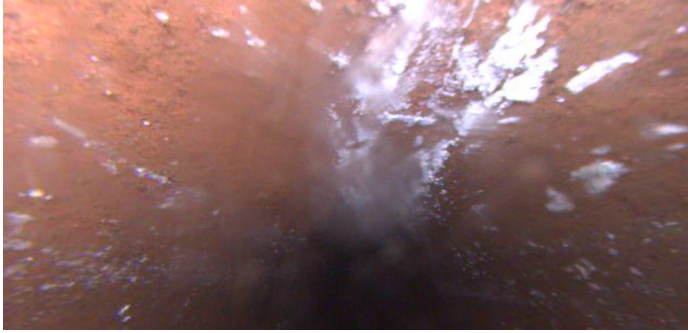
Code:	<b>MSA</b>
Description:	<b>Abandoned Survey</b>
Distance (ft):	<b>18.6</b>
Structural Grade:	<b>0</b>
O&M Grade:	<b>0</b>
Clock Start/From:	
Clock To:	
1st Value:	
2nd Value:	
Value Percent:	
Continuous Index:	
Within 8" of Joint:	<b>NO</b>
Remarks:	<b>debris under water</b>
