Profile/Photo Observation Report

Street:	W 40th ave	Flow Control:	Not Controlled
City:	Hobart, IN	Year Renewed:	
Location:	Other	Tape/Media #:	
Purpose:	Not Known	Dia/Height:	10"
Use:	Sanitary	Material:	VCP
Drain Area:	NA	Lining:	
Category:	NA		
Comment:

Location Details:		Direction of Survey:	Downstream
US MH:	M-603-007	DS MH:	M-603-008
		Total Length Surveyed (ft):	32.2

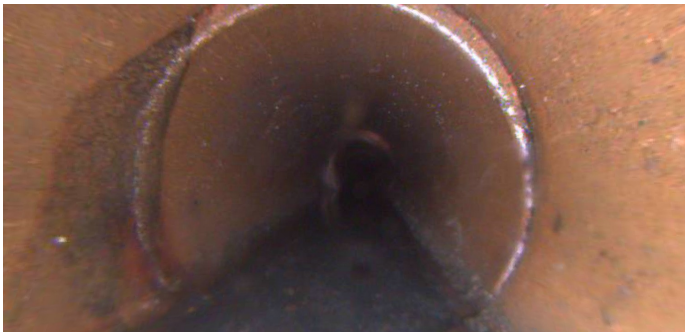
Code:	IW
Description:	Infil Weeper

Distance (ft):	3.6
Structural Grade:	0
O&M Grade:	2
Clock Start/From:	8
Clock To:	10
1st Value:	
2nd Value:	
Value Percent:	
Continuous Index:	
Within 8" of Joint:	YES
Remarks:

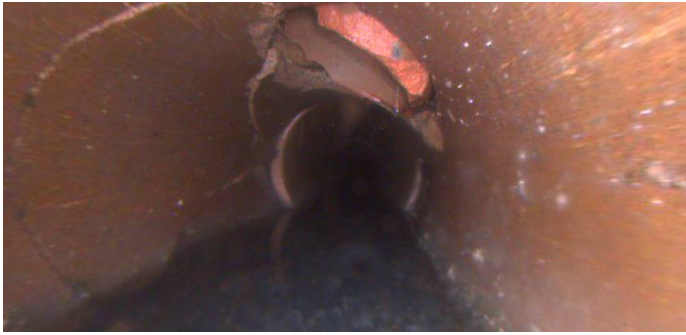
Code: **FM**
Description: **Fracture Multiple**

Distance (ft): **5.5**
Structural Grade: **4**
O&M Grade: **0**
Clock Start/From: **7**
Clock To: **12**
1st Value:
2nd Value:
Value Percent:
Continuous Index:
Within 8" of Joint:
Remarks:

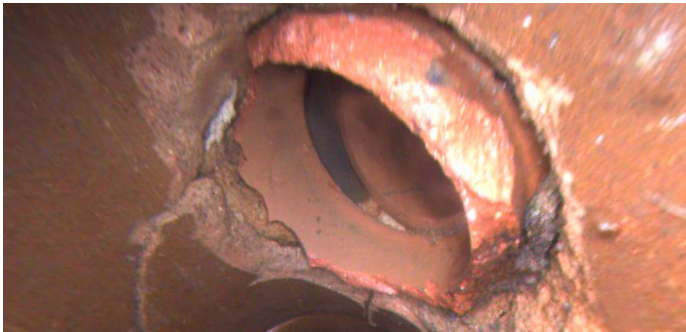
Code: **TBI**
Description: **Tap Break-in Intruding**

Distance (ft): **6.0**
Structural Grade: **0**
O&M Grade: **2**
Clock Start/From: **12**
Clock To:
1st Value: **4.000**
2nd Value: **1.000**
Value Percent:
Continuous Index:
Within 8" of Joint:
Remarks:

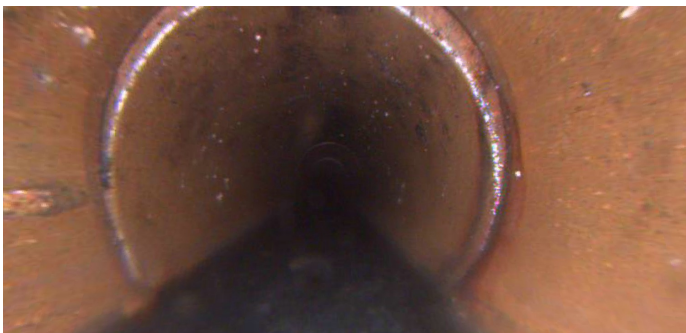
Code: **IW**
Description: **Infil Weeper**

Distance (ft): **18.7**
Structural Grade: **0**
O&M Grade: **2**
Clock Start/From: **2**
Clock To: **4**
1st Value:
2nd Value:
Value Percent:
Continuous Index:
Within 8" of Joint: **YES**
Remarks:

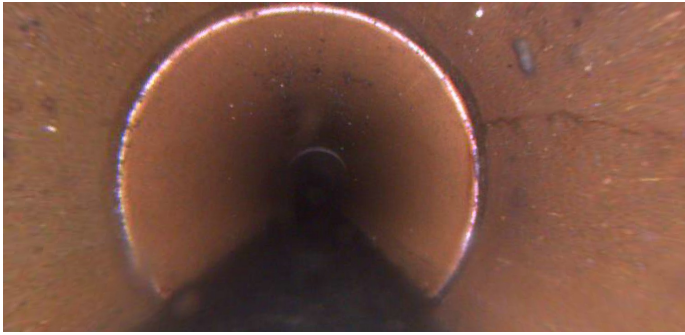
Code: **FL**
Description: **Fracture Longitudinal**

Distance (ft): **21.8**
Structural Grade: **3**
O&M Grade: **0**
Clock Start/From: **3**
Clock To:
1st Value:
2nd Value:
Value Percent:
Continuous Index:
Within 8" of Joint: **YES**
Remarks:

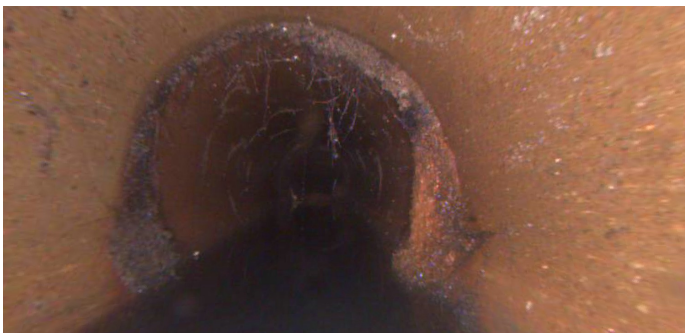
Code: **DAE**
Description: **Deposits Attached Encrustation**

Distance (ft): **27.8**
Structural Grade: **0**
O&M Grade: **2**
Clock Start/From: **8**
Clock To: **4**
1st Value:
2nd Value:
Value Percent: **5.000**
Continuous Index:
Within 8" of Joint: **YES**
Remarks:

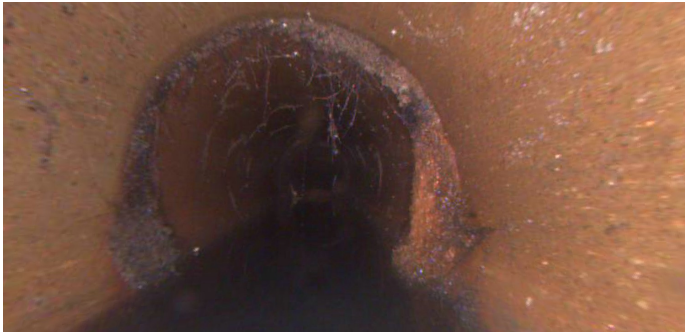
Code: **RMJ**
Description: **Roots Medium Joint**

Distance (ft): **27.8**
Structural Grade: **0**
O&M Grade: **3**
Clock Start/From: **8**
Clock To: **4**
1st Value:
2nd Value:
Value Percent: **5.000**
Continuous Index:
Within 8" of Joint: **YES**
Remarks:

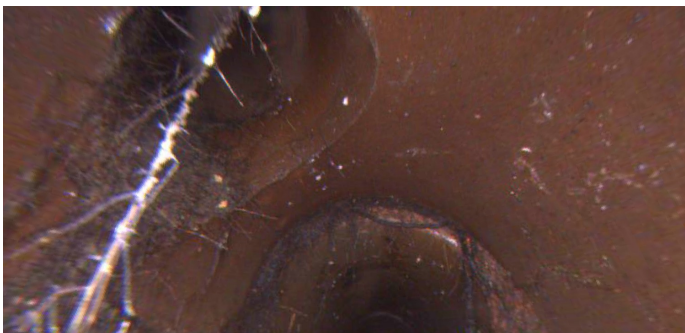
Code: **TFD**
Description: **Tap Factory Defective**

Distance (ft): **30.6**
Structural Grade: **0**
O&M Grade: **2**
Clock Start/From: **11**
Clock To:
1st Value: **4.000**
2nd Value:
Value Percent:
Continuous Index:
Within 8" of Joint:
Remarks: **roots**

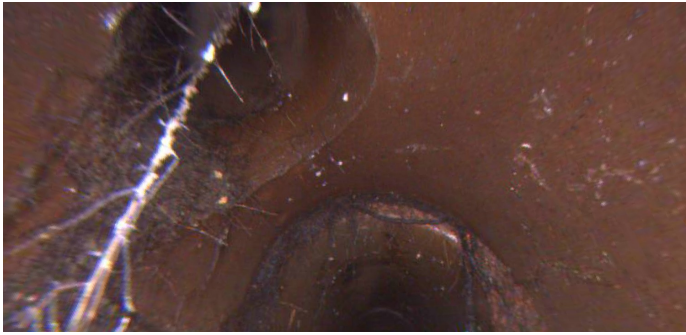
Code: **RFL**
Description: **Roots Fine Lateral**

Distance (ft): **30.6**
Structural Grade: **0**
O&M Grade: **1**
Clock Start/From: **10**
Clock To:
1st Value:
2nd Value:
Value Percent:
Continuous Index:
Within 8" of Joint: **NO**
Remarks:

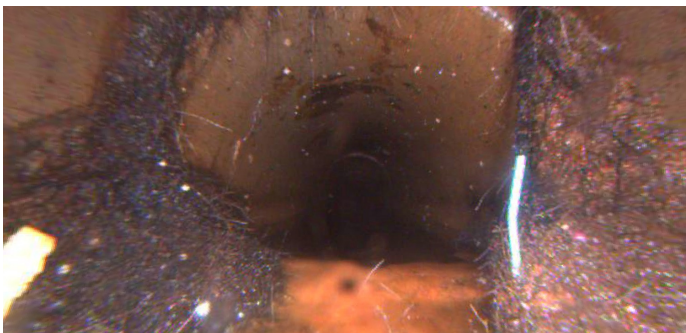
Code: **RMJ**
Description: **Roots Medium Joint**

Distance (ft): **31.1**
Structural Grade: **0**
O&M Grade: **3**
Clock Start/From: **8**
Clock To: **4**
1st Value:
2nd Value:
Value Percent: **10.000**
Continuous Index:
Within 8" of Joint: **YES**
Remarks:

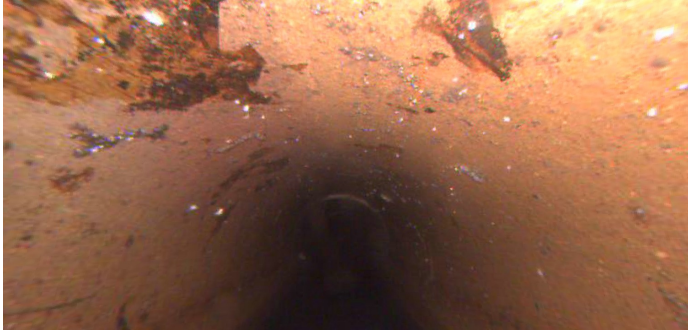
Code:	MSA
Description:	Abandoned Survey
Distance (ft):	32.2
Structural Grade:	0
O&M Grade:	0
Clock Start/From:	
Clock To:	
1st Value:	
2nd Value:	
Value Percent:	
Continuous Index:	
Within 8" of Joint:	NO
Remarks:	rmj
