## Profile/Photo Observation Report

Street:	<b>W 40TH PL</b>	Flow Control:	<b>Not Controlled</b>
City:	<b>Hobart, IN</b>	Year Renewed:	
Location:	<b>Other</b>	Tape/Media #:	
Purpose:	<b>Not Known</b>	Dia/Height:	<b>10"</b>
Use:	<b>Sanitary</b>	Material:	<b>VCP</b>
Drain Area:	<b>NA</b>	Lining:	
Category:	<b>NA</b>		
Comment:

Location Details:		Direction of Survey:	<b>Downstream</b>
US MH:	<b>M-603-007</b>	DS MH:	<b>M-603-009</b>
		Total Length Surveyed (ft):	<b>4.7</b>

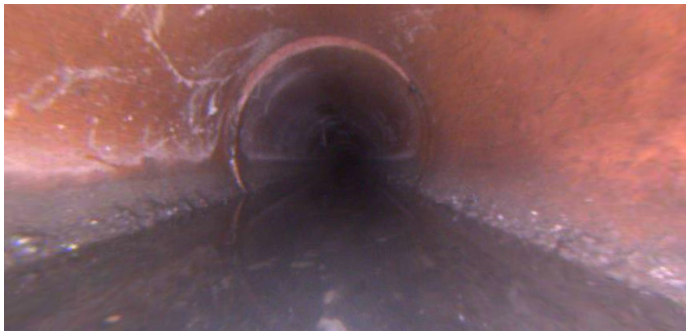
Code: **AMH**  
Description: **Manhole**

Distance (ft): **.0**  
Structural Grade: **0**  
O&M Grade: **0**  
Clock Start/From:  
Clock To:  
1st Value:  
2nd Value:  
Value Percent:  
Continuous Index:  
Within 8" of Joint: **NO**  
Remarks: **M-603-007**

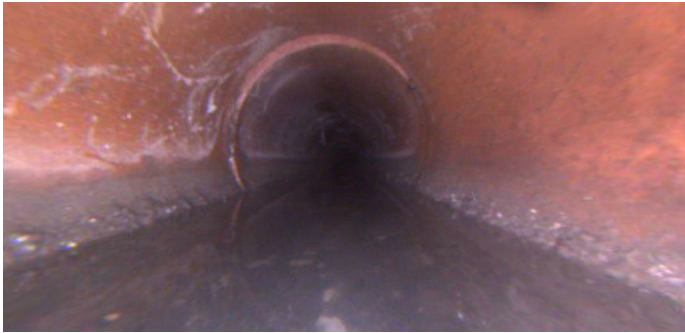
Code:	<b>MWL</b>
Description:	<b>Water Level</b>

Distance (ft):	<b>.0</b>
Structural Grade:	<b>0</b>
O&M Grade:	<b>0</b>
Clock Start/From:	
Clock To:	
1st Value:	
2nd Value:	
Value Percent:	<b>20.000</b>
Continuous Index:	
Within 8" of Joint:	<b>NO</b>
Remarks:

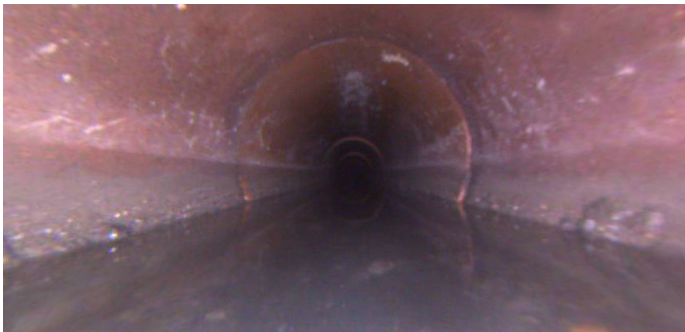
Code:	<b>MSA</b>
Description:	<b>Abandoned Survey</b>

Distance (ft):	<b>4.7</b>
Structural Grade:	<b>0</b>
O&M Grade:	<b>0</b>
Clock Start/From:	
Clock To:	
1st Value:	
2nd Value:	
Value Percent:	
Continuous Index:	
Within 8" of Joint:	<b>NO</b>
Remarks:	<b>debris under water</b>
