Profile/Photo Observation Report

Street: West 39th Place Flow Control: Not Controlled

City: Hobart, IN Year Renewed:
Location: Easement/Right of Way Tape/Media #:

US MH: M-603-009 DS MH: M-603-010 Total Length Surveyed (ft): 158.0

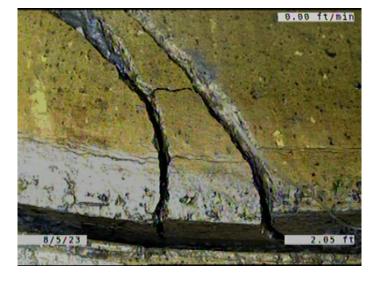
Code: B

Description: Broken

Distance (ft): 2.1
Structural Grade: 4

Clock Start/From: 4

Clock To: 7

Within 8" of Joint: YES

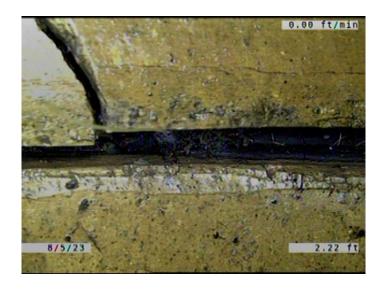
Code: RFJ

Description: **Roots Fine Joint**

Distance (ft): 2.2 Structural Grade: 0 1 O&M Grade: Clock Start/From: 8 Clock To: 4

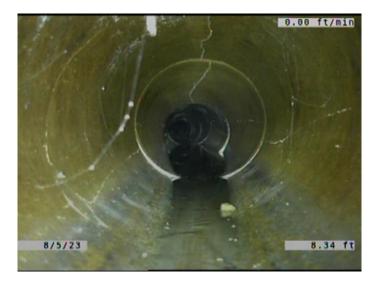
Code: FΜ

Description: **Fracture Multiple**

Distance (ft): 8.3 Structural Grade: 4 O&M Grade: 0 Clock Start/From: 12 12 Clock To:

S01 Within 8" of Joint: YES

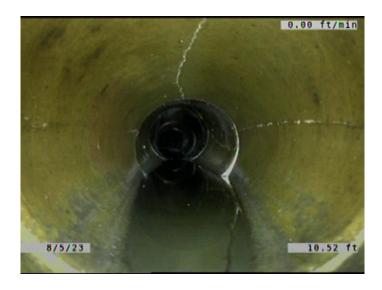
Description: Miscellaneous Water Level Sag

Distance (ft): 10.5
Structural Grade: 2
O&M Grade: 0

Value Percent: 15.000
Continuous Index: S02
Within 8" of Joint: NO

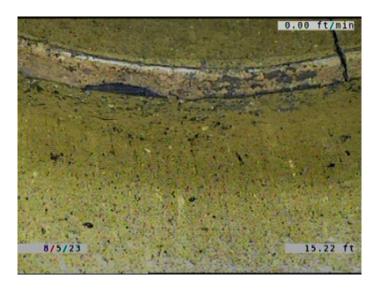
Code: **JOMD**

Description: Joint Offset Medium Defective

Distance (ft): 15.2
Structural Grade: 3
O&M Grade: 0

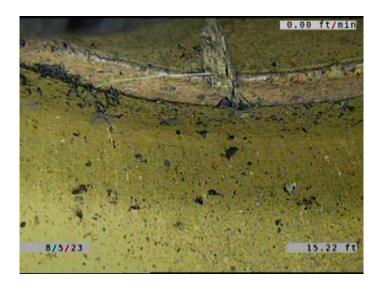
Code: RFJ

Description: Roots Fine Joint

Distance (ft): 15.2
Structural Grade: 0
O&M Grade: 1
Clock Start/From: 9
Clock To: 11

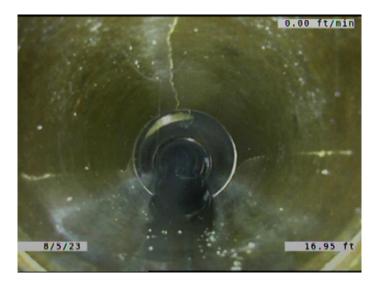
Code: MWLS

Description: Miscellaneous Water Level Sag

Distance (ft): 16.9
Structural Grade: 2
O&M Grade: 0

Value Percent: 15.000
Continuous Index: F02
Within 8" of Joint: NO

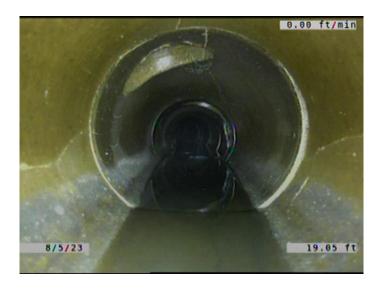
Description: Miscellaneous Water Level Sag

Distance (ft): 19.0 Structural Grade: 2

Value Percent: 20.000
Continuous Index: S03
Within 8" of Joint: NO

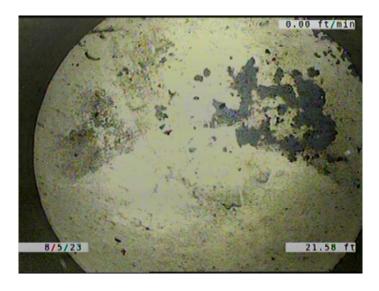
Code: **TFD**

Description: Tap Factory Defective

Distance (ft): 21.6
Structural Grade: 0
O&M Grade: 3
Clock Start/From: 11

Remarks: CAPPED. TAP BROKEN.

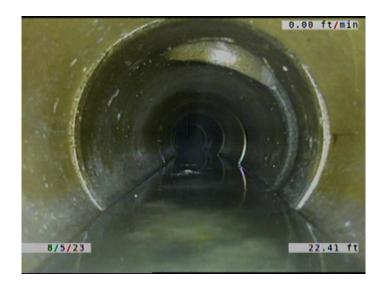
Code: **DSF**

Description: Deposits Settled Fine

Distance (ft): 22.4
Structural Grade: 0
O&M Grade: 2
Clock Start/From: 5
Clock To: 7

Value Percent: 5.000
Continuous Index: S04
Within 8" of Joint: YES

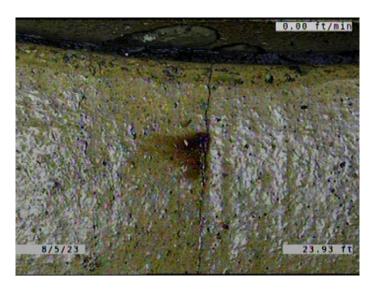
Code: ISB

Description: Infiltration Stain Barrel

Distance (ft): 23.9
Structural Grade: 0
O&M Grade: 1
Clock Start/From: 3
Clock To:
1st Value:
2nd Value:

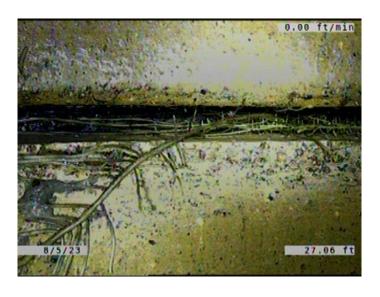
Code: RFJ

Description: Roots Fine Joint

Distance (ft): 27.1
Structural Grade: 0
O&M Grade: 1
Clock Start/From: 8
Clock To: 4
1st Value:
2nd Value:
Value Percent:
Continuous Index: \$05

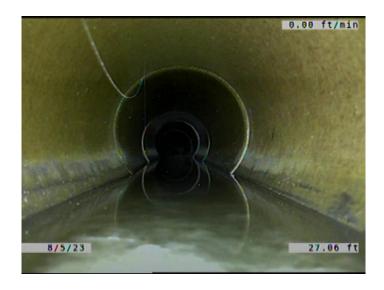
Code: FM
Description: Fracture Multiple

Distance (ft): 27.1
Structural Grade: 4

Continuous Index: F01
Within 8" of Joint: YES

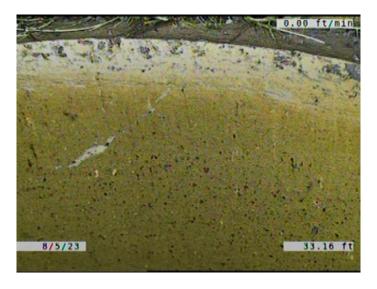
Code: CS

Description: Crack Spiral

Distance (ft): 33.2
Structural Grade: 2
O&M Grade: 0
Clock Start/From: 1
Clock To: 2
1st Value:
2nd Value:
Value Percent:
Continuous Index:

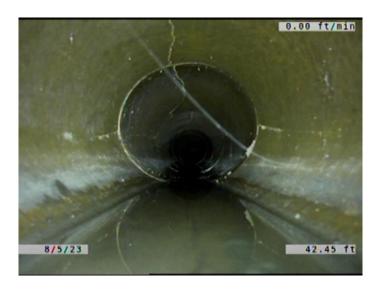
Code: FH4

Description: Fracture Longitudinal Hinge, 4

Distance (ft): 42.5
Structural Grade: 4
O&M Grade: 0
Clock Start/From: 12
Clock To: 12
1st Value:
2nd Value:

Continuous Index: S06
Within 8" of Joint: YES

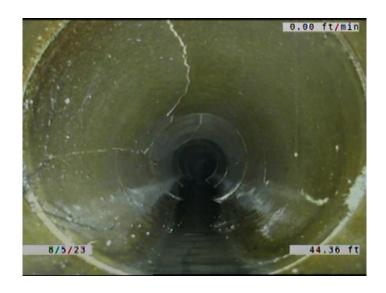
Description: Miscellaneous Water Level Sag

Distance (ft): 44.4
Structural Grade: 2
O&M Grade: 0

Value Percent: 20.000
Continuous Index: F03
Within 8" of Joint: NO

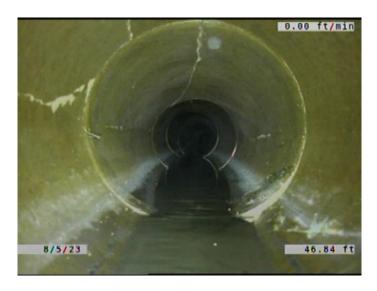
Code: MWLS

Description: Miscellaneous Water Level Sag

Distance (ft): 46.8
Structural Grade: 2
O&M Grade: 0

Value Percent: 20.000
Continuous Index: S07
Within 8" of Joint: NO

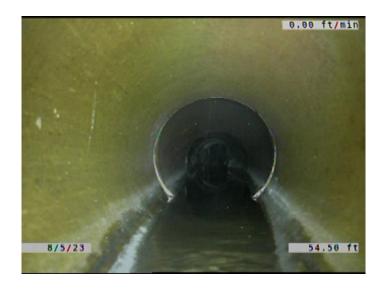
Code: FH4

Description: Fracture Longitudinal Hinge, 4

Distance (ft): 54.5
Structural Grade: 4

Continuous Index: F06
Within 8" of Joint: YES

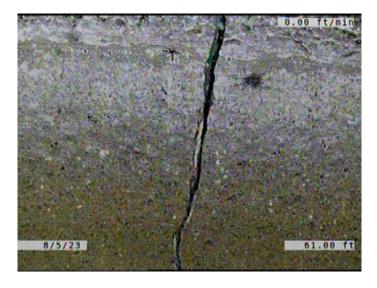
Code: FM

Description: Fracture Multiple

Distance (ft): 61.0
Structural Grade: 4
O&M Grade: 0
Clock Start/From: 8
Clock To: 4
1st Value:
2nd Value:

Continuous Index: \$08
Within 8" of Joint: YES

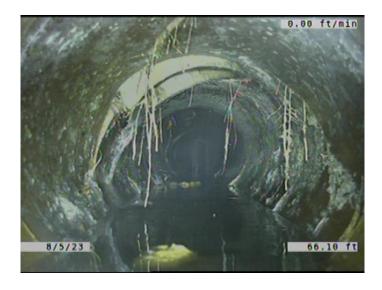
Code: DR

Description: Deformed Rigid

Distance (ft): 66.1
Structural Grade: 4

Value Percent: 5.000
Continuous Index: S09
Within 8" of Joint: NO

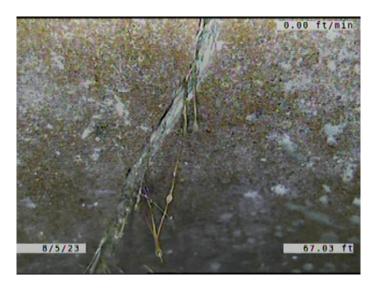
Code: RFB

Description: Roots Fine Barrel

Distance (ft): 67.0
Structural Grade: 0
O&M Grade: 2
Clock Start/From: 8
Clock To: 4
1st Value:
2nd Value:

Continuous Index: **S10**Within 8" of Joint: **NO**

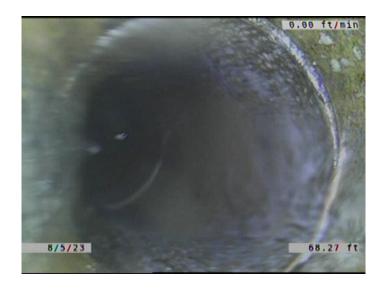
Code: **TBI**

Description: Tap Break-in Intruding

O&M Grade: 2

Remarks: ACTIVITY.

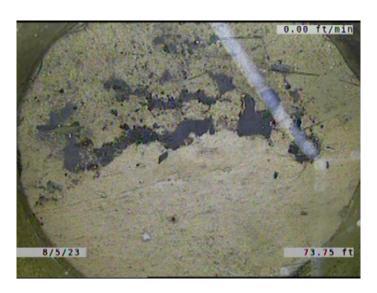
Code: **TFD**

Description: Tap Factory Defective

O&M Grade: 3

Remarks: TAP BROKEN. CAPPED. ROOTS GROWING AROUND THE CAP.

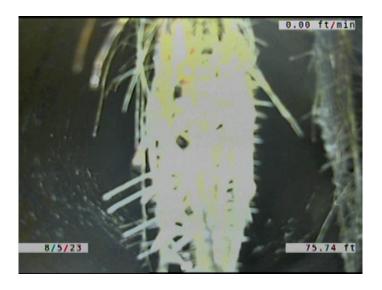
Code: DR

Description: Deformed Rigid

Distance (ft): 75.7
Structural Grade: 4
O&M Grade: 0

Value Percent: 5.000
Continuous Index: F09
Within 8" of Joint: NO

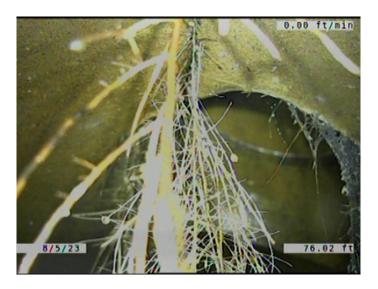
Code: RMB

Description: Roots Medium Barrel

Distance (ft): 76.0
Structural Grade: 0
O&M Grade: 4
Clock Start/From: 10
Clock To: 2
1st Value:

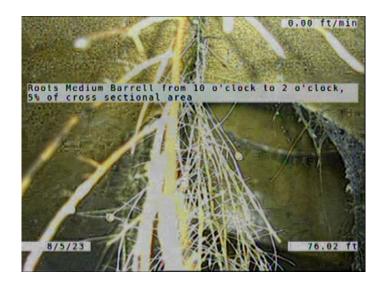
Code: RFL

Description: Roots Fine Lateral

Distance (ft): 76.0
Structural Grade: 0
O&M Grade: 1
Clock Start/From: 1

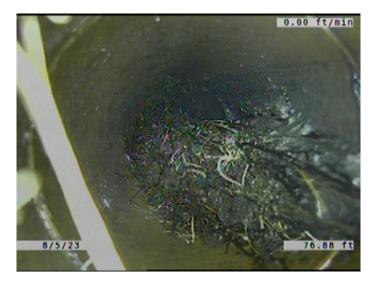
Code: **TFD**

Description: Tap Factory Defective

Distance (ft): 76.9
Structural Grade: 0
O&M Grade: 3
Clock Start/From: 1

Remarks: 80% PLUGGED WITH ROOTS. TAP
BROKEN. ROOTS GROWING FROM T

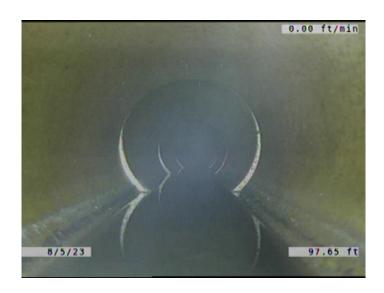
Code: **RFB** Description: **Roots Fine Barrel**

Distance (ft): 97.7 Structural Grade: 0 2 O&M Grade: Clock Start/From: 8 Clock To: 4 1st Value: 2nd Value: Value Percent:

Continuous Index: F10 Within 8" of Joint: NO

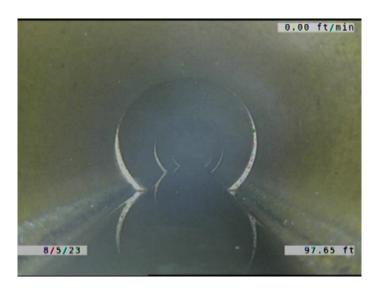
Code: FM

Description: **Fracture Multiple**

Distance (ft): 97.7 Structural Grade: 4 O&M Grade: 0 Clock Start/From: 8 Clock To: 4 1st Value: 2nd Value: Value Percent: Continuous Index: F08 Within 8" of Joint:

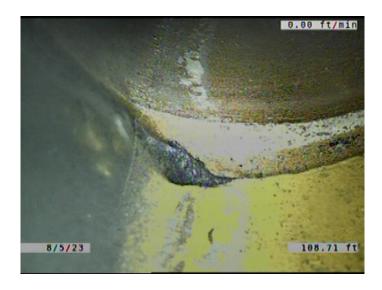
Code: JOMD

Description: Joint Offset Medium Defective

Distance (ft): 108.7
Structural Grade: 3
O&M Grade: 0

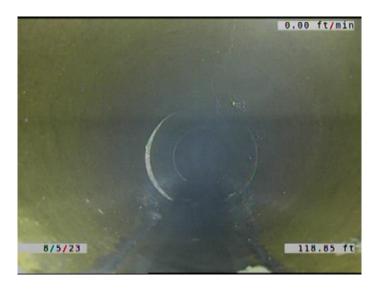
Code: MWLS

Description: Miscellaneous Water Level Sag

Distance (ft): 118.8
Structural Grade: 2
O&M Grade: 0

Value Percent: 20.000
Continuous Index: F07
Within 8" of Joint: NO

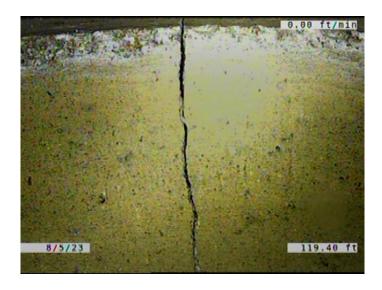
Code: FM
Description: Fracture Multiple

Distance (ft): 119.4
Structural Grade: 4

Continuous Index: **S11** Within 8" of Joint: **YES**

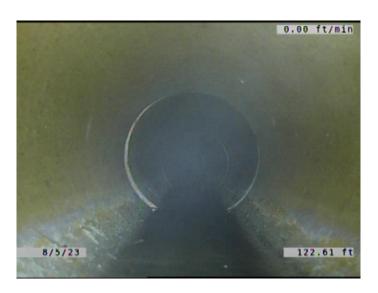
Code: **FM**

Description: Fracture Multiple

Distance (ft): 122.6
Structural Grade: 4
O&M Grade: 0
Clock Start/From: 12
Clock To: 1
1st Value:
2nd Value:
Value Percent:

Continuous Index: F11
Within 8" of Joint: YES

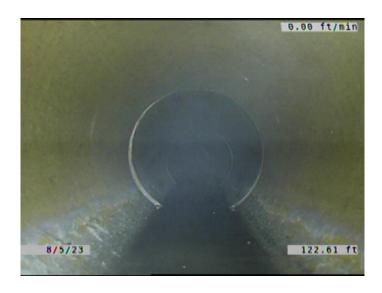
Description: Miscellaneous Water Level Sag

Distance (ft): 122.6
Structural Grade: 2
O&M Grade: 0

Value Percent: 20.000
Continuous Index: S12
Within 8" of Joint: NO

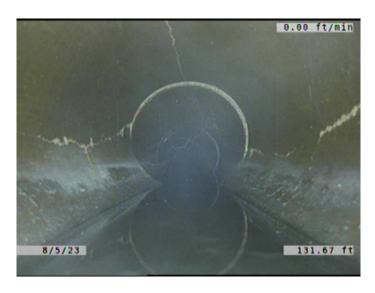
Code: FH3

Description: Fracture Longitudinal Hinge, 3

Distance (ft): 131.7 Structural Grade: 4 O&M Grade: 0 Clock Start/From: 9 3 Clock To: 1st Value: 2nd Value: Value Percent: Continuous Index: Within 8" of Joint: YES

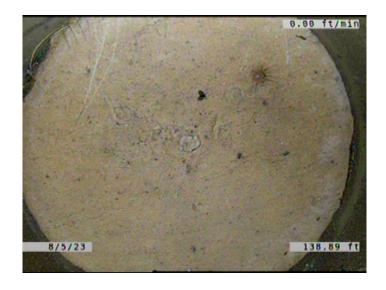
Code: TFC

Description: Tap Factory Capped

Remarks: ROOTS GROWING AROUND THE

CAP.

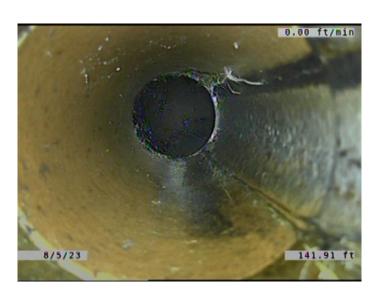
Code: TF

Description: Tap Factory

Remarks: ROOTS GROWING IN THE JOINTS OF

THE SERVICE.

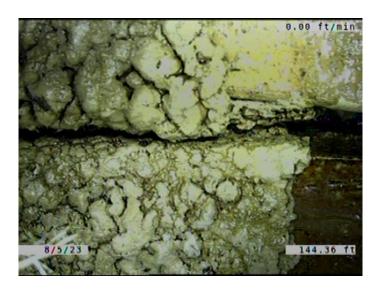
Code: DAE

Description: Deposits Attached Encrustation

Distance (ft): 144.4
Structural Grade: 0
O&M Grade: 2
Clock Start/From: 12
Clock To: 3

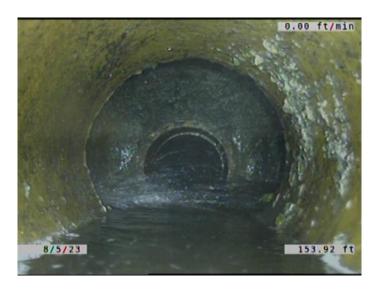
Code: RFJ

Description: Roots Fine Joint

Distance (ft): 153.9
Structural Grade: 0
O&M Grade: 1
Clock Start/From: 8
Clock To: 4
1st Value:
2nd Value:
Value Percent:

Continuous Index: **F05**Within 8" of Joint: **YES**
